# FACILITY CONDITION ASSESSMENT

FACILITY CONDITION ASSESSMENT  
OF  
NORTHSIDE ELEMENTARY  
912 BARTON DRIVE  
ANN ARBOR, MICHIGAN 48105

July 2, 2018

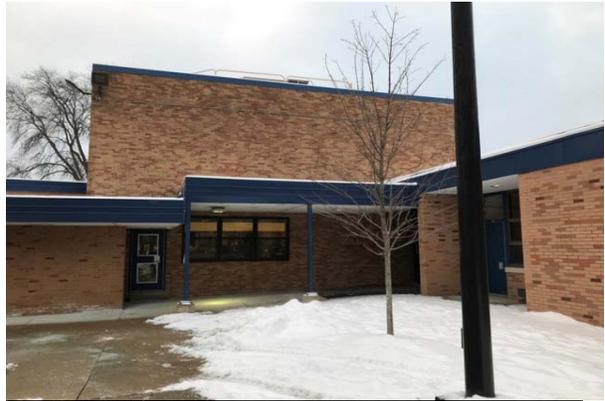
#20:	CLAY BRICK
------	------------

- Isolated portions of the mortar joints along the brick veneer are cracked in small sections throughout the perimeter of the building. The damaged mortar joints must be cleaned and re-pointed.
- There are isolated areas of missing sealant in a small section on the west side of the building. The damaged sealant must be replaced.
- The metal siding has significant portions of the paint that are damaged and faded. The metal siding must be repainted.
- The metal siding has significant portions that are damaged by fire on the east side of the building. The metal siding requires replacement.
- The wall vents are damaged and rusted. The damaged wall vents require replacement.

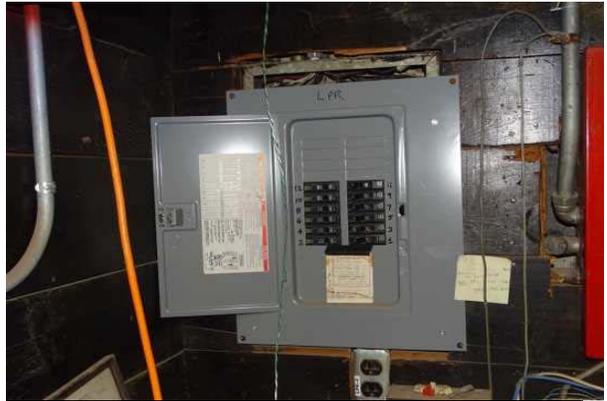
#50:	ELECTRICAL DISTRIBUTION SYSTEM
------	--------------------------------

**MEPF:** The older section of the building has original wiring that should be replaced. Some mechanical components in the building are original and are antiquated. A cost allowance to repair and/or replace these deficient attributes is included in the cost tables

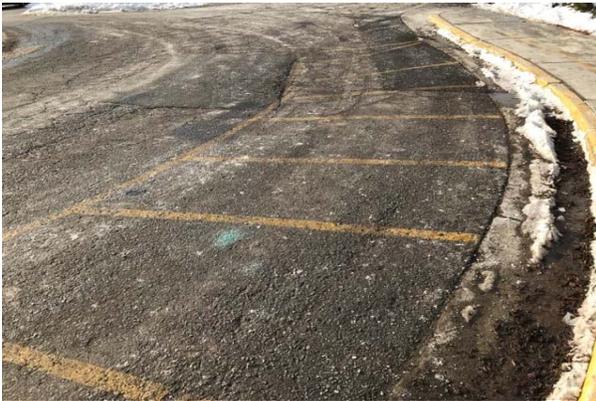
#51:	PARKING LOTS
------	--------------

**Site:** The parking lot has multiple cracks from erosion. A cost allowance to repair and/or replace these deficient attributes is included in the cost tables.
