# FACILITY CONDITION ASSESSMENT

129010.18R000-007.354

June 28, 2018

BACH ELEMENTARY  
600 WEST JEFFERSON STREET  
ANN ARBOR, MICHIGAN 48103

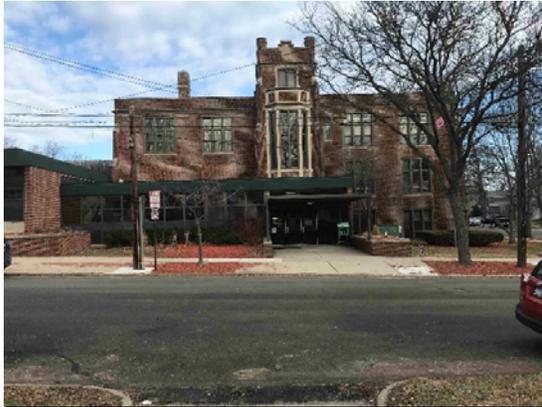
PHOTO #1: FRONT ELEVATION

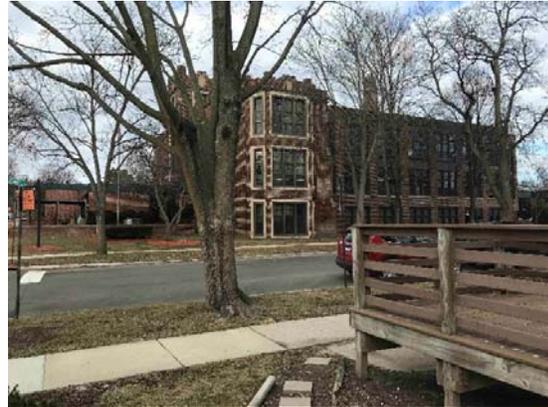
PHOTO #2: SIDE ELEVATION

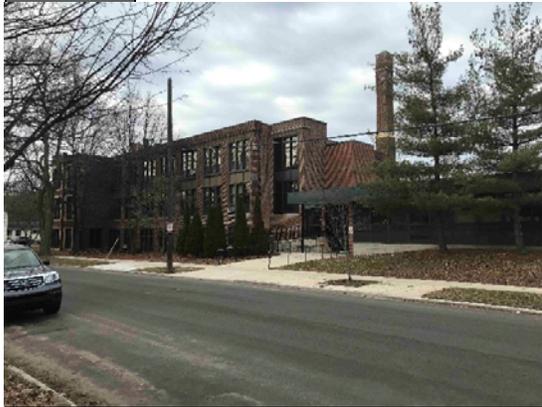
PHOTO #3: SIDE ELEVATION

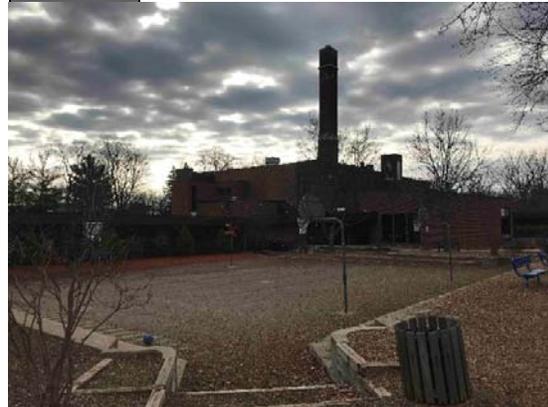
PHOTO #4: REAR ELEVATION

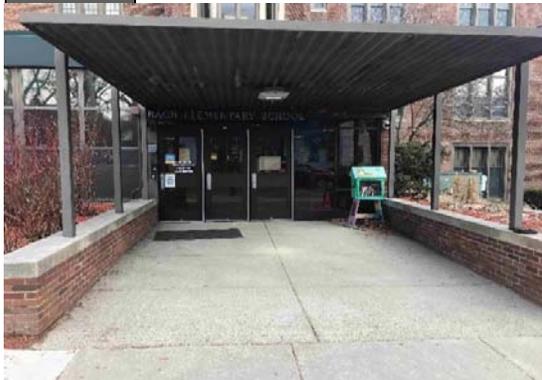
PHOTO #5: MAIN ENTRANCE DOORS

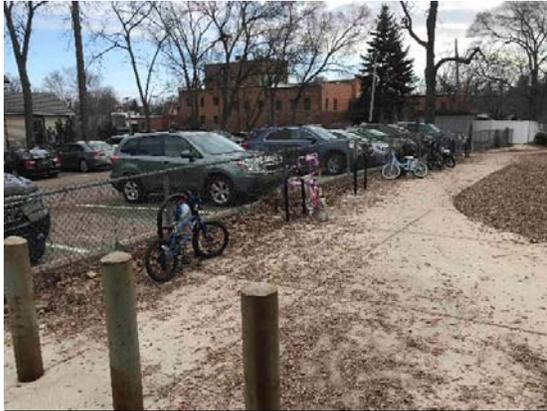
PHOTO #7: CONCRETE SIDEWALKS AND ASPHALT PAVEMENT

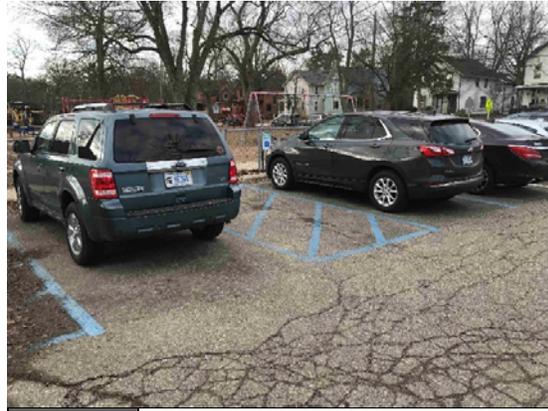
PHOTO #8: ADA PARKING AREA

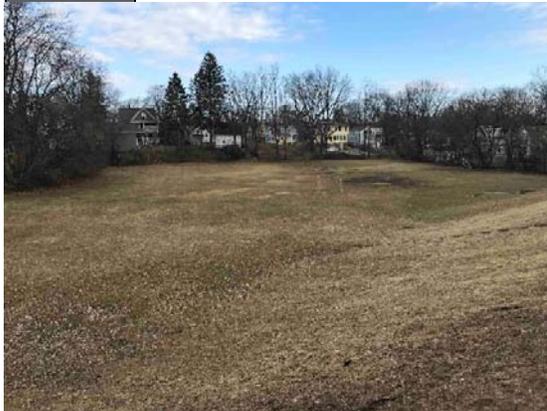
PHOTO #9: SPORTS FIELDS

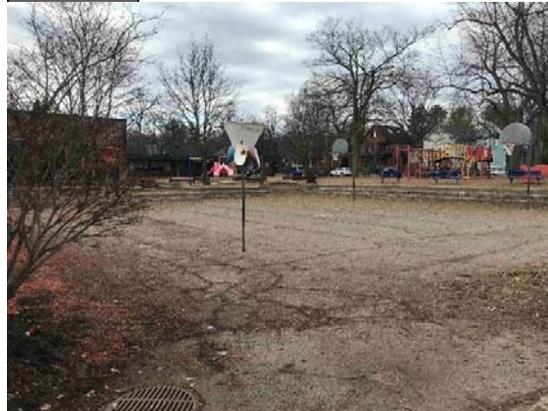
PHOTO #10: BASKETBALL COURT

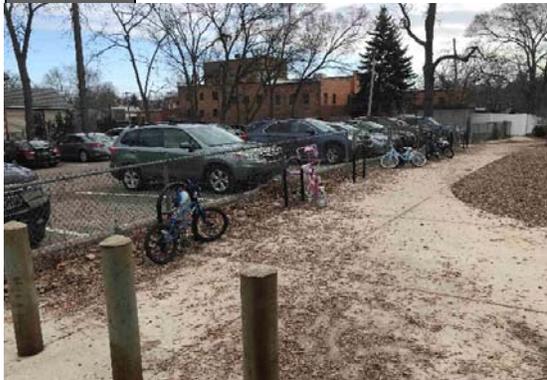
PHOTO #11: CHAIN LINK PERIMETER FENCING

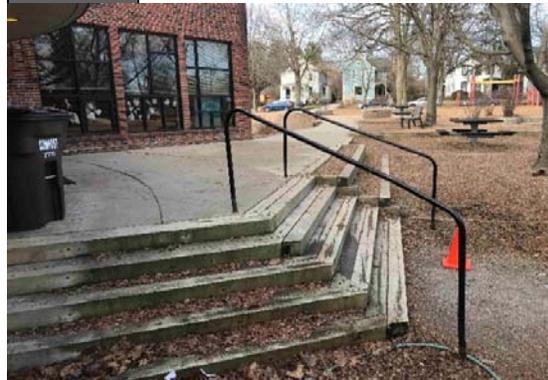
PHOTO #12: CONCRETE STAIRS

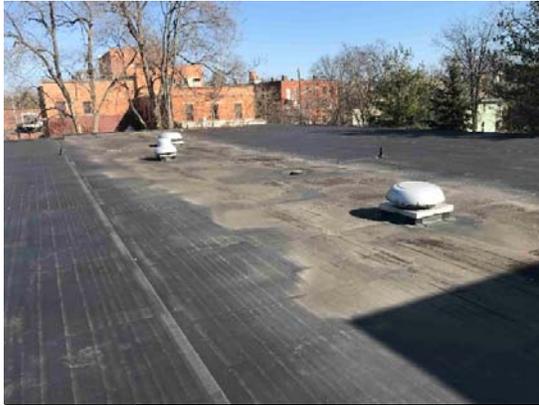
- There is no evidence of roof deck or insulation deterioration. The roof substrate and insulation should be inspected during any future roof repair or replacement work.
- There is evidence of active roof leaks. All active leaks must be repaired.
- Roof drainage appears to be adequate. Clearing and minor repair of drain system components should be performed regularly as part of the property management's routine maintenance and operations program
- The attics are not accessible and it could not be determined if there is moisture, water intrusion, or excessive daylight in the attics.

PHOTO #13: SINGLE-PLY ROOFING

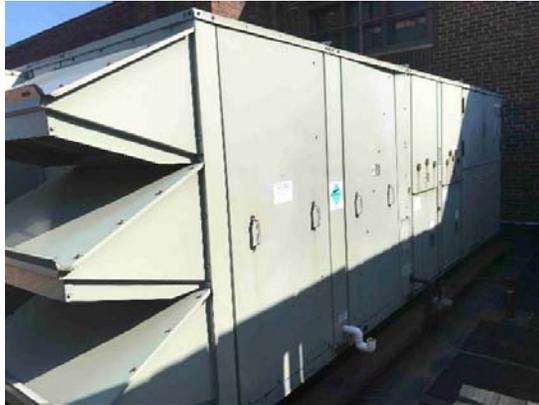
PHOTO #14: ROOFTOP UNIT

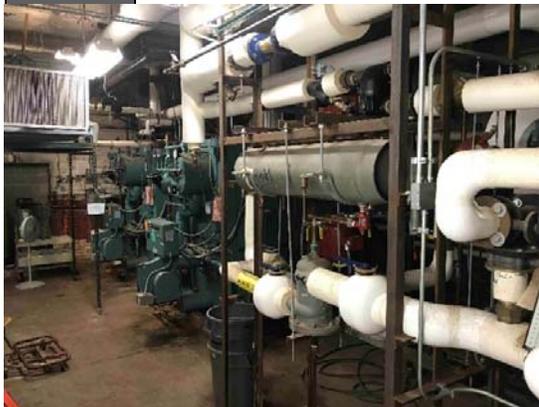
PHOTO #15: HVAC BOILER

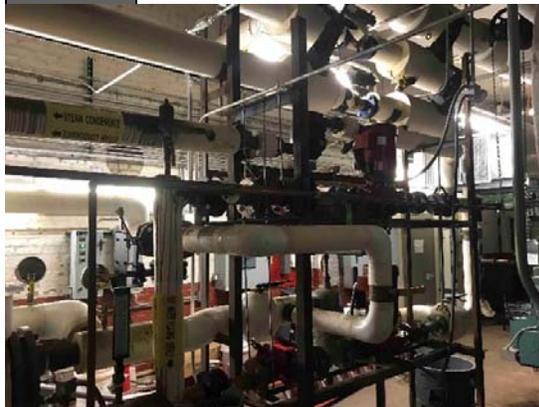
PHOTO #16: CIRCULATION PUMPS

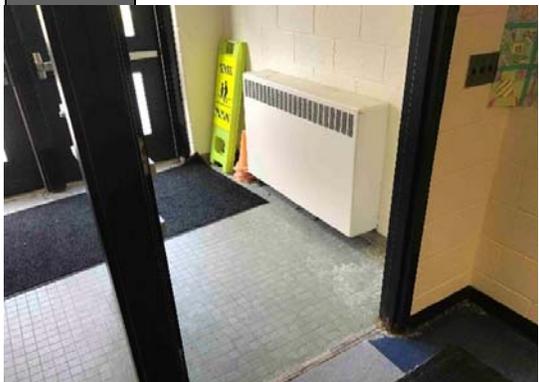
PHOTO #17: HYDRONIC TERMINAL UNIT

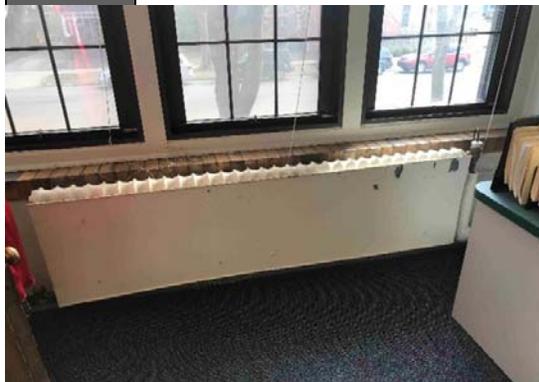
PHOTO #18: CLASSROOM UNIT VENTILATOR

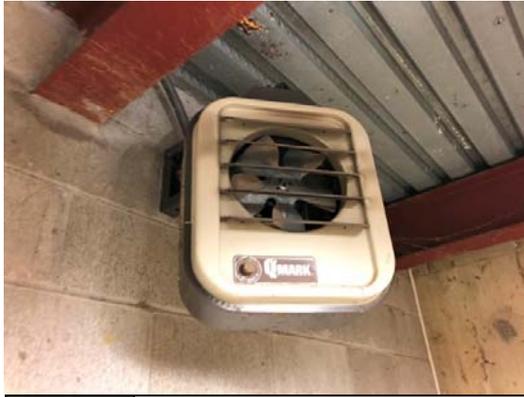
PHOTO #19: SUSPENDED UNIT HEATERS

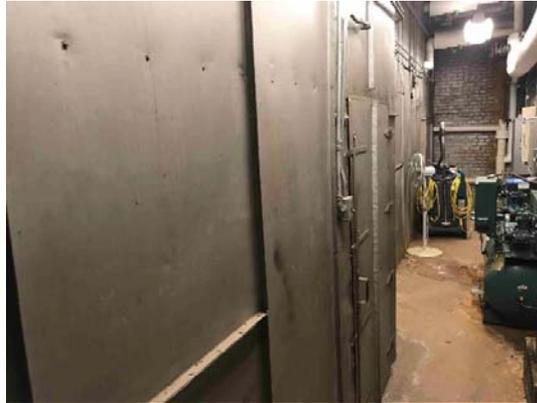
PHOTO #20: AIR HANDLER

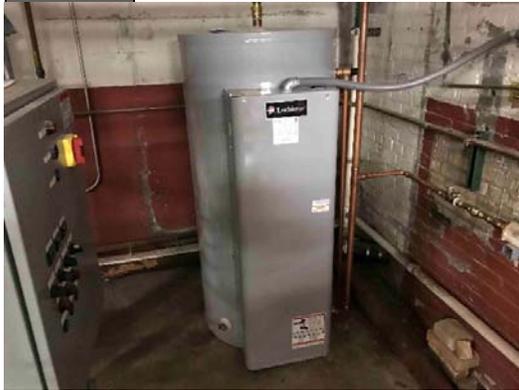
PHOTO #21: DOMESTIC WATER HEATER

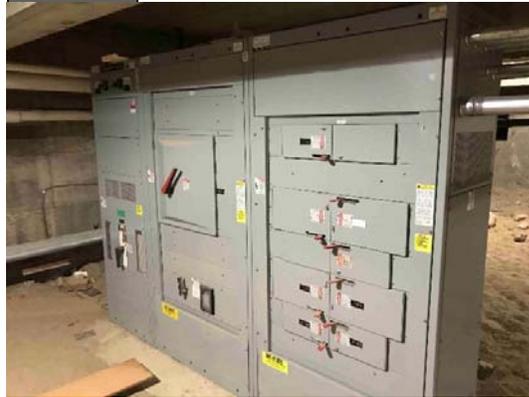
- The panels and switchboards are mostly 1990-2000 components. The electrical service appears to be adequate for the facility's needs. However, due to the age of the panels and switchboards and increasing difficulty of obtaining replacement parts over time, lifecycle replacements are recommended per above.

PHOTO #22: MAIN DISTRIBUTION PANEL

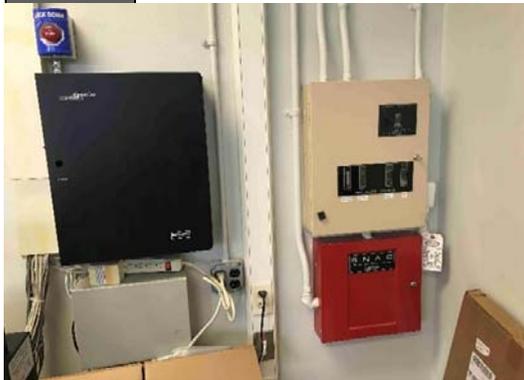
PHOTO #23: FIRE PANEL

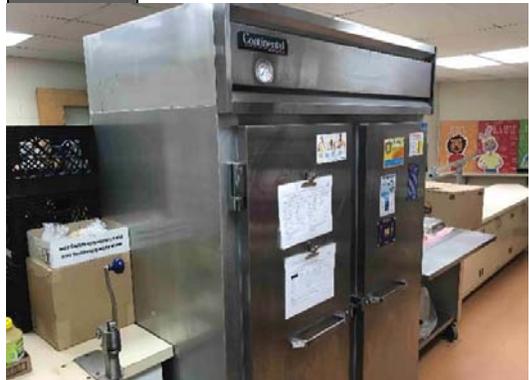
PHOTO #24: KITCHEN EQUIPMENT

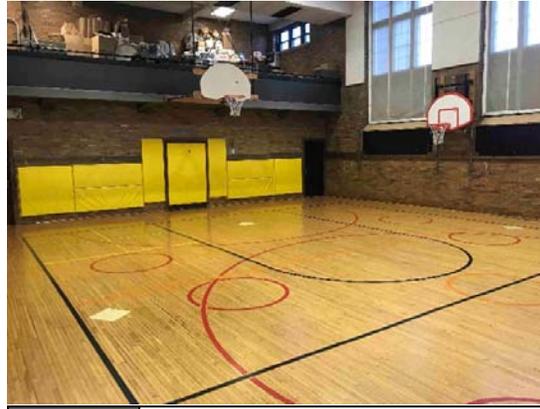
**Architectural :** Finishes include brick veneer exterior walls with concrete accents which are in fair condition and will require re-pointing. The interior ceiling in the gymnasium is damaged and in poor condition. The building lighting system as well as the interior vinyl tile flooring is aged and in fair condition which will need to be replaced. A cost allowance to replace/repair these deficient items is included in the cost tables.

PHOTO #32: GYMNASIUM

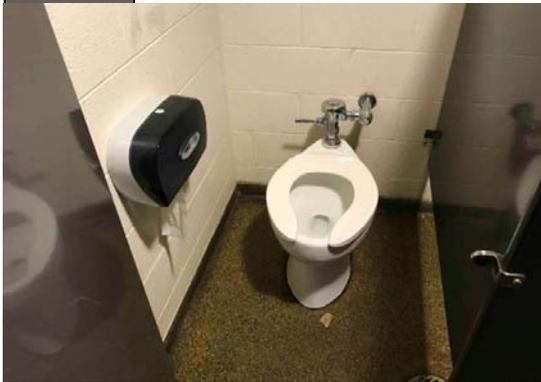
PHOTO #35: RESTROOM STALL

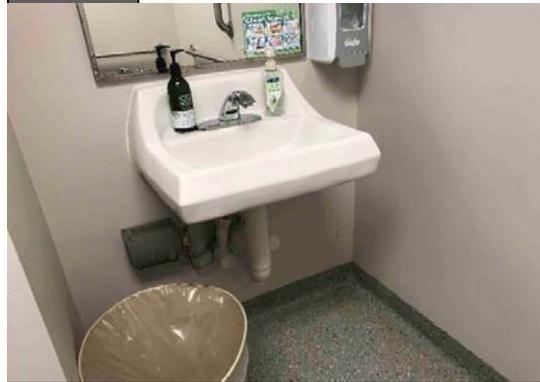
PHOTO #36: RESTROOM SINK
