FACILITY CONDITION ASSESSMENT

129010.18R000-028.354

July 2, 2018

SLAUSON MIDDLE SCHOOL
1019 WEST WASHINGTON
ANN ARBOR, MICHIGAN 48103

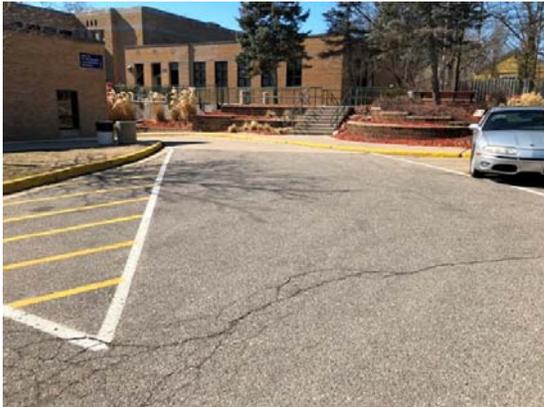
PHOTO #7: CONCRETE SIDEWALKS AND ASPHALT PAVEMENT

Site : Areas of asphalt and concrete are showing deterioration.

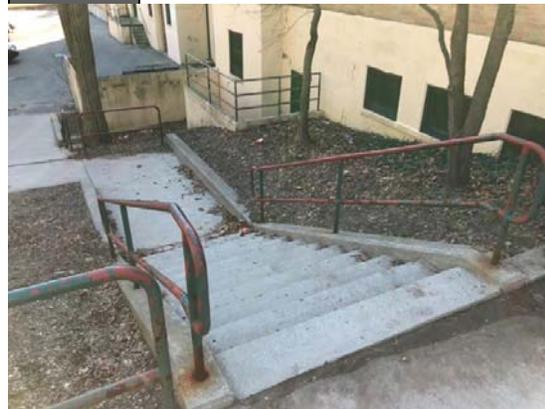
PHOTO #12: CONCRETE STAIRS

B1080 Stairs					
Type	Description	Riser	Handrail	Balusters	Condition
Building Exterior Stairs	Concrete stairs	Closed	Metal	Metal	Fair
Building Interior Stairs	Concrete stairs with ceramic tile treads	Closed	Metal	Metal	Fair

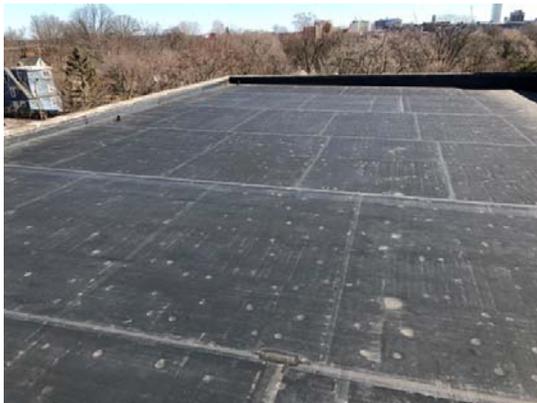
PHOTO #13: SINGLE-PLY ROOFING

Degradation Issues			
Observation	Exists At Site	Observation	Exists At Site
Evidence of roof leaks	<input type="checkbox"/>	Significant ponding	<input checked="" type="checkbox"/>
Excessive patching or repairs	<input type="checkbox"/>	Blistering or ridging	<input type="checkbox"/>
Other	<input type="checkbox"/>	Other	<input type="checkbox"/>

- The roof finishes were installed over ten years ago. Information regarding roof warranties or bonds was not available. The roofs are maintained by an outside contractor.
- There is no evidence of roof deck or insulation deterioration. The roof substrate and insulation should be inspected during any future roof repair or replacement work.
- Current roof leaks should be repaired as a part of routine maintenance.
- Roof drainage appears to be adequate. Clearing and minor repair of drain system components should be performed regularly as part of the property management’s routine maintenance and operations program
- The attics are not accessible and it could not be determined if there is moisture, water intrusion, or excessive daylight in the attics.

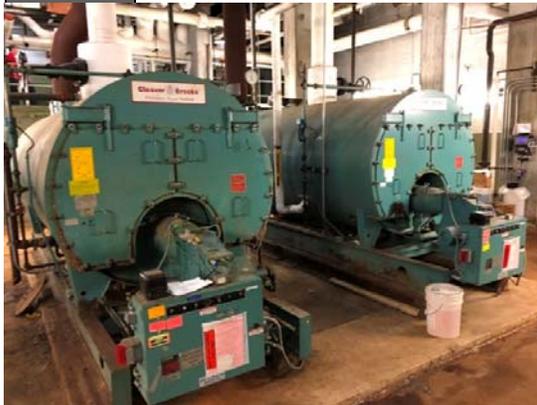
PHOTO #15: HVAC BOILER

- The HVAC systems are maintained by an outside contractor.
- The HVAC equipment varies in age. HVAC equipment is replaced on an "as needed" basis.
- The HVAC equipment appears to be functioning adequately overall. However, due to the inevitable failure of parts and components over time, some of the equipment will require replacement

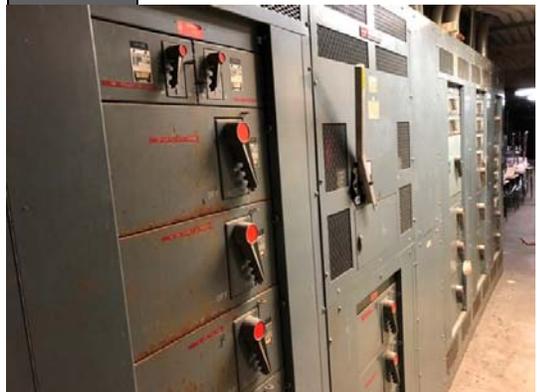
PHOTO #22: MAIN DISTRIBUTION PANEL

- The onsite electrical systems up to the meter are owned and maintained by the respective utility company.
- The electrical service and capacity appear to be adequate for the property's demands.
- The panels and switchboards are mostly 1990-2000 components. The electrical service appears to be adequate for the facility's needs. However, due to the age of the panels and switchboards and increasing difficulty of obtaining replacement parts over time, lifecycle replacements are recommended per above.

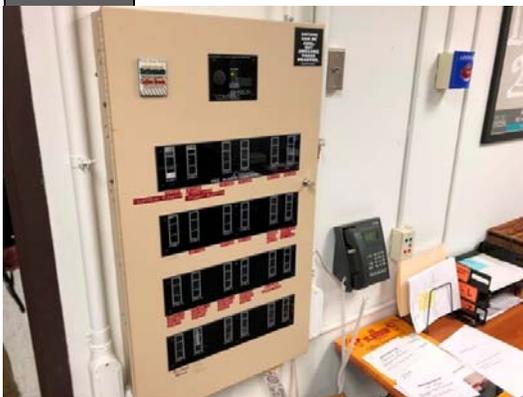
PHOTO #23: FIRE PANEL

D7010 Access Control and Intrusion Detection / D7050 Detection and Alarm		
Item	Description	
Fire Alarm System Condition	Fair	
Central Alarm Panel System	Location of Alarm Panel	Installation Date of Alarm Panel
	Main Office	2000
