FACILITY CONDITION ASSESSMENT

July 2, 2018

TAPPAN MIDDLE SCHOOL
2251 EAST STADIUM BOULEVARD
ANN ARBOR, MICHIGAN 48103

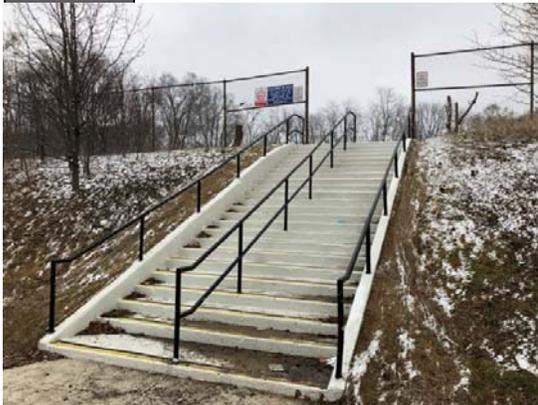
Site : Deteriorating concrete steps.

Site Stairs			
Location	Material	Handrails	Condition
Side entrance	Concrete stairs	Metal	Poor
Glass staircase	Concrete stairs	Metal	Fair
Sports field	Concrete stairs	Metal	Good

PHOTO #9: CONCRETE STEPS AND METAL RAILS

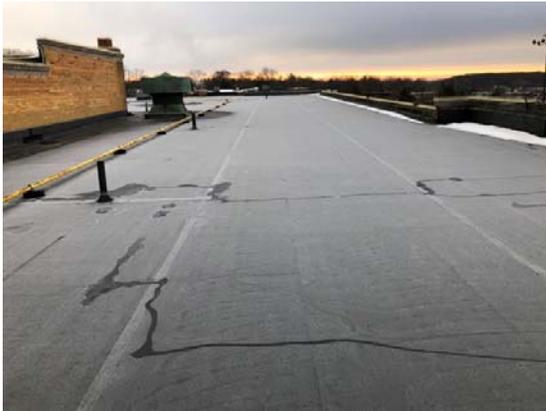
B3010 Primary Roof			
Location	Main Building	Finish	Single-ply membrane
Type / Geometry	Flat	Roof Age	10+ Yrs
Flashing	Sheet metal	Warranties	Unknown
Parapet Copings	None	Roof Drains	Internal drains
Fascia	Metal Panel	Insulation	Rigid Board
Soffits	Concealed Soffits	Skylights	No
Attics	Concrete-topped steel decks	Ventilation Source-1	None
Roof Condition	Fair	Ventilation Source-2	None

Degradation Issues			
Observation	Exists At Site	Observation	Exists At Site
Evidence of roof leaks	<input type="checkbox"/>	Significant ponding	<input checked="" type="checkbox"/>
Excessive patching or repairs	<input type="checkbox"/>	Blistering or ridging	<input type="checkbox"/>
Other	<input type="checkbox"/>	Other	<input type="checkbox"/>

PHOTO #13: SINGLE-PLY ROOFING

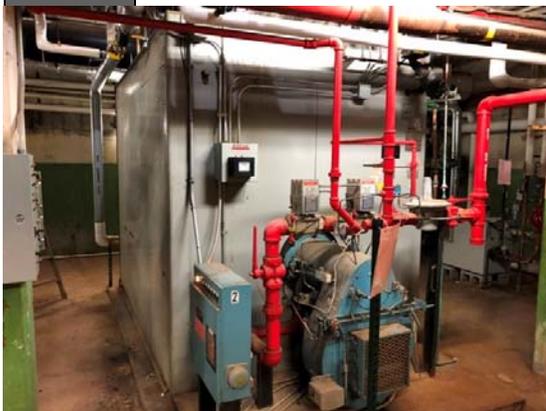
Mechanical room	Boiler	Gas, 4,201 to 10,000 MBH	1	EA	Fair	Replace	7	332,868
Mechanical room	Boiler	Gas, 4,201 to 10,000 MBH	1	EA	Fair	Replace	7	332,868
Roof	Heat Pump	Packaged (RTU), 6 to 10 Ton	1	EA	Fair	Replace	5	15,325
Roof	Heat Pump	Packaged (RTU), 6 to 10 Ton	1	EA	Fair	Replace	5	15,325
Roof	Exhaust Fan	Centrifugal, 251 to 800 CFM	20	EA	Fair	Replace	5	40,437
Roof	Pump	Split System, 5 Ton	1	EA	Fair	Replace	2	6,440
Roof	Heat Pump	Packaged (RTU), 3.5 to 5 Ton	1	EA	Fair	Replace	5	8,928
Roof	Ductless Split System	Single Zone, 2.5 to 3 Ton	1	EA	Good	Replace	14	6,577
Roof	Heat Pump	Packaged (RTU), 2.5 to 3 Ton	1	EA	Fair	Replace	5	5,771
Roof	Heat Pump	Packaged (RTU), 6 to 10 Ton	1	EA	Fair	Replace	5	15,325
Roof	Heat Pump	Packaged (RTU), 3.5 to 5 Ton	1	EA	Fair	Replace	5	8,928
Throughout	Air Conditioner	Window/Thru-Wall, 1.5 to 2 Ton	10	EA	Fair	Replace	2	25,885
Throughout	Radiator	Hydronic Baseboard	1250	LF	Fair	Replace	2	165,963

PHOTO #17: HVAC BOILER

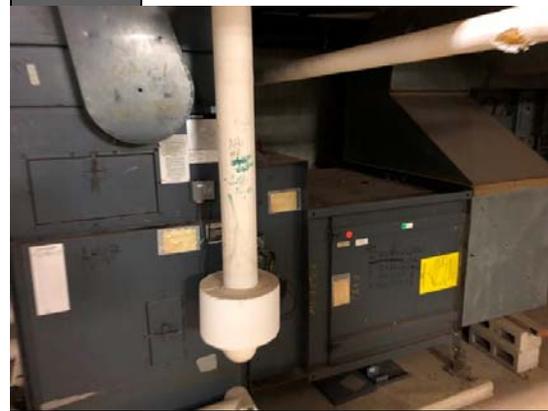
Location	Component	Component Description	Quantity	Unit	Condition	Action	RUL	Est. Cost
Interior	Air Handler	Interior, 50,001 to 65,000 CFM	1	EA	Fair	Replace	5	191,166
Interior	Air Handler	Interior, 50,001 to 65,000 CFM	1	EA	Fair	Replace	12	191,166
Interior	Air Handler	Interior, 50,001 to 65,000 CFM	1	EA	Fair	Replace	5	191,166
Interior	Air Handler	Interior, 50,001 to 65,000 CFM	1	EA	Fair	Replace	12	191,166
Interior	Air Handler	Interior, 50,001 to 65,000 CFM	1	EA	Fair	Replace	5	191,166
Interior	Air Handler	Interior, 50,001 to 65,000 CFM	1	EA	Fair	Replace	5	191,166
Interior	Air Handler	Interior, 50,001 to 65,000 CFM	1	EA	Fair	Replace	5	191,166
Interior	Unit Ventilator	1,501 to 2,000 CFM	20	EA	Fair	Replace	3	254,540
Mechanical room	Distribution Pump	Heating Water, 5 HP	2	EA	Fair	Replace	7	11,038
Mechanical room	Unit Heater	Hydronic, 13 to 36 MBH	4	EA	Fair	Replace	9	6,067
Mechanical room	Pump	Split System, 2.5 Ton	1	EA	Fair	Replace	5	3,366

PHOTO #18: AIR HANDLER
