FACILITY CONDITION ASSESSMENT

EMG

June 29, 2018

KING ELEMENTARY
3800 WALDENWOOD DRIVE
ANN ARBOR, MICHIGAN 48105

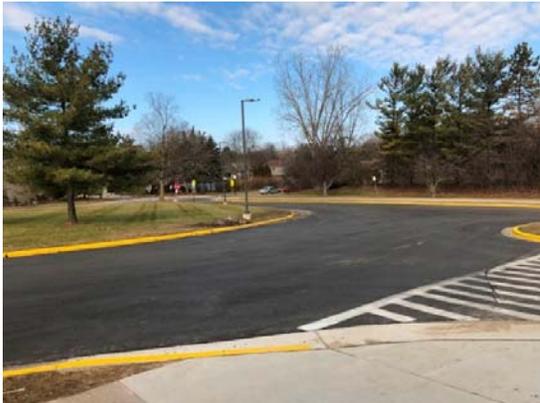
PHOTO #7: CONCRETE SIDEWALKS AND ASPHALT PAVEMENT

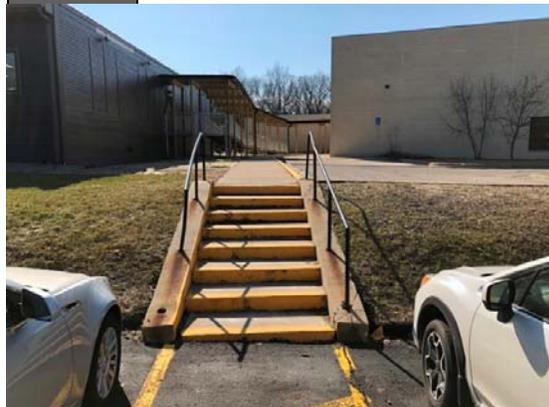
PHOTO #12: CONCRETE STAIRS

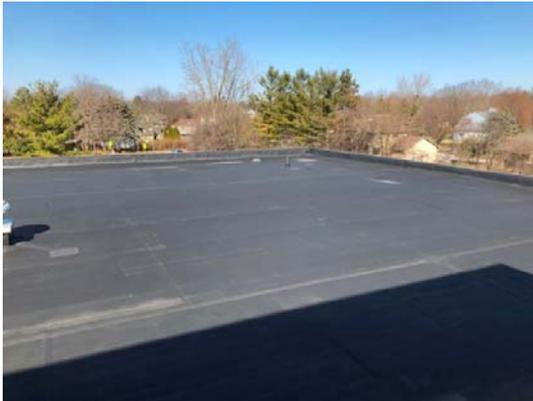
PHOTO #13: SINGLE-PLY ROOFING

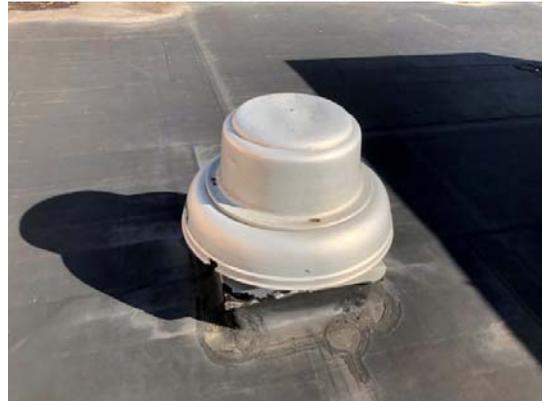
PHOTO #14: EXHAUST FAN

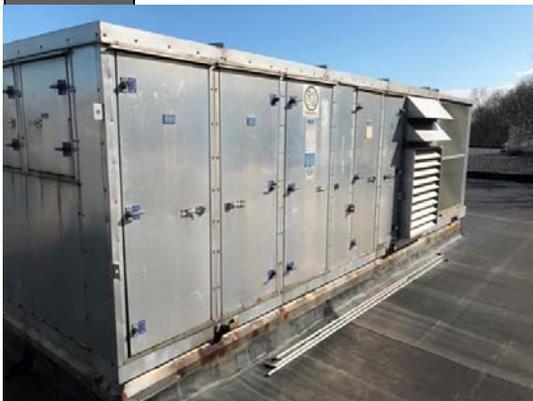
PHOTO #15: ROOFTOP UNIT

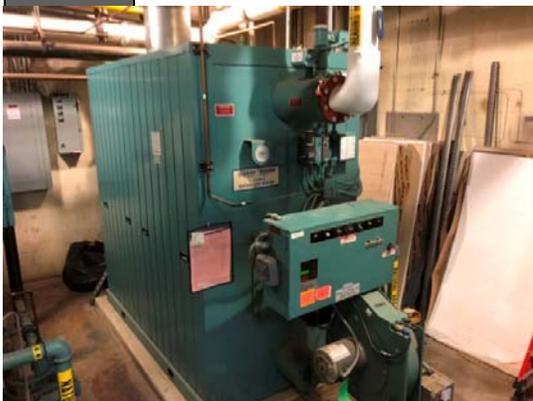
PHOTO #17: HVAC BOILER

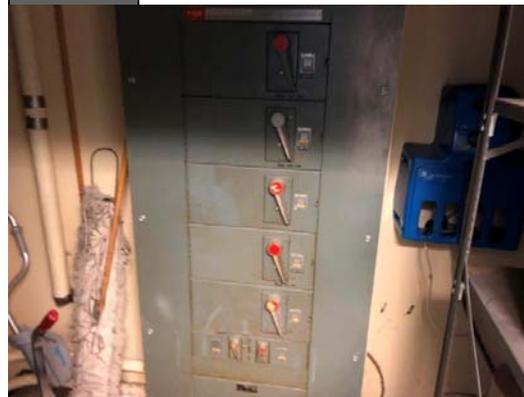
PHOTO #22: MAIN DISTRIBUTION PANEL
