# FACILITY CONDITION ASSESSMENT

June 29, 2018

FACILITY CONDITION ASSESSMENT

MACK ELEMENTARY / OPEN SCHOOL  
920 MILLER ROAD  
ANN ARBOR, MICHIGAN 48103

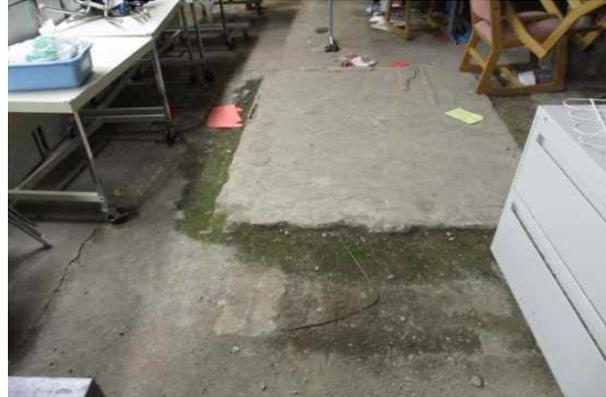
#4:	OLD BOILER ROOM FLOOR, CRUMBLING AND MOISTURE
-----	--

- Replacement of the old boiler room floor

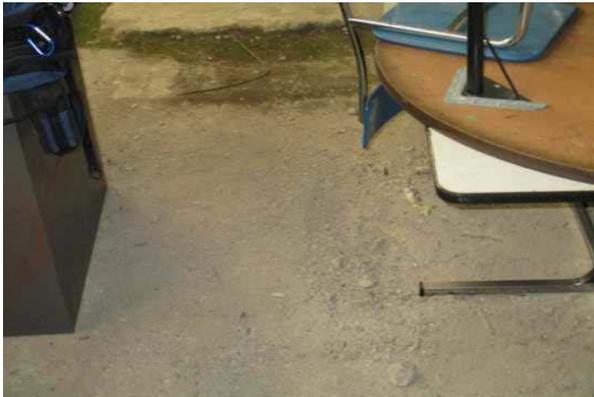
#5:	OLD BOILER ROOM FLOOR, CRUMBLING
-----	-------------------------------------

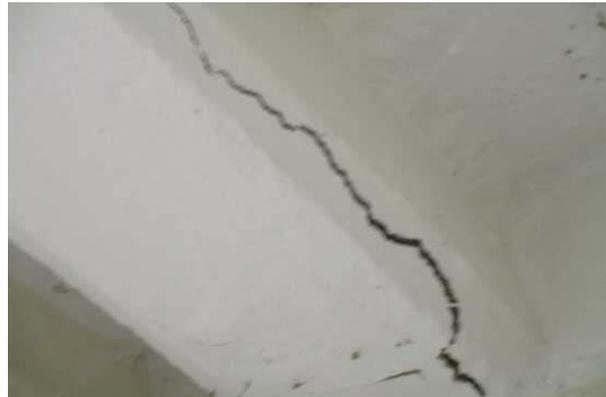
The concrete beams are in poor condition. These beams have wide deep cracks in them, they are located in the stairwell of the upper storage rooms. A professional engineer must be retained to analyze the existing condition, provide recommendations and, if necessary, estimate the scope and cost of any required repairs. The cost of this study is included in the cost tables. Due to the ambiguity of the required repair scope at the time of this assessment, the cost for any possible subsequent repairs is not included.

- The superstructure is exposed in some locations, which allows for limited observation. There is isolated evidence of cracking of the “T” casted with the roof decking. These cracks are visible in the stairwell to the upper floor storage area. A Professional Engineer with specific expertise in structural design and construction in this geographical area must be retained to evaluate the structure and to provide remedial recommendations consistent with local regulatory and code requirements.

#6:	CRACKED ROOF SUPPORT
-----	----------------------

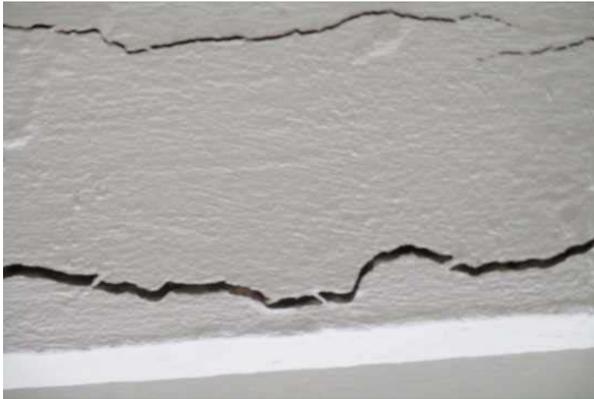
#7:	CRACKED ROOF SUPPORT
-----	----------------------

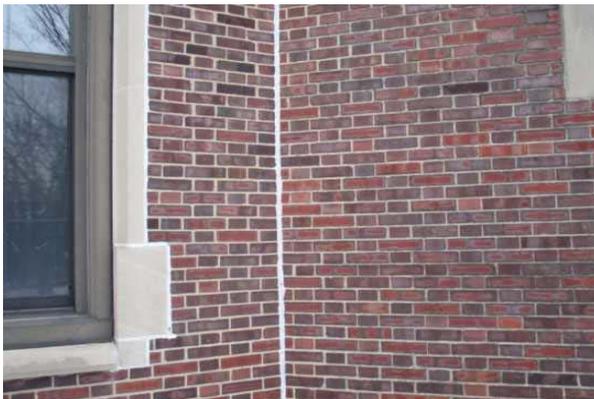
#11:	WINDOW AND EXPANSION JOINT CAULKING
------	-------------------------------------

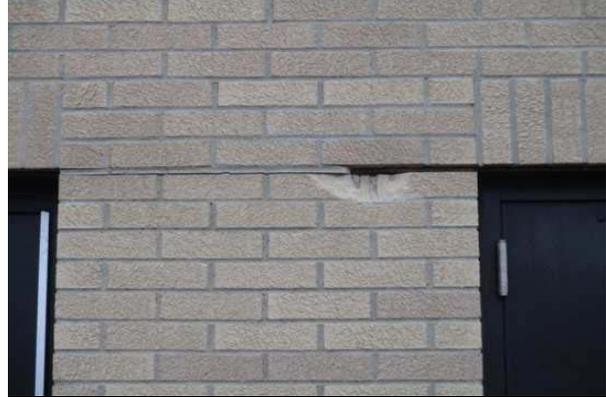
- On-going periodic maintenance, including patching repairs, graffiti removal, and re-caulking, is highly recommended.
- The brick veneer has isolated areas of loose units and deteriorated mortar joints (some locations are on the back wall of the gym, on the original building facility the pool building). The damaged veneer must be repaired.

#14:	RE-POINTING OF WALL
------	---------------------

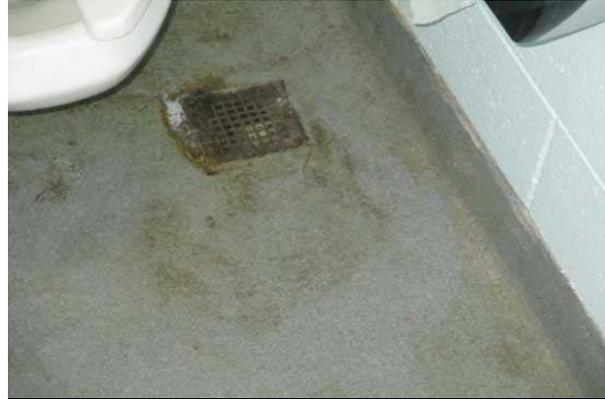
#20:	STAINED EPOXY FLOORING
------	------------------------

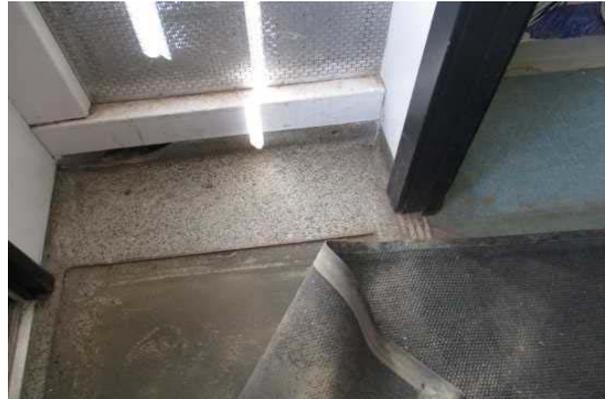
- The VCT at the intermediate landings will require replacement.
- The Terrazzo stairs have isolated areas of damaged terrazzo surfaces, stairs by teacher lounge, landing by graffiti artist work. The damaged portions of the stairs must be repaired. There are other location with small holes in the risers that need patching. The patching work could be done as routine maintenance.

#22:	TERRAZZO DAMAGE AND AREA TO BE IN FILLED
------	--

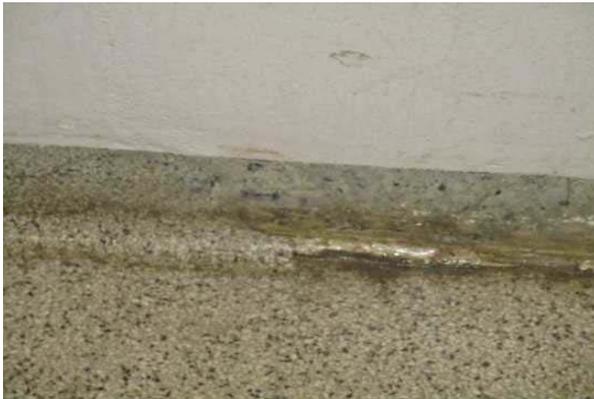
#23:	MISSING TERRAZZO BASE
------	-----------------------

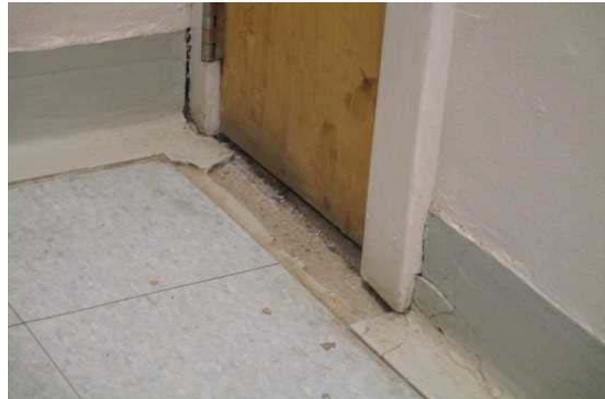
#24:	DAMAGED TERRAZZO
------	------------------

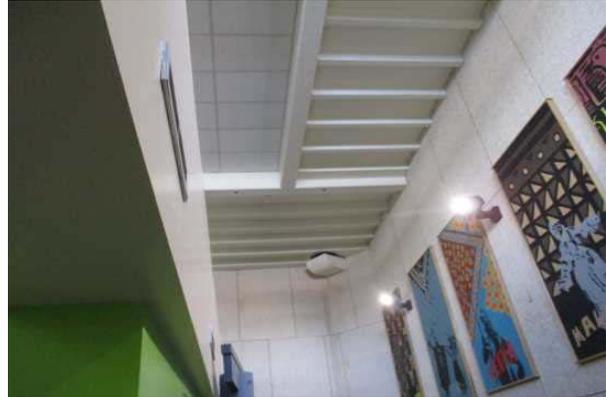
**Architectural :** The facility does have some cracks in the "T" of the poured concrete deck of the upper storage room roof. The painted decking in the office area and gym have peeling paint conditions. Floor in the old boiler room has integrity issues, moss was present in areas.

#26:	PAINTED CEILING WITH PEELING PAINT AND SOUND DAMPENING PANELS
------	---

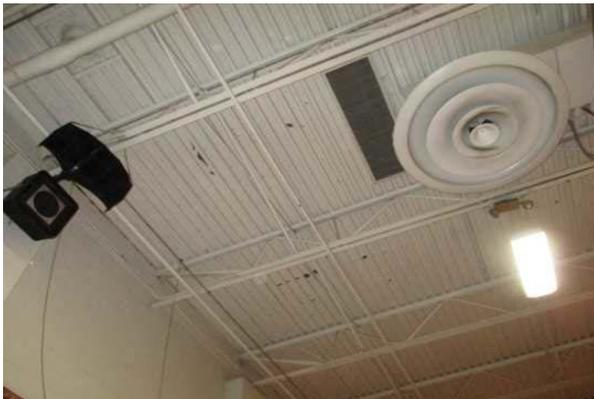
- Roof leaks have occurred within the past year, and some of these leaks remain active. The leaks occur (in the gym near the office/storeroom door, above the main office block. There are other areas within the gym with failing paint at the deck). All active leaks must be repaired.

#27:	GYM CEILING WITH PEELING PAINT
------	--------------------------------

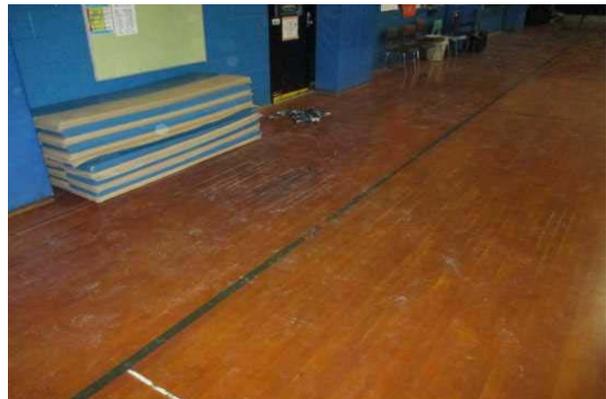
#30:	WATER DAMAGED AREA OF GYM FLOOR
------	---------------------------------

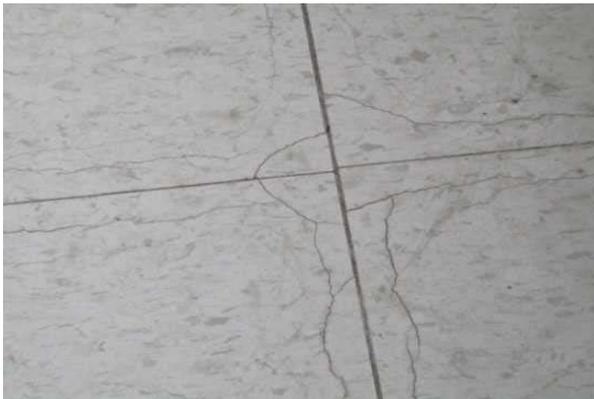
#33:	CRACKED VINYL TILE (VCT)
------	--------------------------

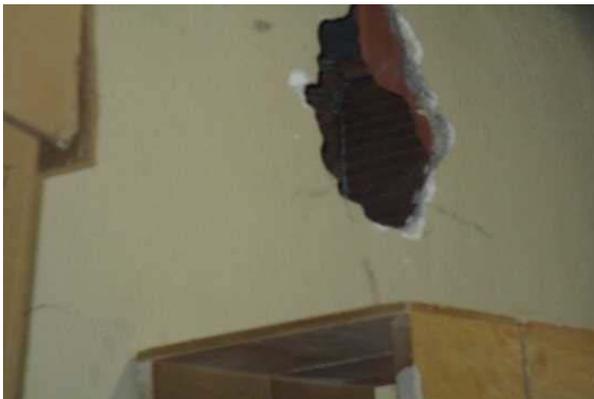
#35:	DAMAGED WALL
------	--------------
