FACILITY CONDITION ASSESSMENT

Ann Arbor Public Schools
2555 South State Street
Ann Arbor, Michigan 48104
Jim Vibbart

March 5, 2018

FACILITY CONDITION ASSESSMENT
OF
TRANSPORTATION AND 2 STORAGE BUILDINGS
2400 BROADWALK STREET
ANN ARBOR, MICHIGAN 48104

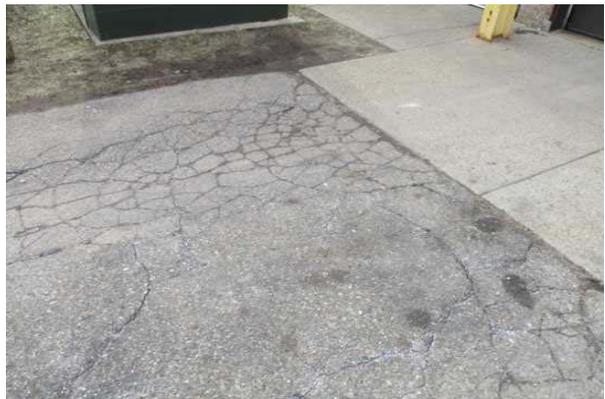
#12:	ASPHALT PAVEMENT
------	------------------

Site : The paving requires a milling and overlay. A program for seal coating should be implemented to preserve the asphalt paving. There are areas with depressions and larger areas alligator cracking of the parking lot. With no curbs on the west side of the property, runoff water from adjacent properties can enter the bus parking area.

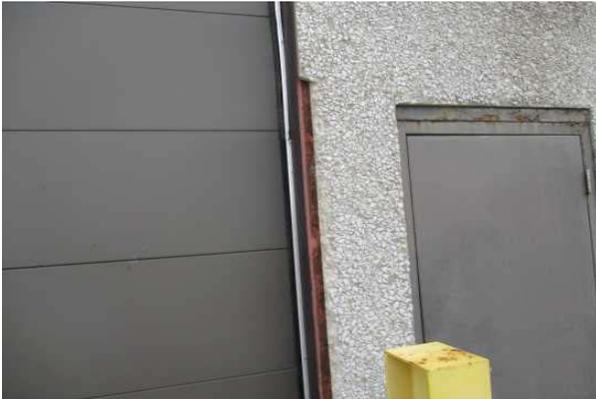
- There are significant areas of brittle and deteriorated sealant. The damaged sealant must be replaced.
- The wall panels are damaged and cracking at the panel joints. The wall panels require repairs.

#15:	DAMAGED WALL PANEL
------	--------------------

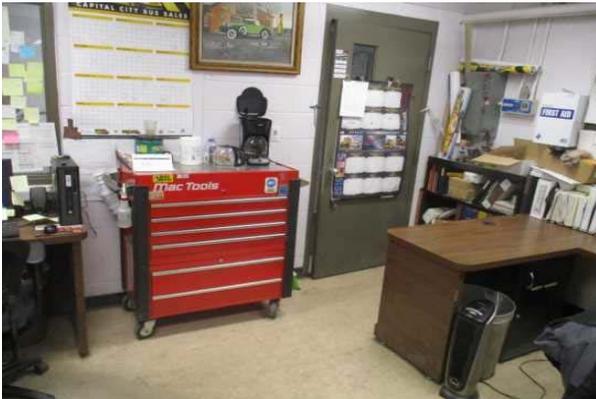
#17:	NON-COMPLIANT DOOR HARDWARE
------	-----------------------------

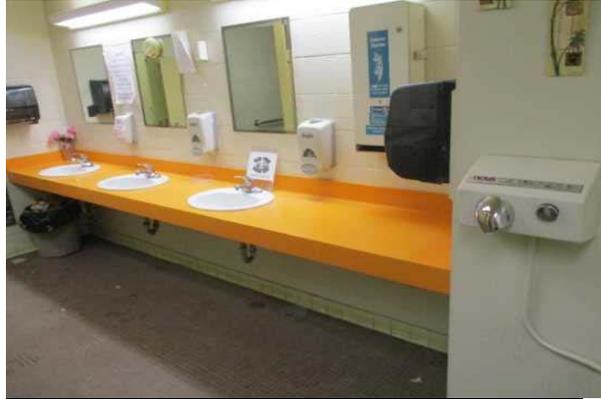
#20: BATHROOM SINKS AND COUNTER MISSING PIPE WRAP

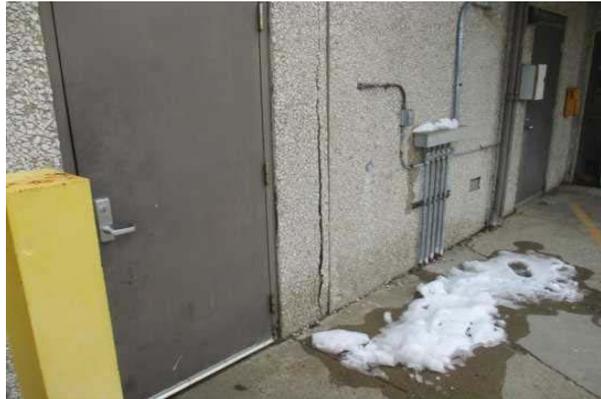
#22: CRACKED EXTERIOR WALL PANEL

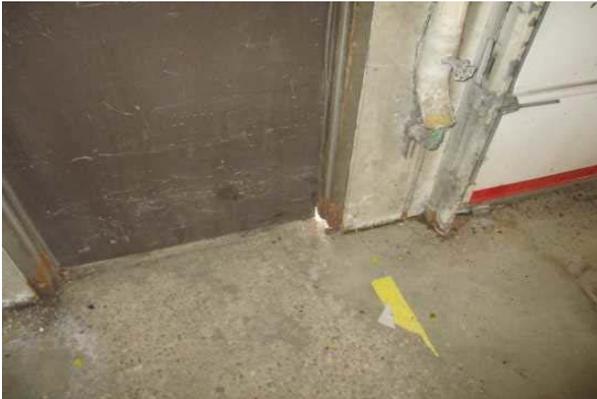
- The windows are antiquated, energy-inefficient units with single-pane glazing. Window operation not tested.
- Exterior man doors have rusted out frames and require replacement.

#33: EXTERIOR DOOR RUSTED OUT FRAME

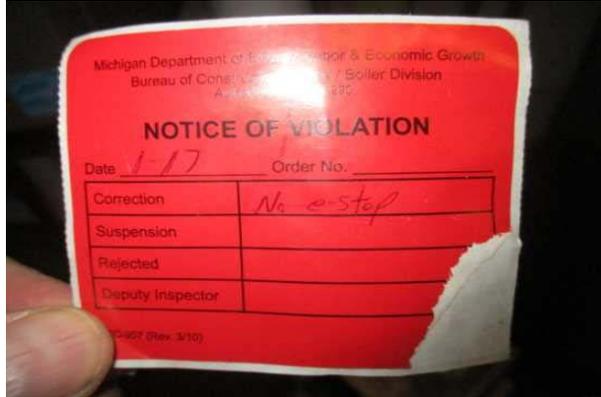
MEPF : There is an open Red Tag on the new boiler installed on the mezzanine mechanical room. This form is dated 1-17. Plumbing in the restrooms should be investigated for leaks and clogs. The fire sprinkler system should be expanded into the office areas. The building controls should be upgraded to a network based digital system.

#50: RED TAG ON NEW BOILER

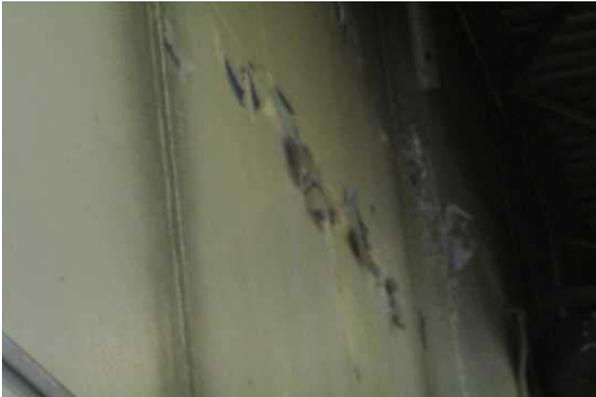
#51: INTERIOR FLOOR FINISH PEELING

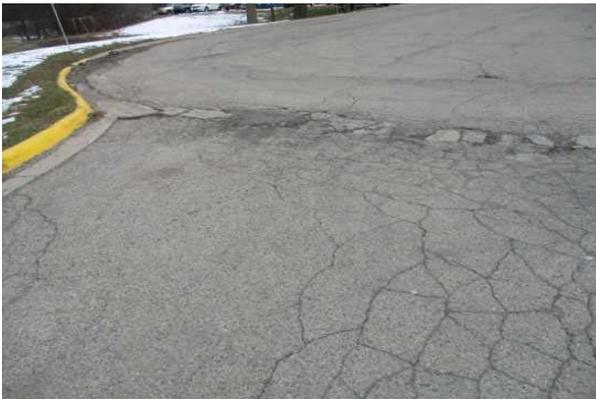
#57:	DAMAGED ASPHALT PAVEMENT
------	--------------------------
