# FACILITY CONDITION ASSESSMENT

129010.18R000-027.354

July 2, 2018

FORSYTHE MIDDLE SCHOOL  
1655 NEWPORT ROAD  
ANN ARBOR, MICHIGAN 48103

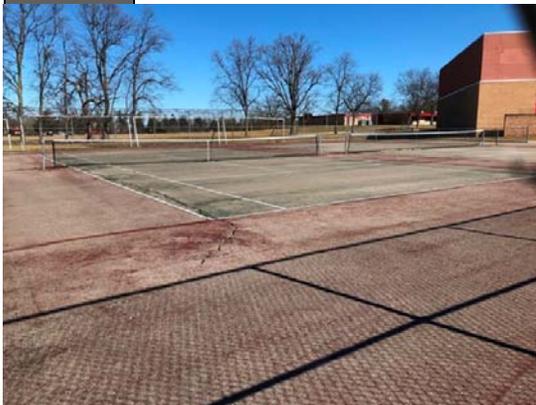
PHOTO #9: TENNIS COURT

**Site :** Deteriorating court surfaces on the basketball court and tennis courts.

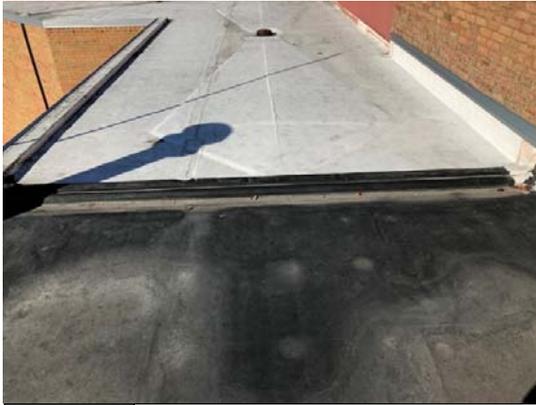
PHOTO #13: SINGLE-PLY ROOFING

Degradation Issues			
Observation	Exists at Site	Observation	Exists at Site
Evidence of roof leaks	<input type="checkbox"/>	Significant ponding	<input checked="" type="checkbox"/>
Excessive patching or repairs	<input type="checkbox"/>	Blistering or ridging	<input type="checkbox"/>
Other	<input type="checkbox"/>	Other	<input type="checkbox"/>

- The roof finishes were installed over ten years ago. Information regarding roof warranties or bonds was not available. The roofs are maintained by an outside contractor.
- There is no evidence of roof deck or insulation deterioration. The roof substrate and insulation should be inspected during any future roof repair or replacement work.
- Current roof leaks should be repaired as a part of routine maintenance.
- Roof drainage appears to be adequate. Clearing and minor repair of drain system components should be performed regularly as part of the property management's routine maintenance and operations program
- The attics are not accessible and it could not be determined if there is moisture, water intrusion, or excessive daylight in the attics.
