# FACILITY CONDITION ASSESSMENT

*129010.18R000-006.354*

*June 28, 2018*

ANGELL ELEMENTARY  
1608 SOUTH UNIVERSITY AVENUE  
ANN ARBOR, MICHIGAN 48103

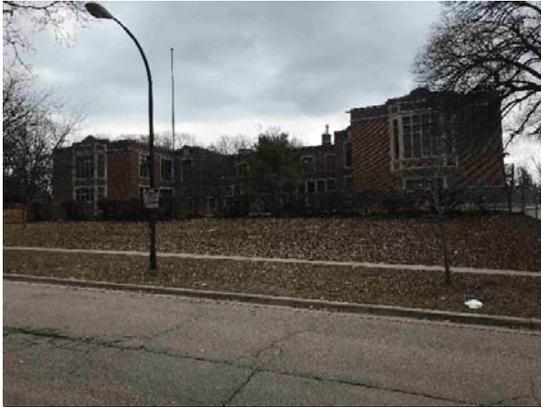
PHOTO #1: FRONT ELEVATION

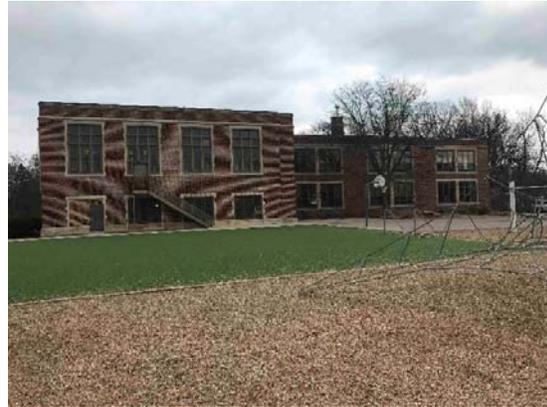
PHOTO #2: SIDE ELEVATION

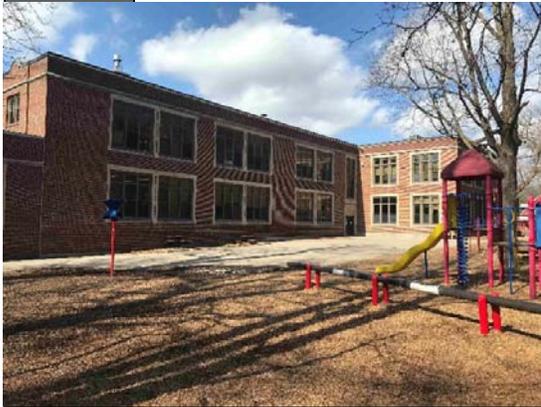
PHOTO #3: SIDE ELEVATION

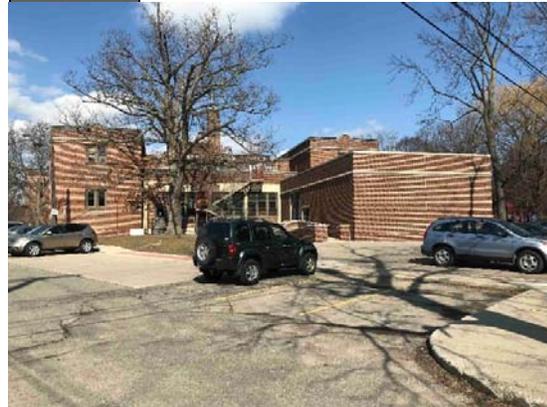
PHOTO #4: REAR ELEVATION

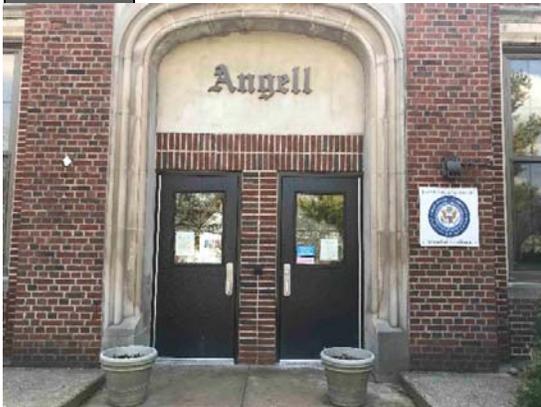
PHOTO #5: MAIN ENTRANCE DOORS

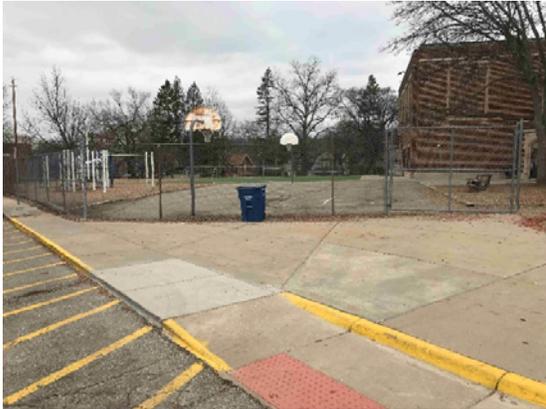
PHOTO #7: CONCRETE SIDEWALKS AND ASPHALT PAVEMENT

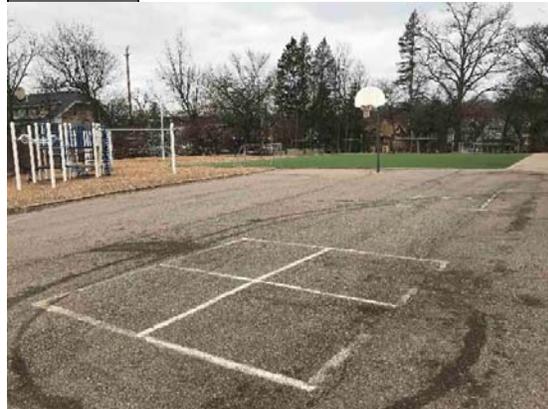
PHOTO #10: BASKETBALL COURT

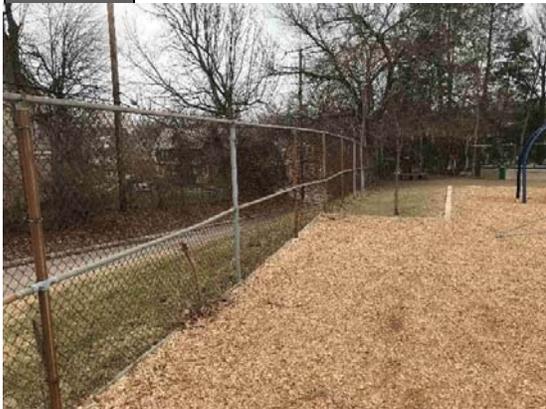
PHOTO #11: CHAIN LINK PERIMETER FENCING

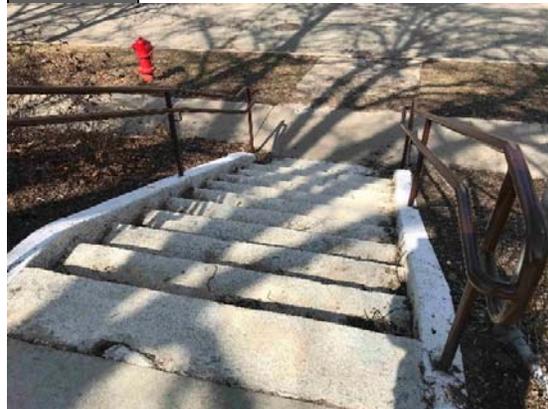
PHOTO #12: CONCRETE STAIRS

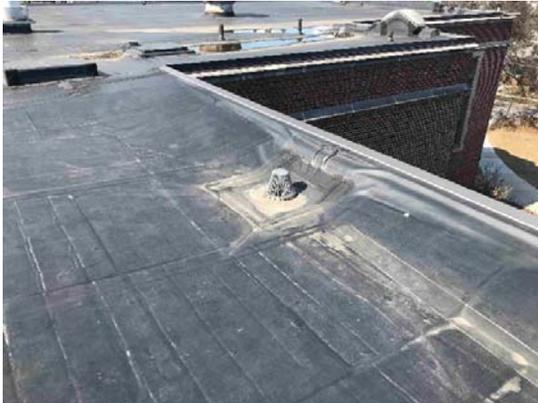
- The roof finishes were installed over ten years ago. Information regarding roof warranties or bonds was not available. The roofs are maintained by an outside contractor.
- There is no evidence of roof deck or insulation deterioration. The roof substrate and insulation should be inspected during any future roof repair or replacement work.
- Current roof leaks should be repaired as a part of routine maintenance.
- Roof drainage appears to be adequate. Clearing and minor repair of drain system components should be performed regularly as part of the property management's routine maintenance and operations program
- The attics are not accessible and it could not be determined if there is moisture, water intrusion, or excessive daylight in the attics.

PHOTO #13: SINGLE-PLY ROOFING

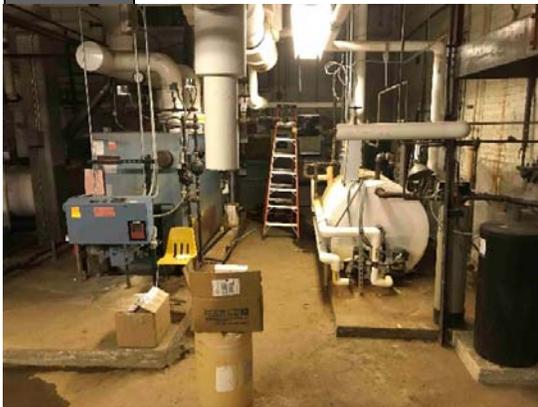
PHOTO #15: HVAC BOILER

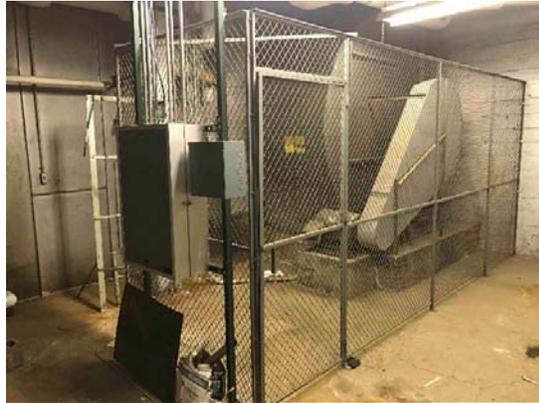
PHOTO #20: AIR HANDLER

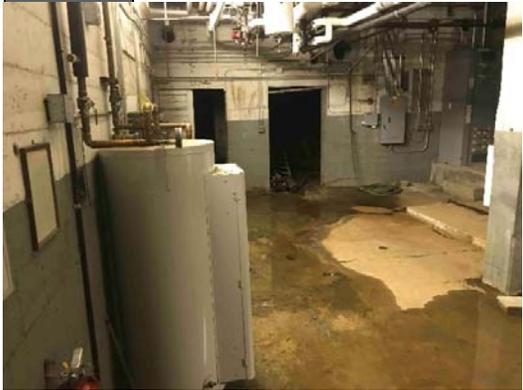
PHOTO #21: DOMESTIC WATER HEATER

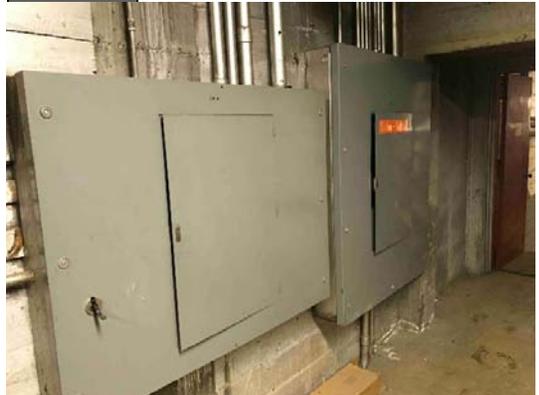
PHOTO #22: MAIN DISTRIBUTION PANEL

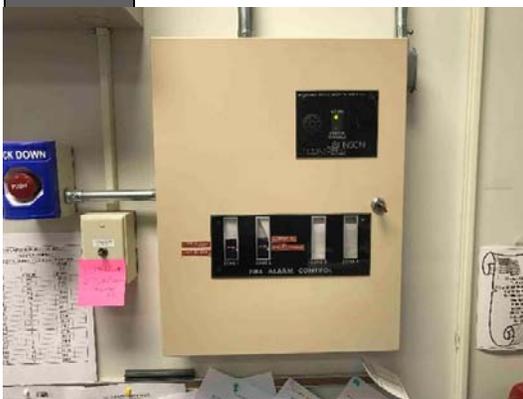
PHOTO #23: FIRE PANEL

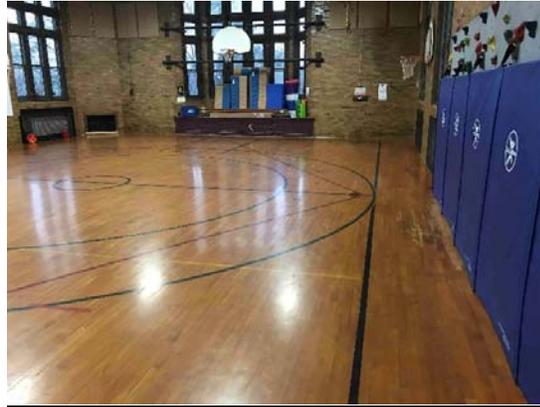
**Architectural :** Finishes include brick veneer exterior walls with concrete accents which are in fair condition and will require re-pointing. The interior ceiling in the gymnasium is damaged and in poor condition. A cost allowance to replace/repair these deficient items is included in the cost tables.

PHOTO #32: GYMNASIUM
