FACILITY CONDITION ASSESSMENT

February 1, 2018

MITCHELL ELEMENTARY
3550 PITTSVIEW DRIVE
ANN ARBOR, MICHIGAN 48108

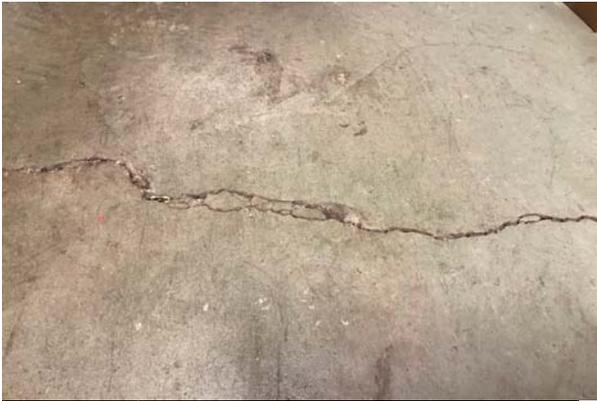
- The foundations and footings cannot be directly observed. However, there are isolated areas of cracking, movement, and vertically displaced slabs in the utility closet. Cracking of the CMU walls in the building interior indicate settling has occurred.. This condition typically indicates excessive settlement or other potential problems with the foundation system. A Professional Engineer with specific expertise in structural design and construction in this geographical area must be retained to evaluate the structure and to provide remedial recommendations consistent with local regulatory and code requirements. Although the estimated cost of repair cannot be accurately determined without the recommended study, a budgetary cost allowance to repair the affected elements is also included.

#7:	CRACKED CONCRETE SLAB-ON-GRADE
-----	--------------------------------

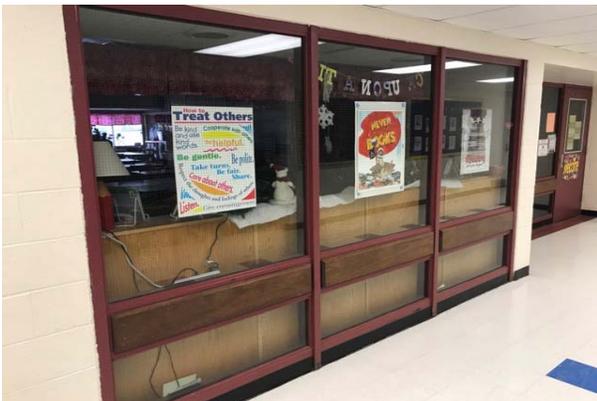
#9:	STOREFRONT WINDOWS
-----	--------------------

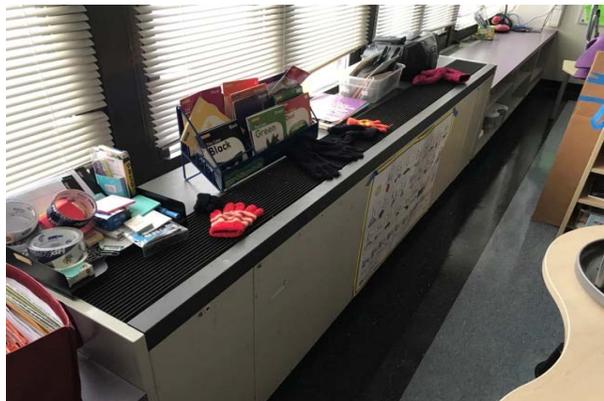
MEPF : The original fan coil units that were installed in the facility have failed and should be replaced. The BAS system is a hybrid of DDC and pneumatic and should be replaced. The facility does not have a fire suppression system, and only four certified fire extinguishers in the entire facility.

#10:	FAN COIL UNIT
------	---------------

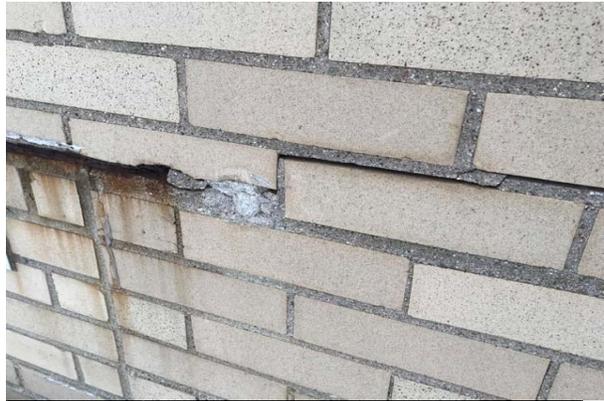
- Significant portions of the mortar joints along the brick veneer are cracked on all elevtions of the facility. The damaged mortar joints must be cleaned and re-pointed.

#14:	BRICK VENEER CRACKING
------	-----------------------

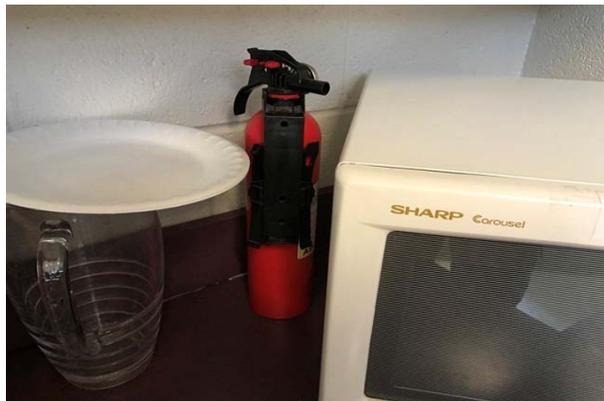
- The building is not protected by fire suppression. Due to its construction date, the facility is most likely “grandfathered” by code and the installation of fire sprinklers not required until major renovations are performed. Regardless of when or if installation of facility-wide fire suppression is required by the governing municipality, EMG recommends a retrofit be performed. A budgetary cost is included.
- Fire extinguishers appear to be missing at many locations. New fire extinguishers must be installed at all required locations immediately.

#18:	NON-CERTIFIED FIRE EXTINGUISHER
------	------------------------------------

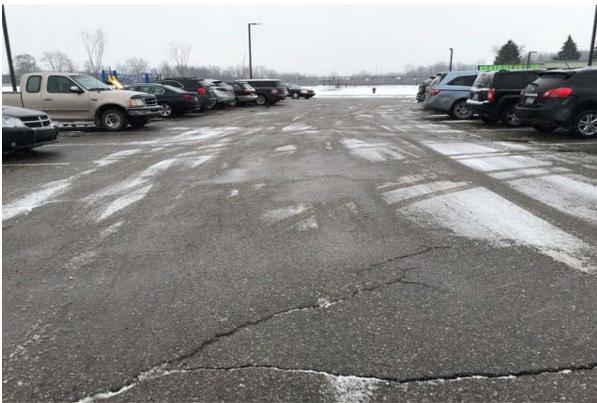
Site : The parking lot and drive way need to be milled and overlaid with new asphalt. The playground equipment shows signs of corrosion.

#21:	PARKING LOT
------	-------------

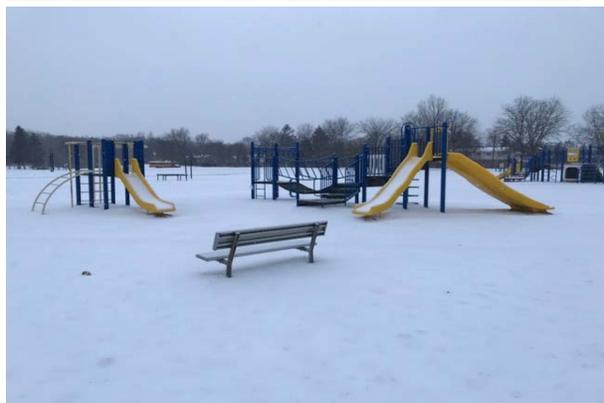
#24:	PLAY STRUCTURE
------	----------------

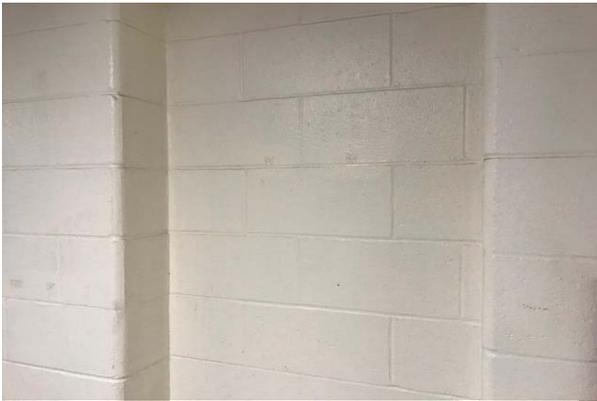
- The superstructure is exposed in some locations, which allows for limited observation. There is isolated evidence of deflection and movement illustrated by cracks in the CMU wall. A Professional Engineer with specific expertise in structural design and construction in this geographical area must be retained to evaluate the structure and to provide remedial recommendations consistent with local regulatory and code requirements.

#27:	STRUCTURAL WALLS, CMU
------	-----------------------
