FACILITY CONDITION ASSESSMENT

June 29, 2018

February 8, 2018

HAISLEY ELEMENTARY
825 DUNCAN SREET
ANN ARBOR, MICHIGAN 48103

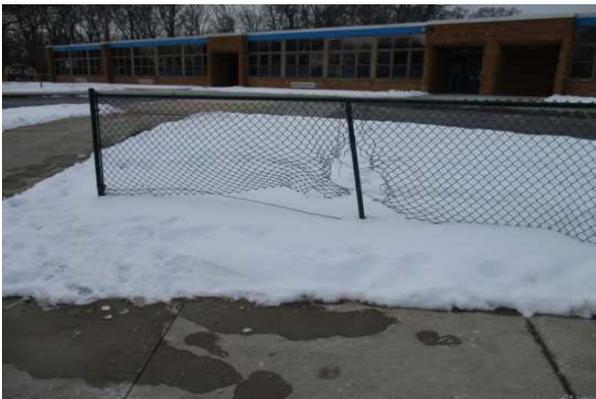
#5:	FENCES & GATES, VINYL, 4' HIGH
-----	-----------------------------------

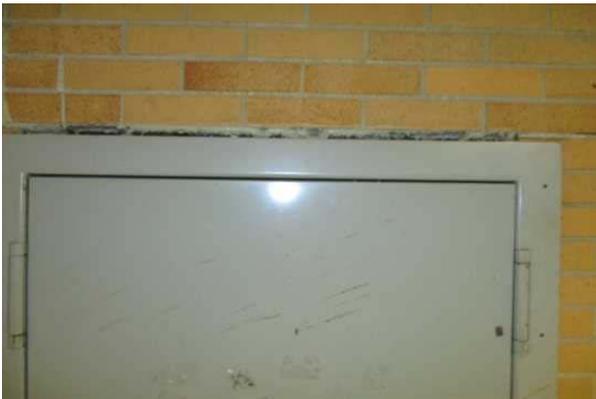
#9: EXTERIOR WALL, JOINT CAULKING

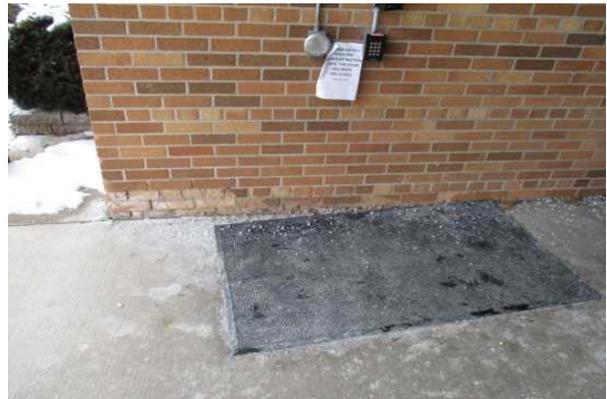
#10: RE-POINTING AND BRICK REPLACEMENT

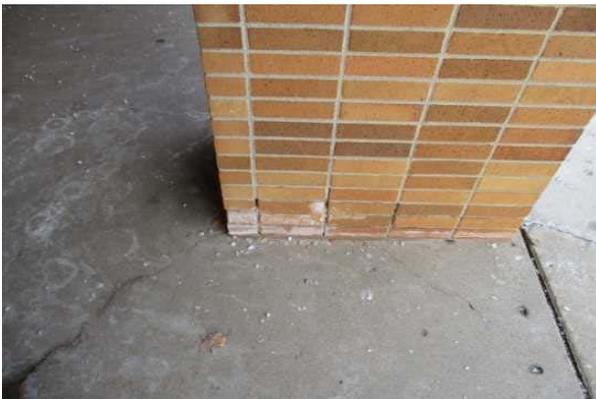
#11: RE-POINTING AND BRICK REPLACEMENT

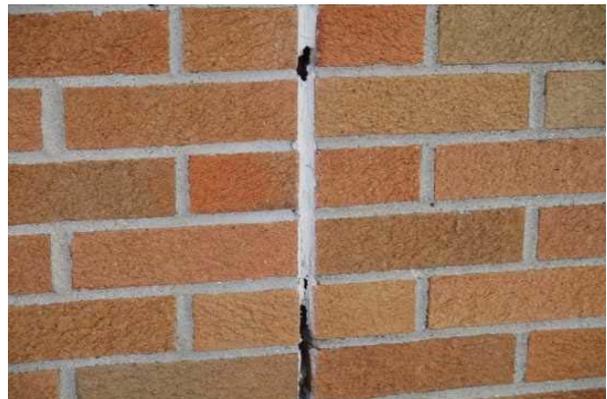
#12: JOINT CAULKING EXTERIOR WALL

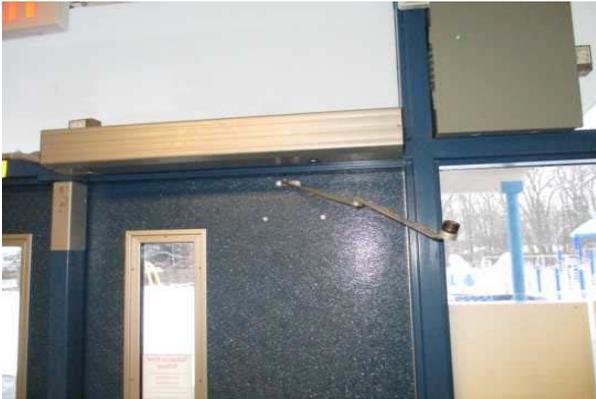
#13: ADA DOOR OPENER (BROKEN)

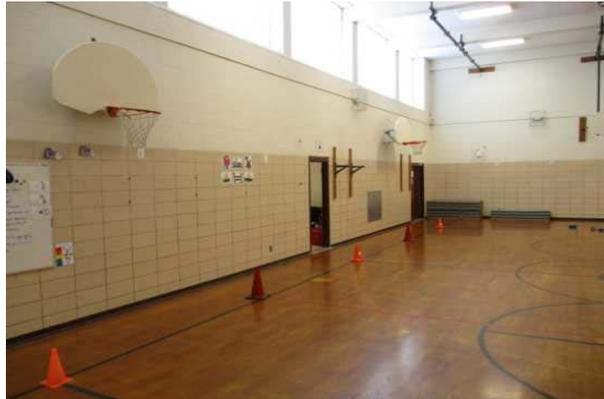
#14: FLOOR TO BE REFINISHED

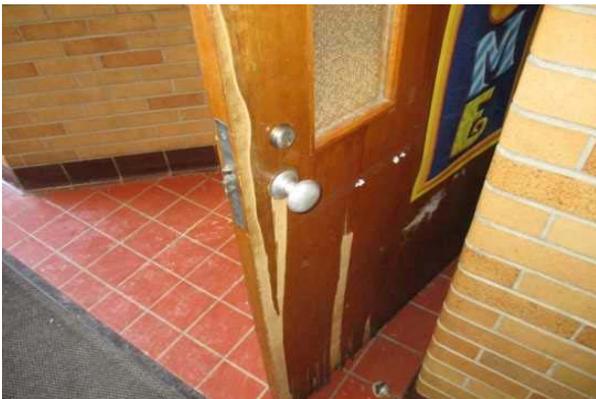
#17: DAMAGED INTERIOR DOOR

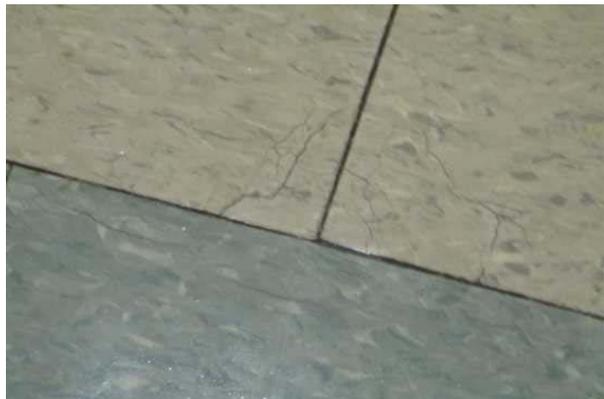
#18: DAMAGED VCT TILE

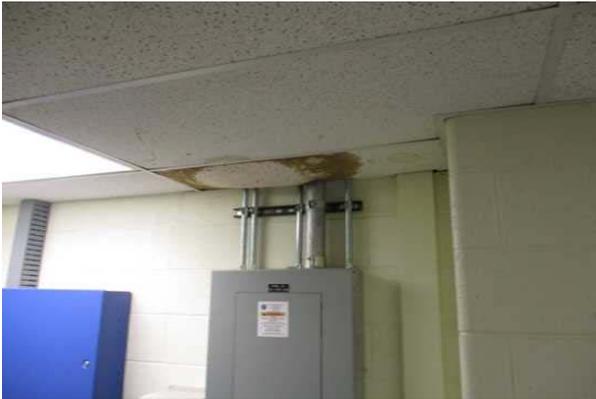
- The roof finishes appear to be more than 20years old. Information regarding roof warranties was not available. The roofs are maintained by an outside contractor.
- The roof was covered with snow at the time of the assessment.
- The ceiling does have signs of active roof leaks. The worst being over the electrical panel in the computer lab.
- The attics are not accessible and it could not be determined if there is moisture, water intrusion, or excessive daylight in the attics.

#19: SUSPENDED ACOUSTICAL TILE (ACT) WITH SIGNS OF ROOF LEAK

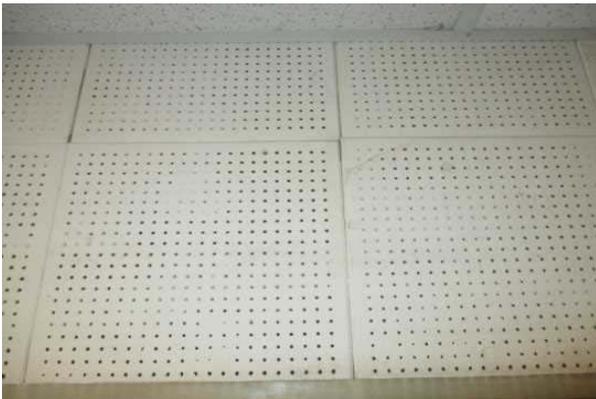
- The interior areas appear to have been refinish about 10 years ago.
- On-going periodic maintenance is highly recommended. Future lifecycle replacements of the components listed above will be required.
- Some of the ceiling tiles and wall tiles may contain asbestos material . An engineering study to evaluate the facility for asbestos is recommended. Areas to be checked should include above the ceiling in the 300 aisle, the mechanical mezzanine, the classrooms with the sound tiles on the wall, and the gym ceiling. There is a section of pipe insulation with a caution sign about asbestos.

#21: POTENTIAL ASBESTOS MATERIAL (ACM)

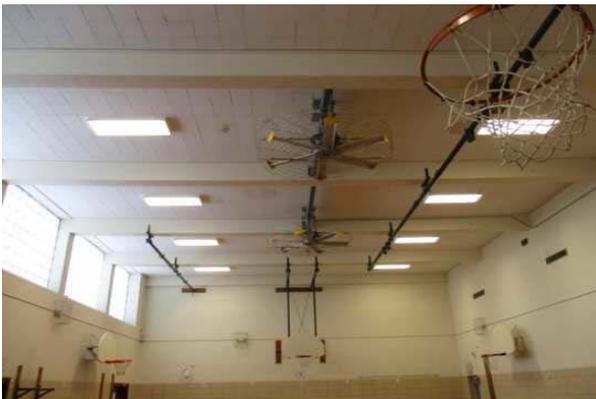
#23: SOUND DAMPENING CEILING TILES POTENTIAL ASBESTOS MATERIAL (ACM)

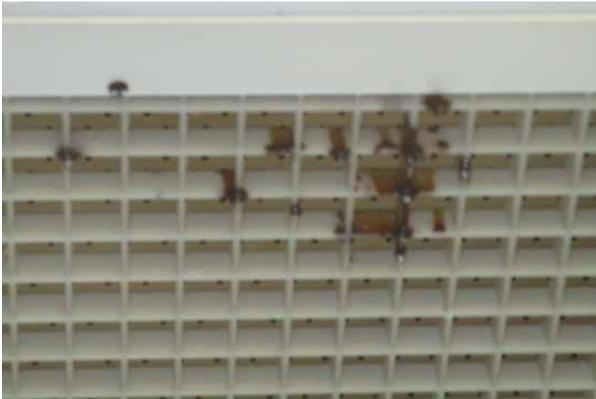
#25:	POTENTIAL ASBESTOS MATERIAL (ACM)
------	-----------------------------------

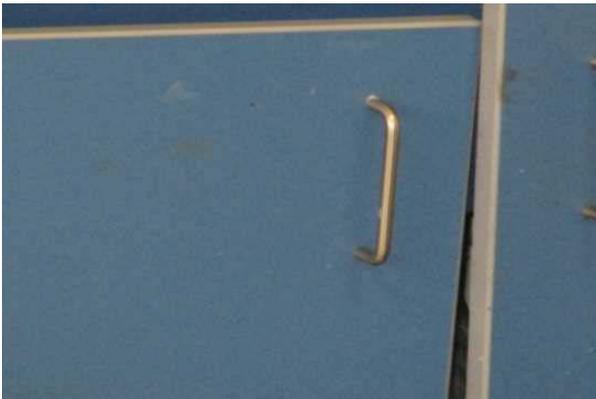
#27:	KITCHEN CABINET DAMAGED
------	-------------------------

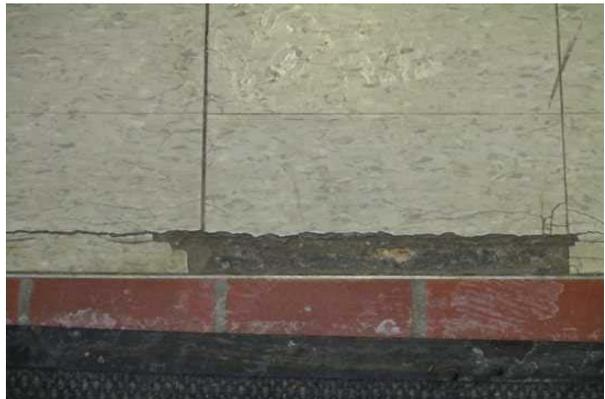
#28:	DAMAGED VCT TILE
------	------------------

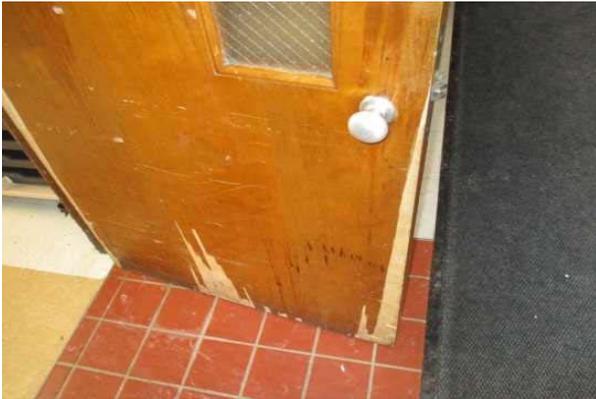
#31:	DAMAGED INTERIOR DOOR
------	-----------------------

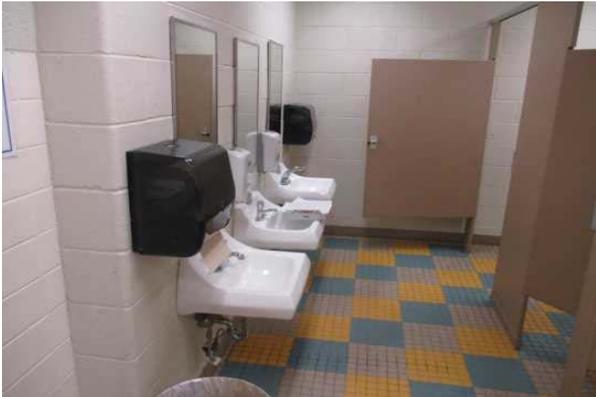
#39: SINKS WITHOUT ADA PIPE WRAPING

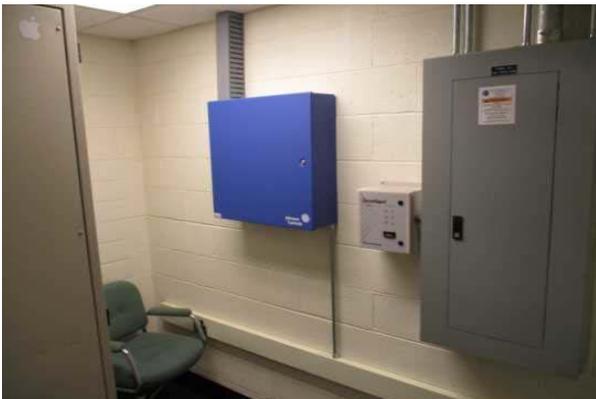
- The HVAC systems are maintained by an outside contractor. Records of the installation, maintenance, upgrades, and replacement of the HVAC equipment at the property have not been maintained since the property was first occupied.
- Approximately five percent of the HVAC equipment is original. The HVAC equipment varies in age, a major replacement was completed in 2006. The HVAC equipment appears to be functioning adequately overall.
- The facility HVAC is controlled using an outdated pneumatic system supplied by an air compressor. For modernization, reliability, and increased control, full conversion to a web-based direct digital control (DDC) platform is highly recommended.

#47: BUILDING AUTOMATION SYSTEM (HVAC CONTROLS) AND ELECTRICAL PANEL

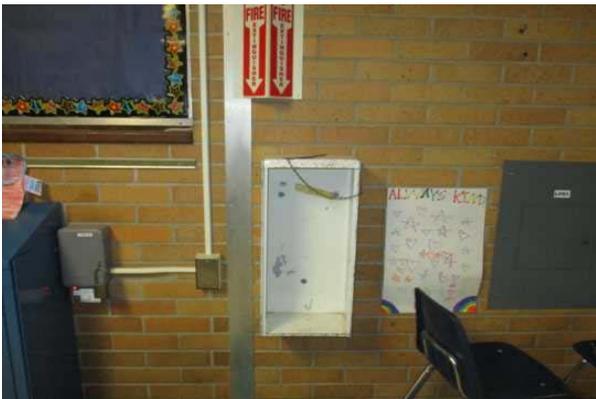
#53: FIRE EXTINGUISHER CABINET, MISSING COVER AND FIRE EXTINGUISHER

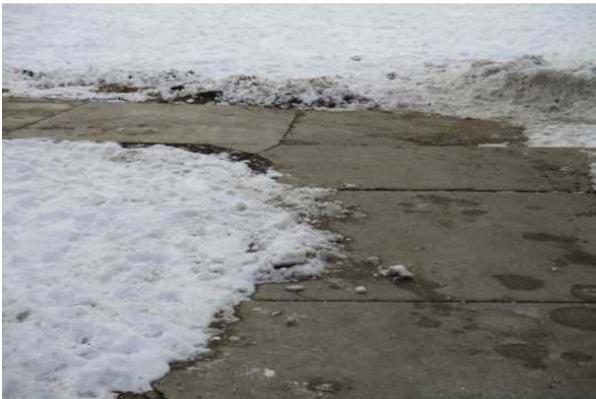
#63:	SIDEWALK HEAVED
------	-----------------
