# FACILITY CONDITION ASSESSMENT

LAWTON ELEMENTARY  
2250 SOUTH SEVENTH STREET  
ANN ARBOR, MICHIGAN 48103

*June 29, 2018*

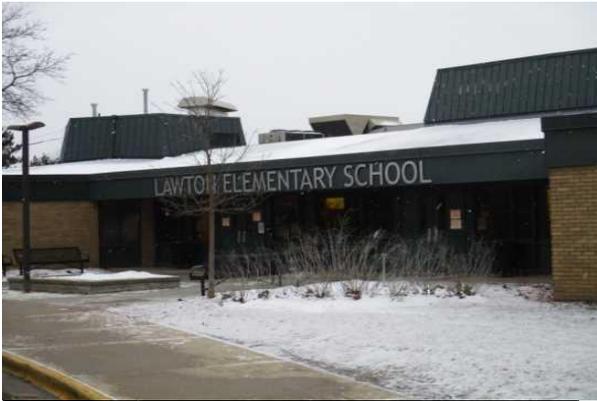
#1:	FRONT ELEVATION
-----	-----------------

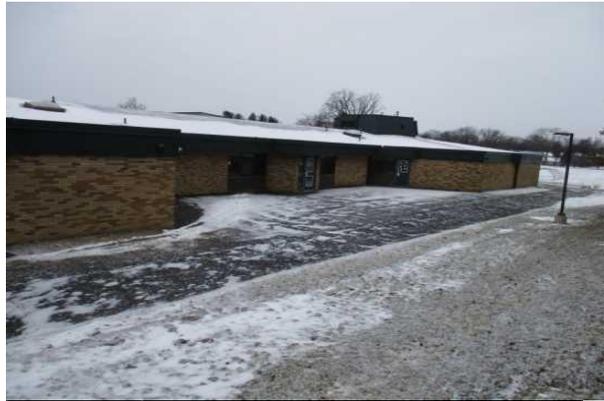
#2:	RIGHT ELEVATION
-----	-----------------

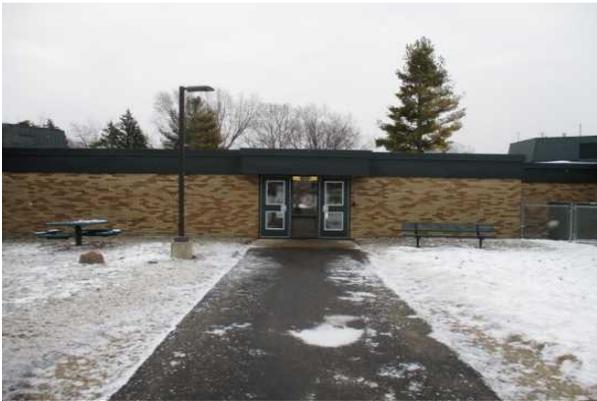
#3:	REAR ELEVATION
-----	----------------

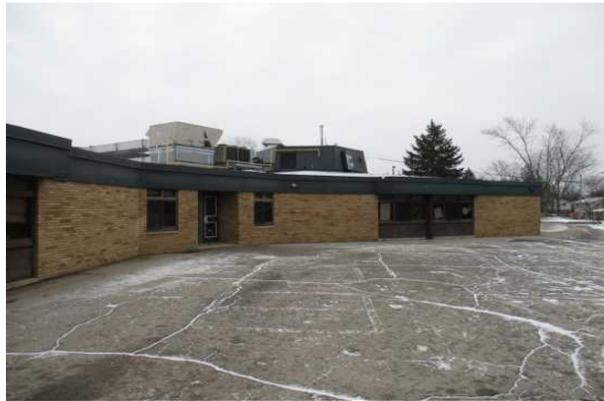
#4:	LEFT ELEVATION
-----	----------------

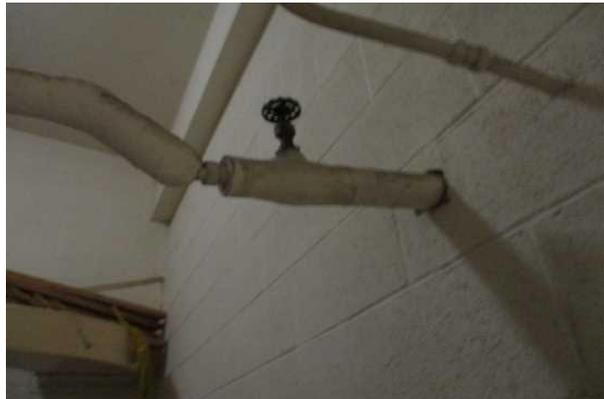
#6:	PIPE INSULATION WITH POSSIBLE ASBESTOS
-----	--

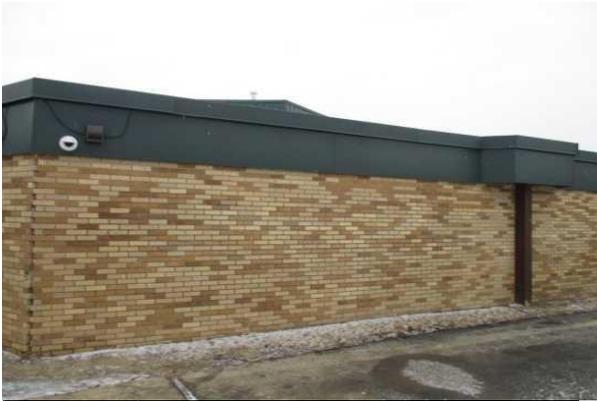
#7:	EXTERIOR WALL
-----	---------------

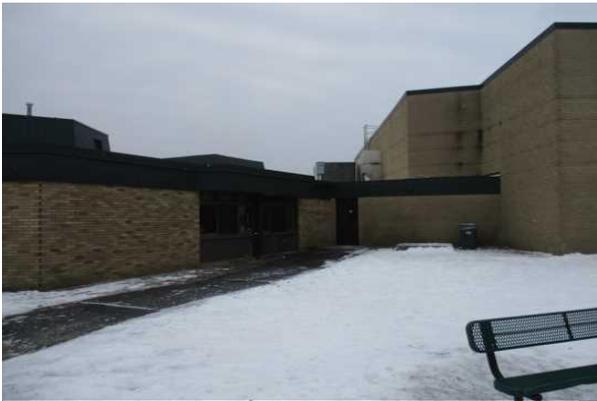
#9:	EXTERIOR DOOR
-----	---------------

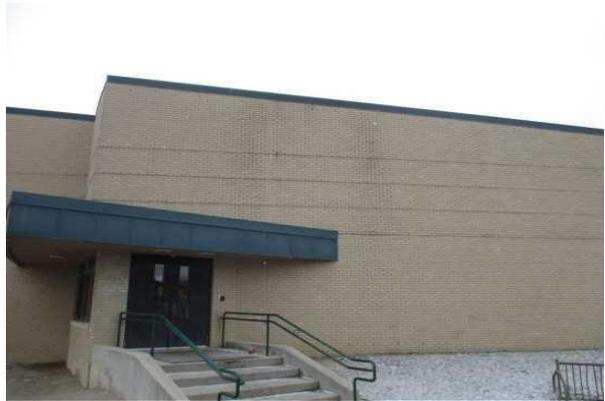
#10:	EXTERIOR STAIR/RAMP RAILS
------	---------------------------

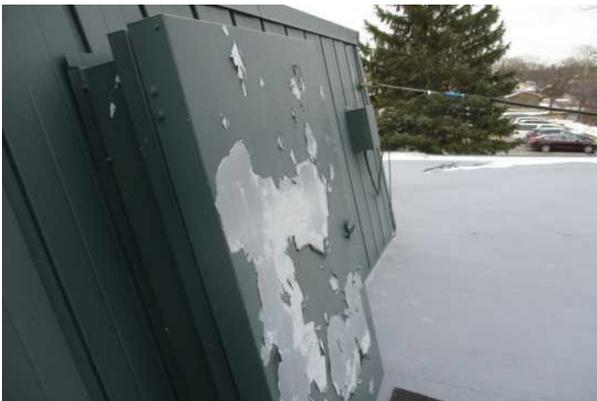
#11:	MECHANICAL ROOM HATCH NEEDS PAINTING
------	--------------------------------------

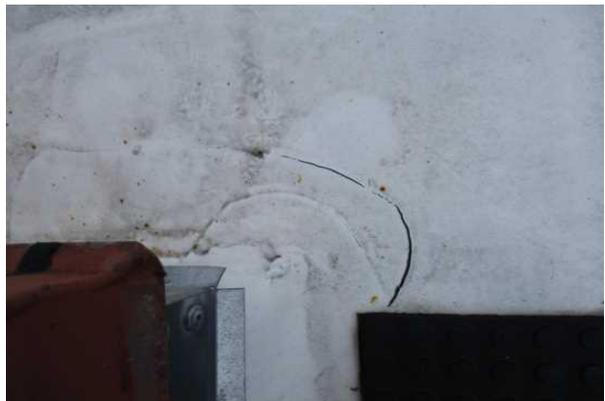
- According to the Principal, there are active roof leaks. There is evidence of active roof leaks. The locations were not identified. But, these leaks should be addressed and repaired.

#12:	ROOF MEMBRANE
------	---------------

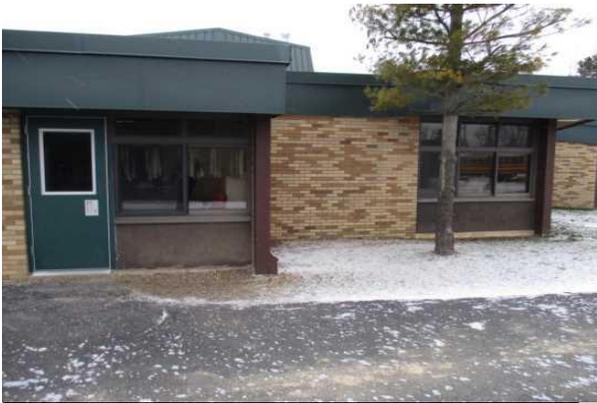
#13:	WINDOWS
------	---------

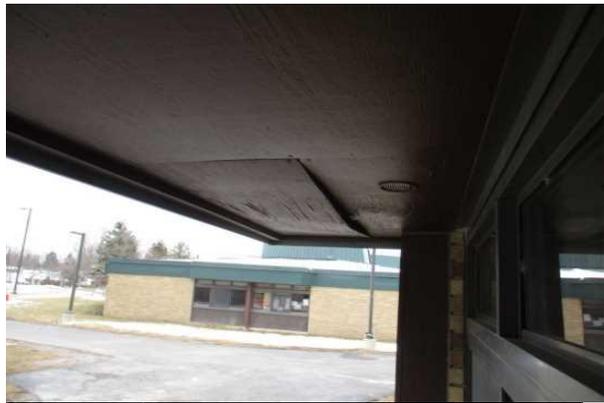
- Building has an issue with ants inside the facility. This is most noticed in the 5th grade class rooms.
- The wood soffit around 314/315 has come loose and may require replacement and painting. The cost of this work is relatively insignificant and the work can be performed as part of the property management's routine maintenance program

#14:	WOOD SOFFIT
------	-------------

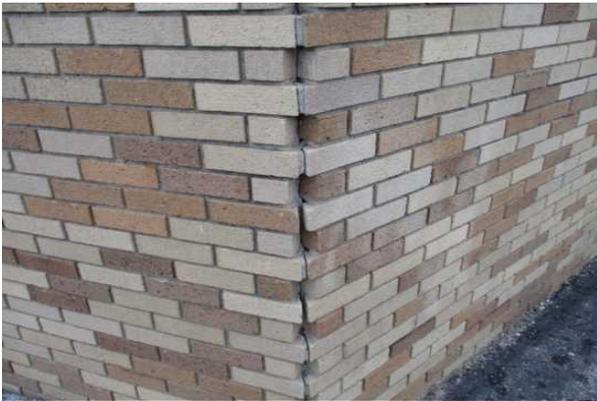
- The brick veneer has significant areas of loose units and deteriorated mortar joints (at the non-ninety-degree corners). The damaged veneer must be repaired and/or replaced.

#15:	DAMAGED BRICK VENEER
------	----------------------

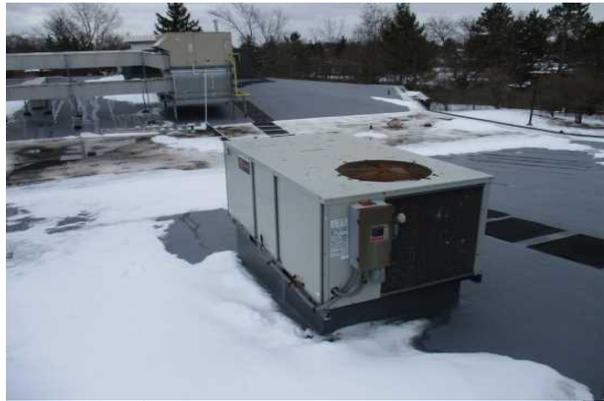
#16:	ROOF HVAC
------	-----------

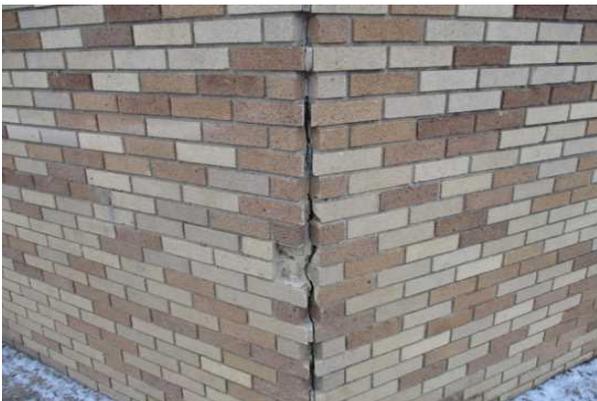
- The metal siding below fascia has significant areas that require repainting.
- Isolated portions of the mortar joints along the brick veneer are cracked (at the non-ninety degree corners). The damaged mortar joints must be cleaned and re-pointed.

#17:	BRICK VENEER
------	--------------

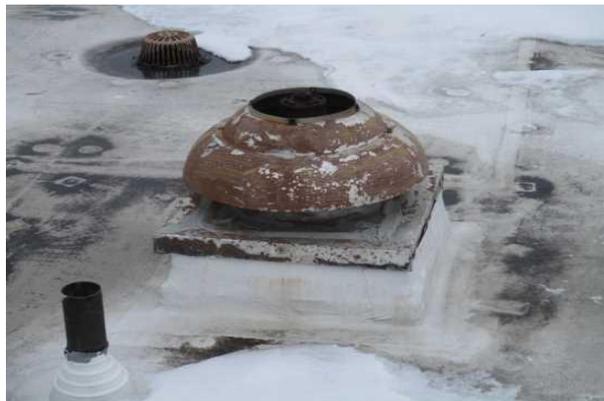
#18:	ROOF EXHAUST FAN
------	------------------

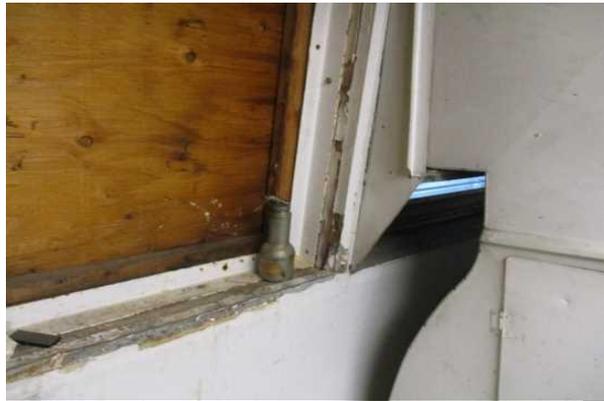
#28:	REPAIR INTERIOR WALL FINISH
------	-----------------------------

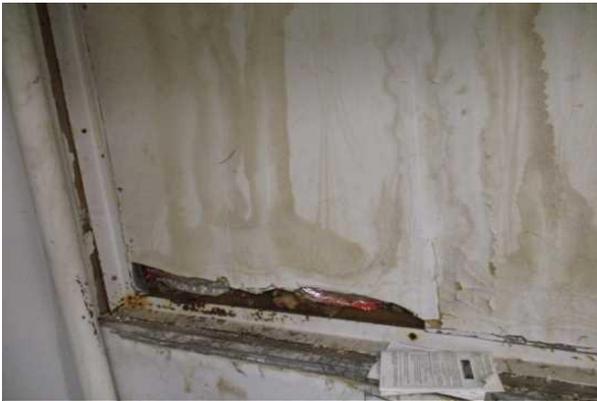
#33:	REPAIR INTERIOR WALL FINISH
------	-----------------------------

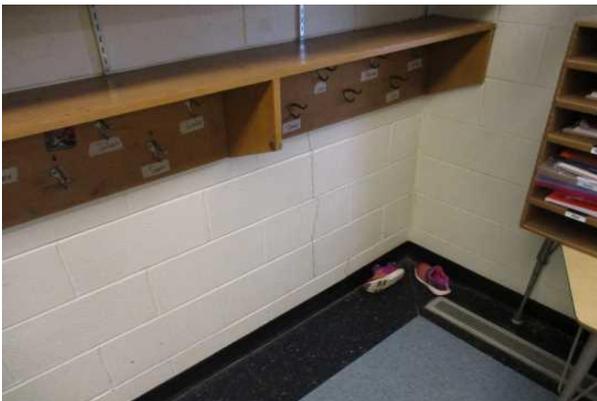
#35:	DAMAGED CONCRETE BLOCK
------	------------------------

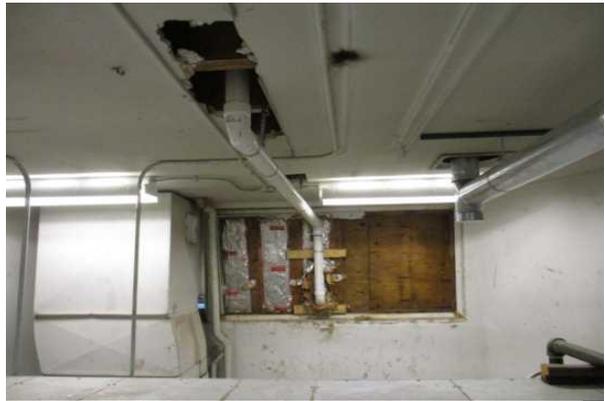
#46:	INTERIOR WALL AND CEILING FINISH TO REPAIR
------	--

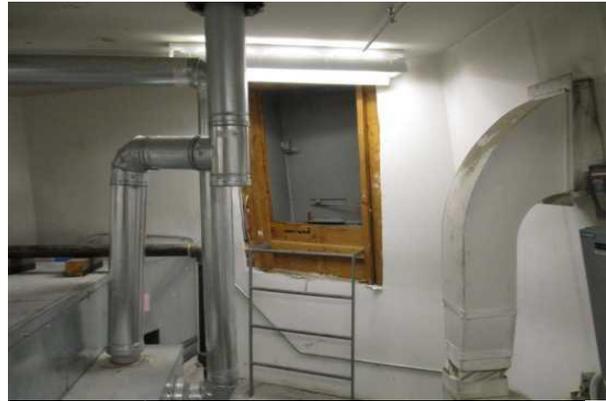
#50:	INTERIOR WALL FINISH TO REPAIR
------	--------------------------------
