FACILITY CONDITION ASSESSMENT

129010.18R000-024.354

July 2, 2018

COMMUNITY HIGH SCHOOL
401 NORTH DIVISON STREET
ANN ARBOR, MICHIGAN 48104

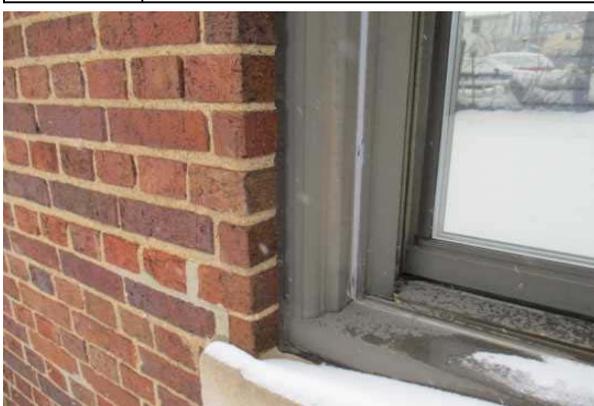
#5:	EXTERIOR WALL RE-POINTING JOINTS
-----	----------------------------------

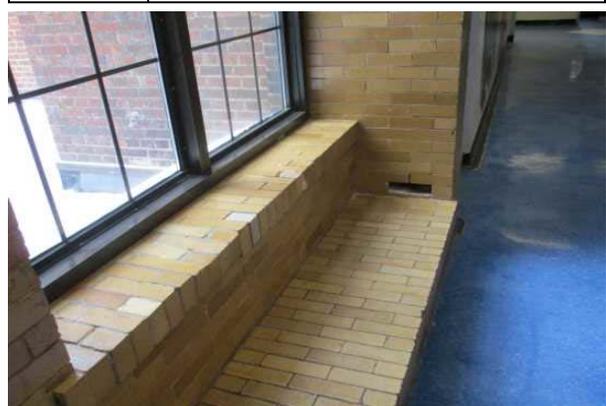
#6:	INTERIOR WALL RE-POINTING AND BRICK REPLACEMENT
-----	---

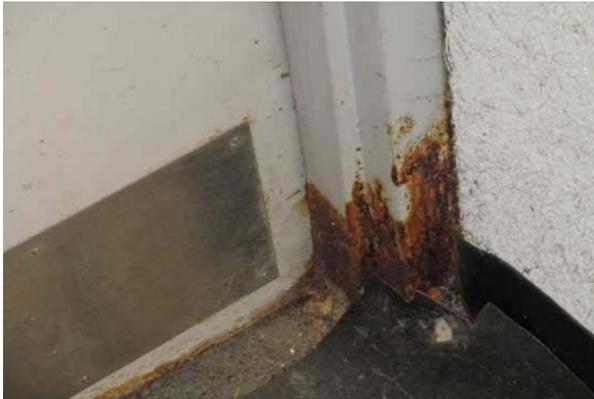
#7: EXTERIOR DOOR AND FRAME RUSTING OUT

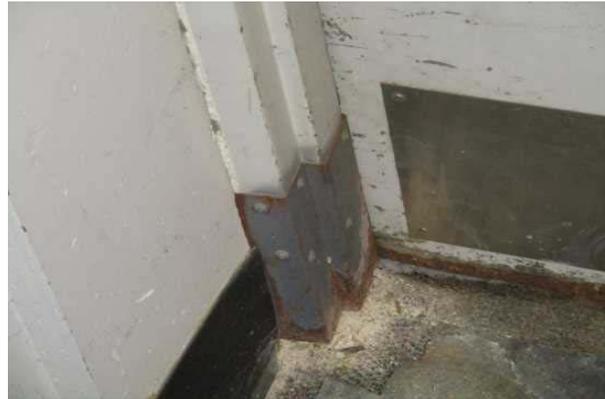
#8: EXTERIOR DOOR FRAME AND DOOR RUSTING OUT

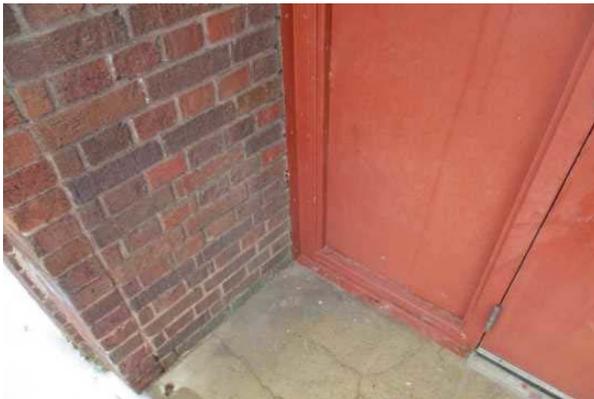
#9: CAULK JOINT AND TRIM DOOR PAINTING

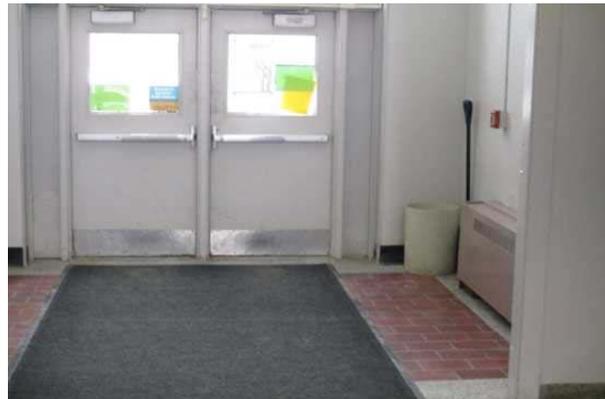
#10: EXTERIOR DOOR PAINTING

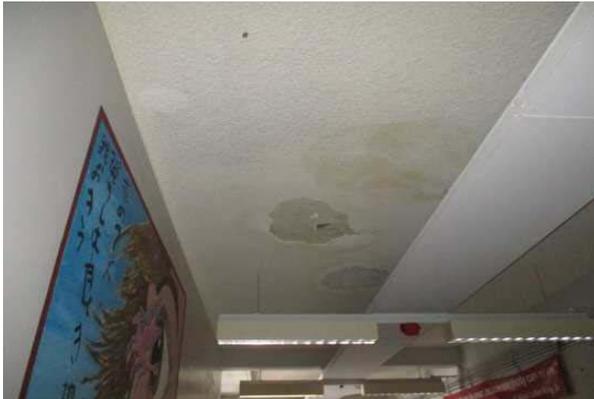
#13:

- There are isolated areas of water-damaged ceiling finishes, in the halls near the courtyard windows, south stairwell and some third-floor classrooms. The damaged ceiling areas need to be repaired.

PLASTER CEILING REPAIR AND
PANTNG

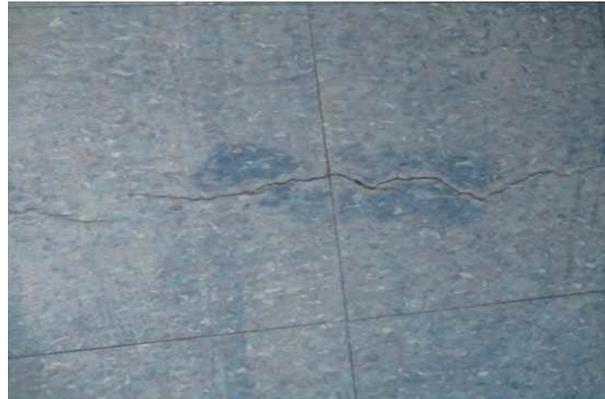
#14:

- The hardwood floor in the gym is in need of refinishing and painting of sport lines.
- The VCT flooring near the vending machine by the gym has pieces missing and the landings of the stairs are the most worn and should be replaced on a more frequent schedule.

VCT REPLACEMENT

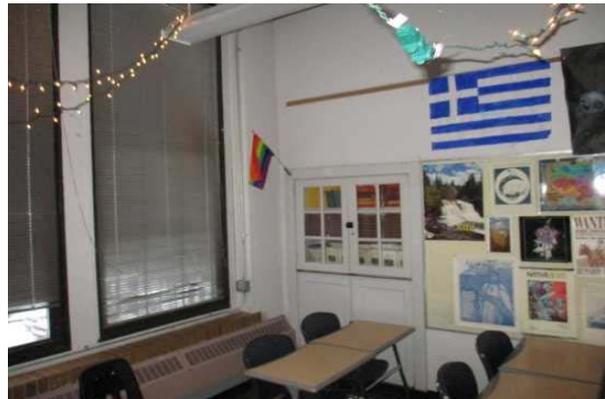
#16:

PAINTING OF INTERIOR WALLS

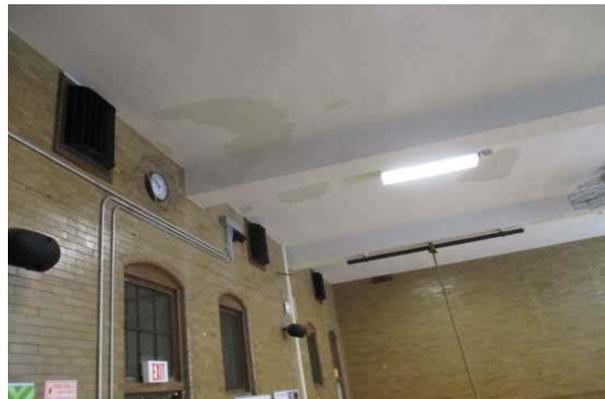
#24:	CEILING REPAIR AND REPAINT
------	----------------------------

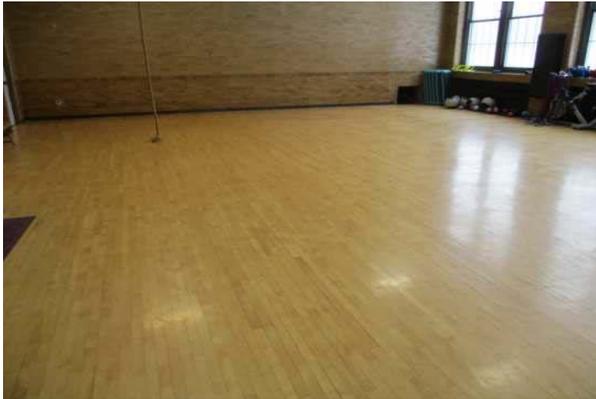
#25:	GYM FLOOR
------	-----------

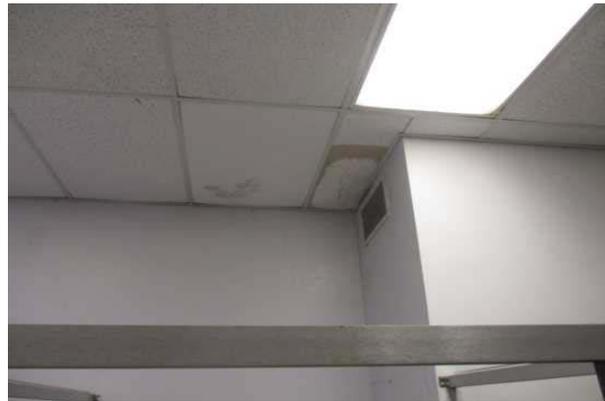
- The concrete stairs show wear and require painting.
- The ceiling tiles have isolated areas of water-damaged ceiling tiles. The damaged ceiling tiles need to be replaced.

#28:	STAINED ACT
------	-------------

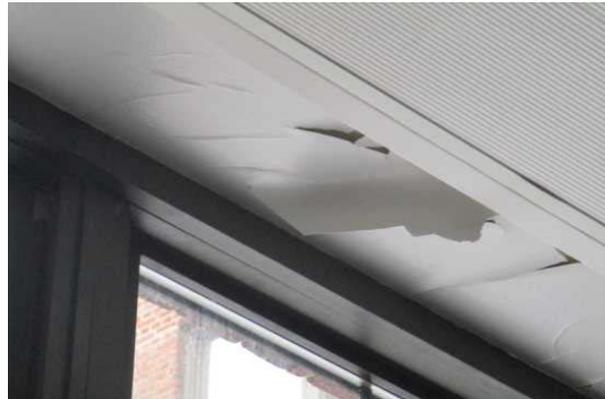
#30:	CEILING, PAINT PEELING
------	------------------------

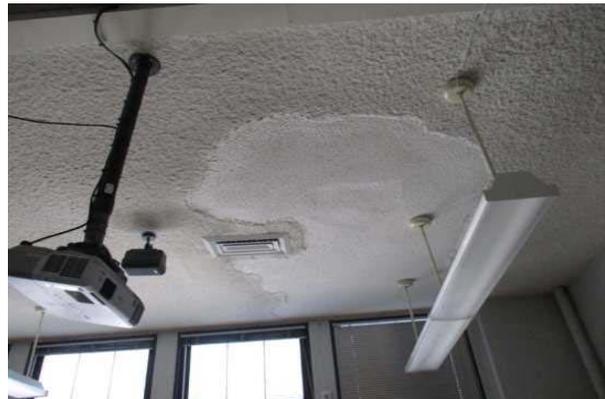
#34:	CEILING REPAIR AND REPAINTING
------	----------------------------------

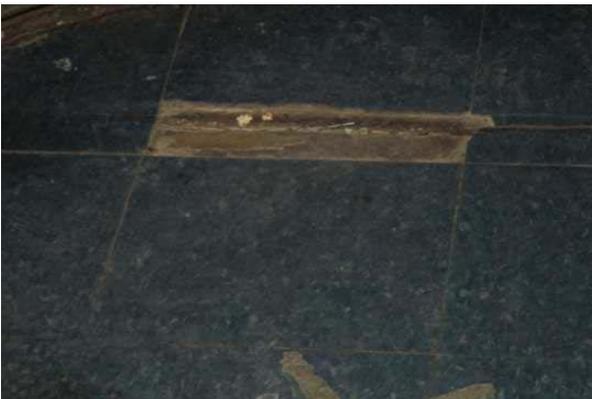
#41: BROKEN VCT TILE

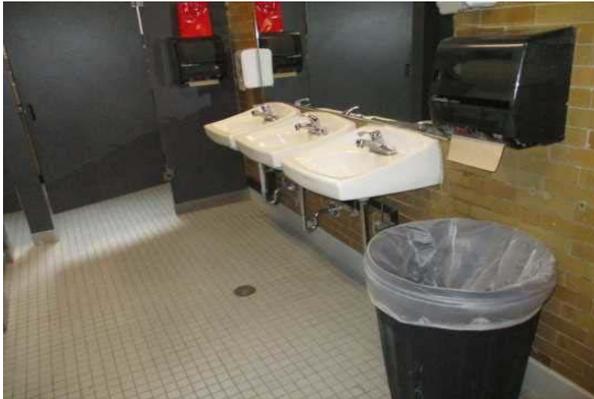
- The plumbing systems appear to be well maintained and functioning adequately. The water pressure appears to be sufficient. No significant repair actions or short-term replacement costs are required. Routine and periodic maintenance is recommended. Future lifecycle replacements of the components or systems listed above will be required.
- Some of the ADA restrooms do not have the drain pipes and water supply lines insulated/wrapped.

#49: ADA LAVATORY PIPE WRAPS

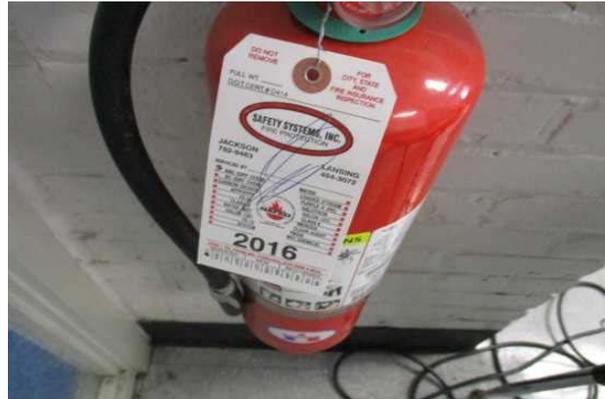
#68: FIRE EXTINGUISHER OUT OF DATE
