FACILITY CONDITION ASSESSMENT

June 29, 2018

LAKEWOOD ELEMENTARY
344 GRALAKE AVENUE
ANN ARBOR, MICHIGAN 48103

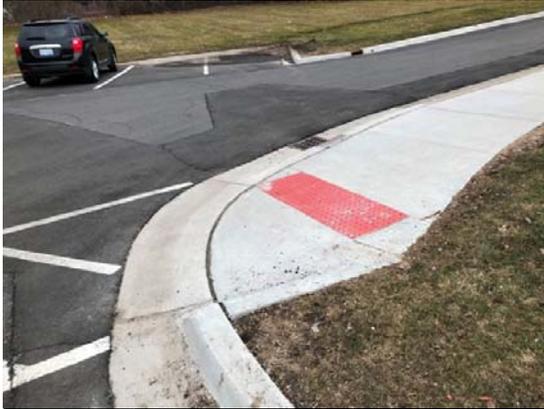
PHOTO #7: CONCRETE SIDEWALKS AND ASPHALT PAVEMENT

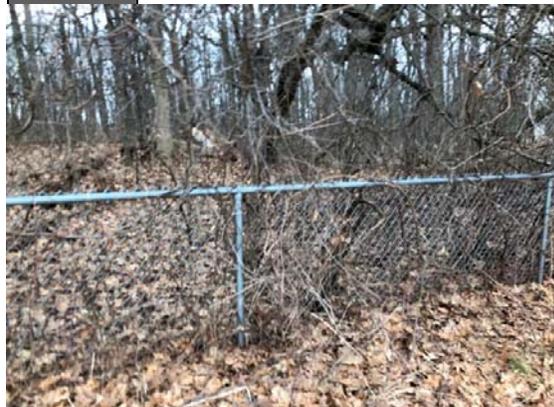
PHOTO #12: CHAIN LINK FENCING

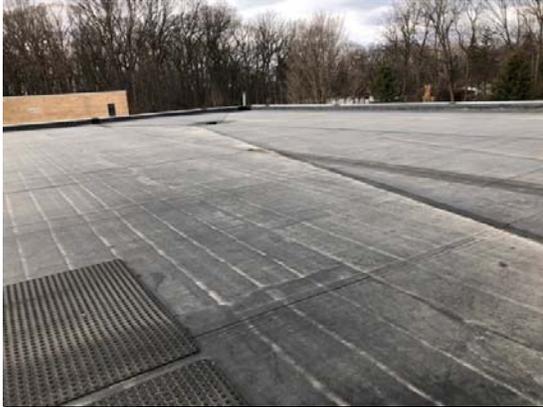
PHOTO #13: SINGLE-PLY ROOFING

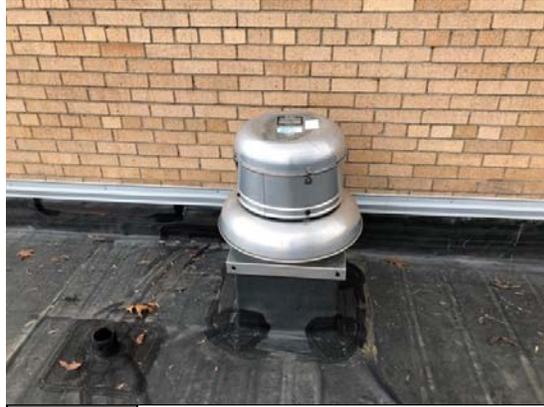
PHOTO #14: EXHAUST FAN

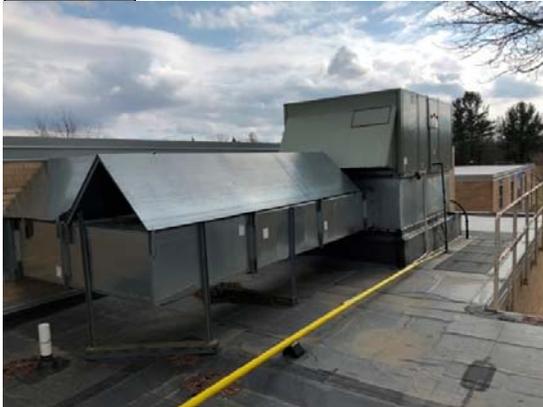
PHOTO #15: ROOFTOP UNIT

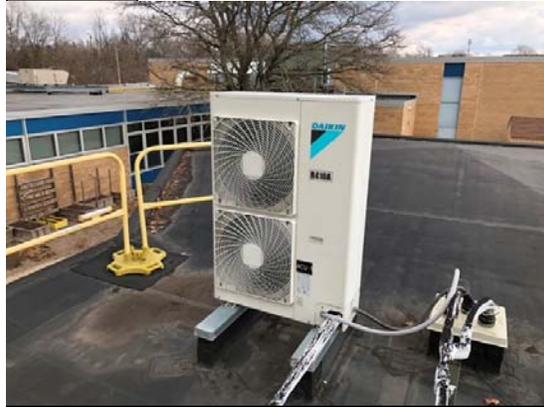
PHOTO #16: DUCTLESS SPLIT SYSTEM

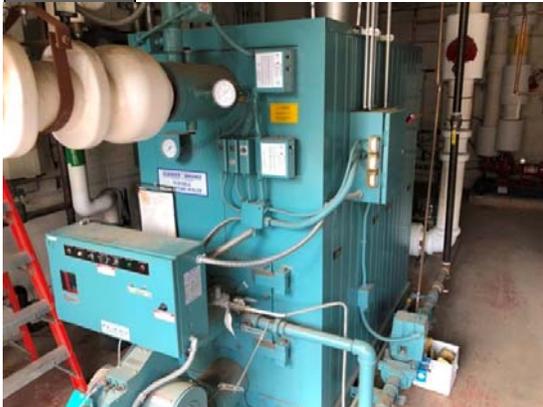
PHOTO #17: HVAC BOILER

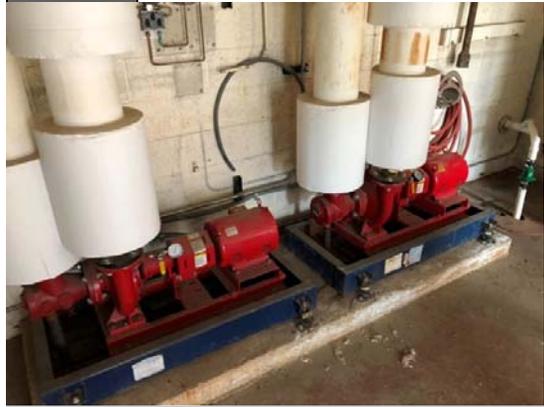
PHOTO #18: CIRCULATION PUMPS

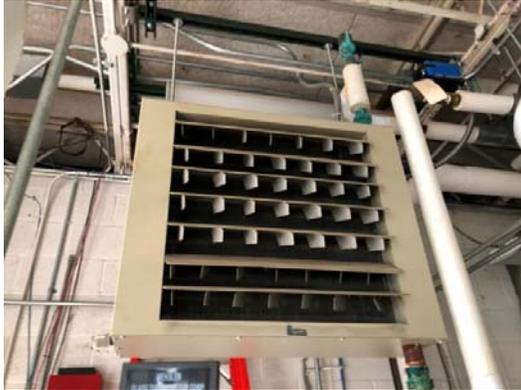
PHOTO #19: SUSPENDED UNIT HEATERS

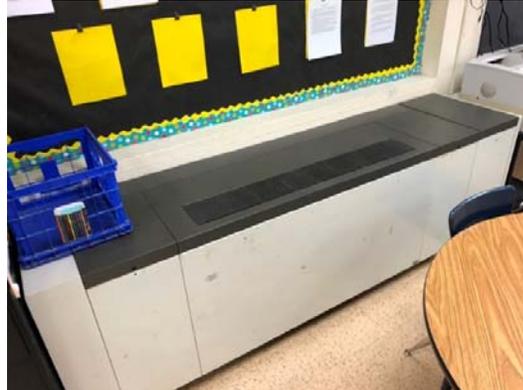
PHOTO #20: UNIT VENTILATORS

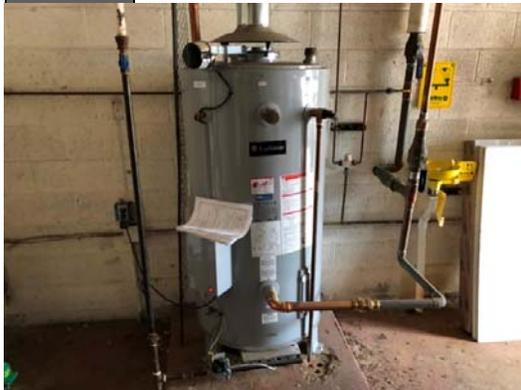
PHOTO #21: DOMESTIC WATER HEATER

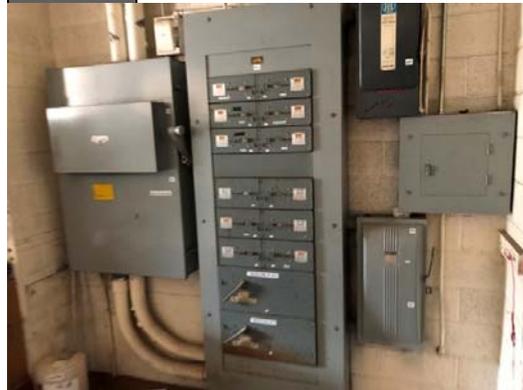
PHOTO #22: MAIN DISTRIBUTION PANEL

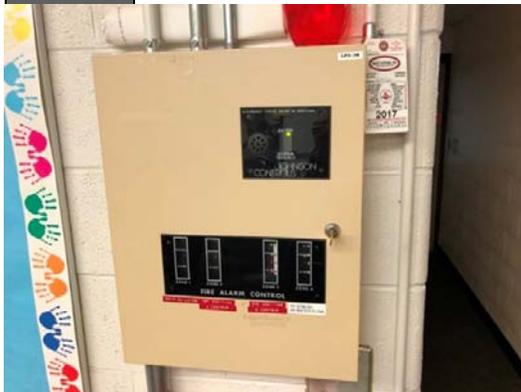
PHOTO #23: FIRE PANEL

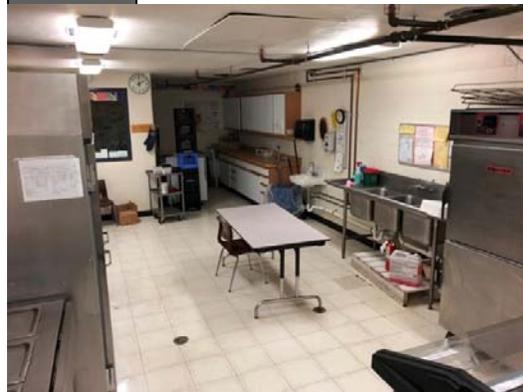
PHOTO #24: KITCHEN EQUIPMENT
