FACILITY CONDITION ASSESSMENT

June 28, 2018

ABBOT ELEMENTARY
2670 SEQUOIA PARKWAY
ANN ARBOR, MICHIGAN 48103

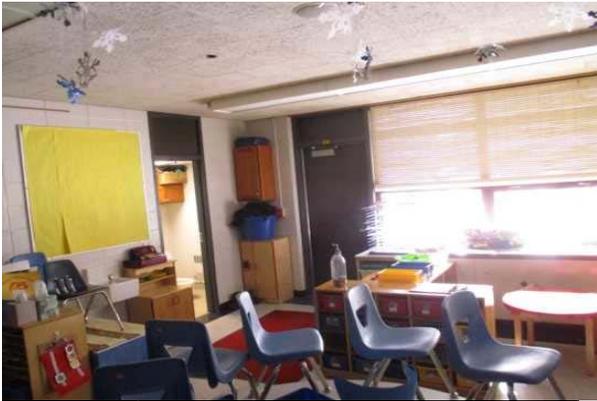
#6:	FAILED CAULKING AT CURTAIN WALL
-----	---------------------------------

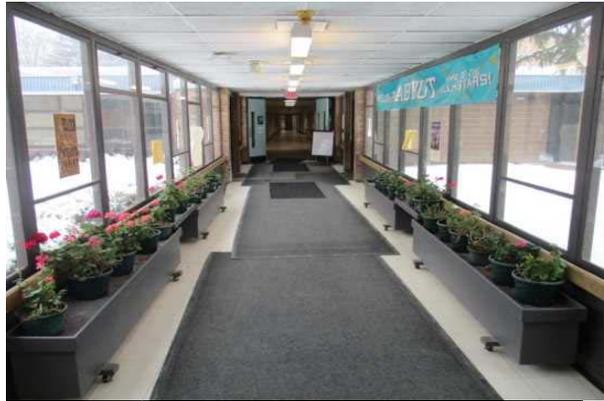
#7: EXTERIOR DOOR AND POSSIBLE ASBESTOS CEILING TILES

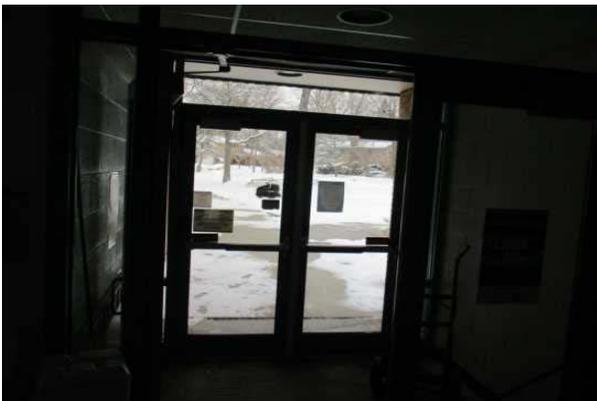
- The curtain wall system has significant areas of deteriorated panels and cracked sealants. The glass panes used are wire reinforced which are no longer permit per, Mr. Jim Vibbart. The curtain wall bottom panels and track are rusting at the joints. There is rust in some areas is showing the layering stage of deterioration. The ceiling caulking is opening up and pulling away. The glazing and panel are all uninsulated. The curtain wall must be replaced.

#8: CURTAIN WALLS

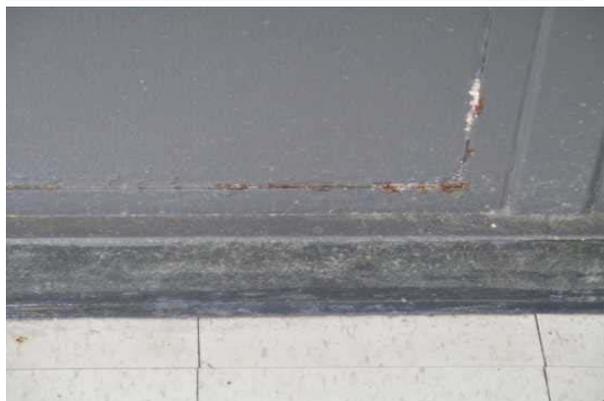
- The brick walls have isolated areas of cracked mortar and efflorescence. The damaged mortar must be repaired and the bricks cleaned and sealed. The efflorescence is a sign of water leakage into the facility. This could be related to roof, flashing or caulking issues. There is not a way to tell when this was caused.

#11: RUSTING CURTAIN WALL PANEL AND EFFLORESCENCE

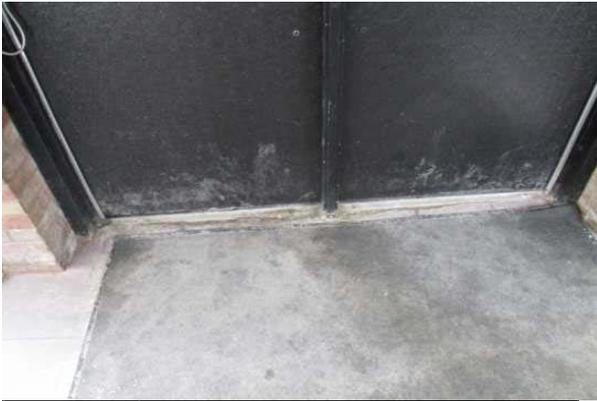
#12: RUSTING UN-INSULATED CURTAIN WALL PANEL

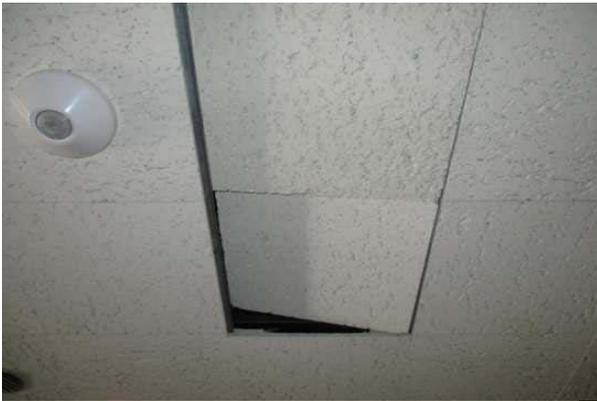
#14:	DAMAGED ACOUSTICAL CEILING
------	----------------------------
