FACILITY CONDITION ASSESSMENT

Ann Arbor Public Schools
2555 South State Street
Ann Arbor, Michigan 48104
Jim Vibbart

July 2, 2018

WINES ELEMENTARY
1701 NEWPORT ROAD
ANN ARBOR, MICHIGAN 48103

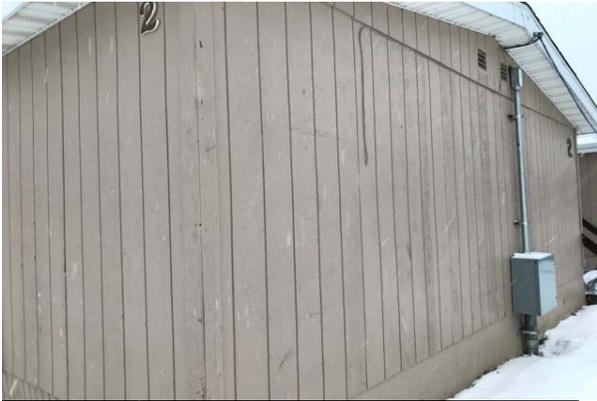
#19:	EAST BUILDINGS, WOOD SIDING
------	-----------------------------

- The soffits have isolated areas of cracking and faded paint. The soffits require painting.
- The wood siding has isolated areas of damage. The damaged areas of wood siding require replacement.

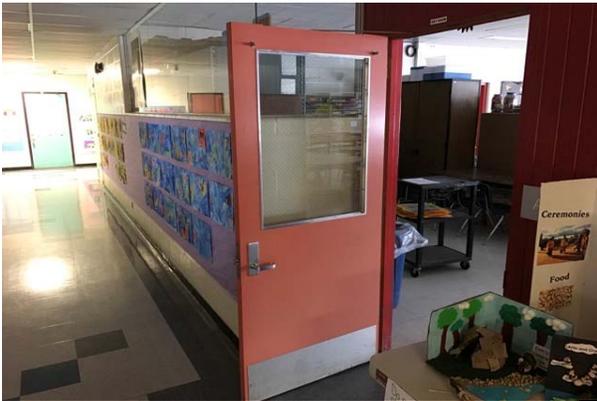
#27:	INTERIOR DOOR
------	---------------

- It appears that the interior finishes have been renovated within the last 25 years.
- The walls have significant portions that are faded paint. The affected portions of the walls must be repainted.
- The acoustical ceiling tiles are show signs of water damage. The damaged acoustical ceiling tiles require replacement.
- The restroom partitions are damaged and antiquated. The damaged restroom partitions require replacement.
- The doors are hard to open and are damaged. The damaged doors require replacement.

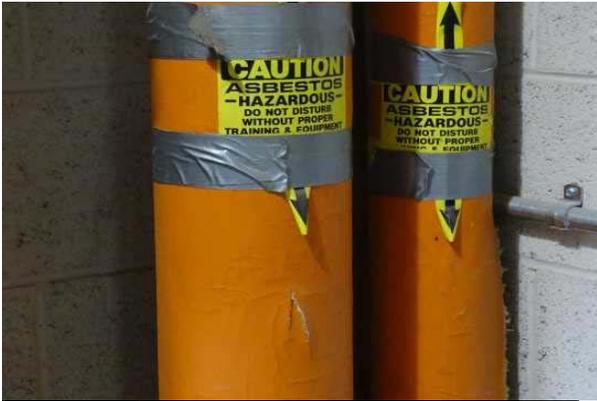
#37:	ASBESTOS PIPING
------	-----------------

MEPF: Some mechanical components in the building are original and are antiquated. The piping is in poor condition and the wrapping contains asbestos. Asbestos has also been found throughout the building. A professional engineer must be retained to analyze the existing condition, provide recommendations for of any required abatement. The cost of this study is included in the cost tables.

- The common area restroom accessories and plumbing fixtures appear outdated. The restroom accessories and plumbing fixtures are recommended for replacement.
- The piping is in poor condition and contains asbestos wrapping. A professional engineer must be retained to analyze the existing condition, provide recommendations and, if necessary, estimate the scope and cost of any required repairs. The cost of this study is included in the cost tables.
