FACILITY CONDITION ASSESSMENT

February 7, 2018

LOGAN ELEMENTARY
2685 TRAVER ROAD
ANN ARBOR, MICHIGAN 48105

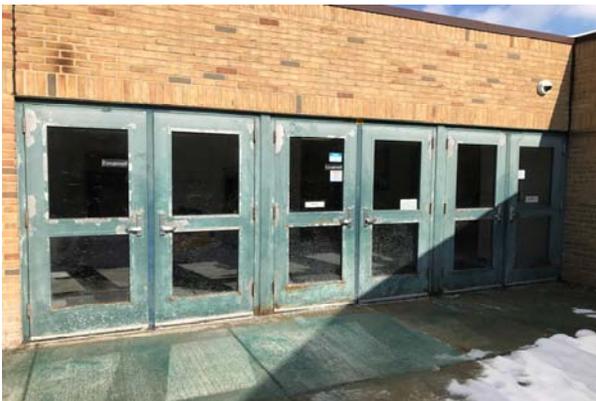
#11:	EXTERIOR DOORS
------	----------------

- There are a significant number of damaged, delaminated, deteriorated and rusted doors and door frames. The damaged doors and frames must be replaced.

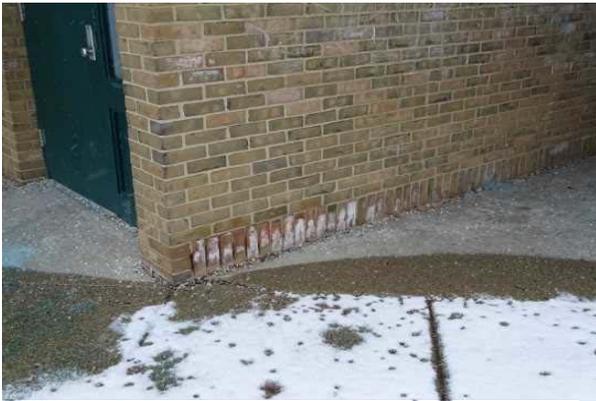
#15:	BRICK
------	-------

Architectural: Isolated portions of the mortar joints along the brick are cracked around the property. A cost allowance to repair and/or replace these deficient attributes is included in the cost tables.

- The soffits have significant portions that are rusted, faded and weathered. The affected portions of the soffits must be sanded and painted.
- Isolated portions of the mortar joints along the brick are cracked around the property. The damaged mortar joints must be cleaned and re-pointed.

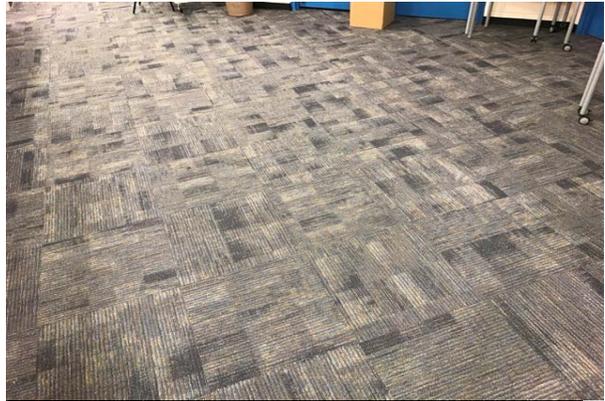
#20:	INTERIOR FLOOR FINISH, CARPET
------	-------------------------------

- The carpet was installed in 1996, has areas of damage, stains, and is past its useful life. The carpet is recommended for replacement.

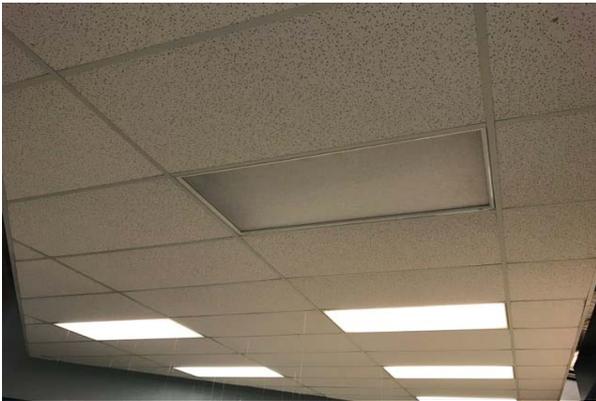
#21:	SUSPENDED ACOUSTICAL TILE (ACT)
------	---------------------------------

- The ceiling tiles have isolated areas of water-damaged ceiling tiles throughout the building. The damaged ceiling tiles need to be replaced. The cost for this work is relatively insignificant and the work can be performed as part of the property management's routine maintenance program.

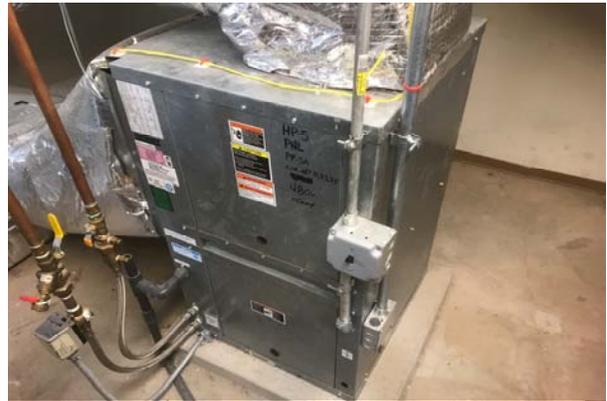
#28:	WATER SOURCE HEAT PUMP
------	------------------------

MEPF: Some electrical components in the building are original and are antiquated. Some of the water source heat pumps show signs of damage and are antiquated. A cost allowance to repair and/or replace these deficient attributes is included in the cost tables.

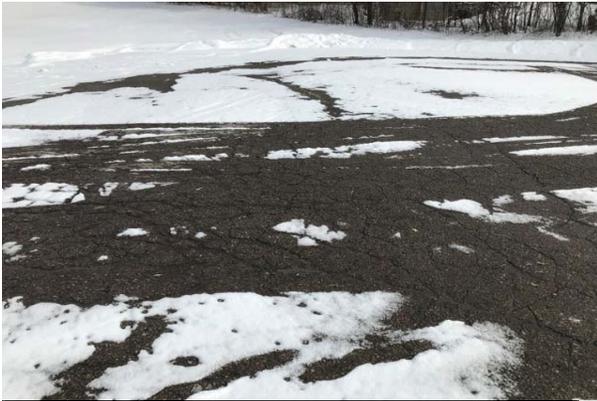
#49:	PARKING LOTS
------	--------------

Site: The parking lot has multiple cracks from erosion. The fencing in the front of the property is damaged. The basketball backboards are distressed. A cost allowance to repair and/or replace these deficient attributes is included in the cost tables.
