FACILITY CONDITION ASSESSMENT

129010.18R000-010.354

March 8, 2018

DICKEN ELEMENTARY
2135 RUNNYMEADE BOULEVARD
ANN ARBOR, MICHIGAN 48103

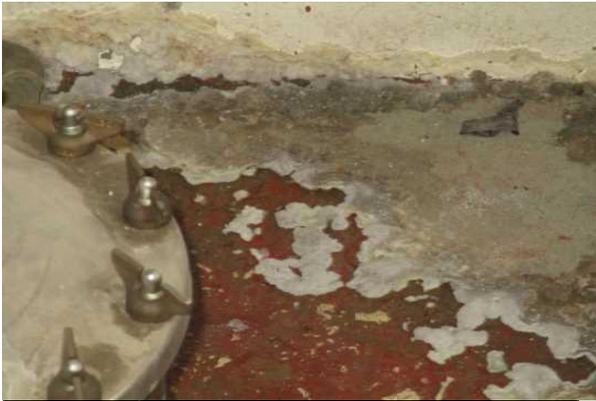
- The flooring in the boiler room has been attacked by the chemicals used in the hot water boilers. The flooring should be replaced with a chemical resistant epoxy that includes an integral base.

#7:	BOILER ROOM FLOOR FINISH
-----	--------------------------

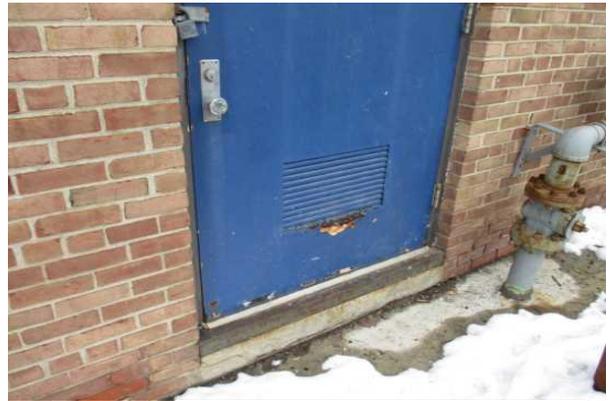
- No significant actions are identified at the present time. On-going periodic maintenance is highly recommended. Future lifecycle replacements of the components listed above will be required.
- There are a few rusted door frames. The damaged doors must be replaced.
- The function of the windows should be tested and confirmed functional for Active Shooter. This should include the windows, screens and blinds. Replacing missing/damaged blinds.
- The glazing system has significant areas of damaged and/or missing sealant (throughout the classrooms). The damaged sealant must be replaced.
- The rusted exterior doors should be repaired or replaced.

#10:	EXTERIOR SERVICE DOOR
------	-----------------------

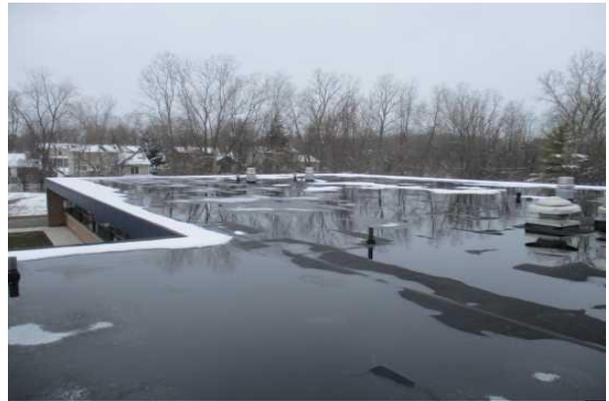
- The roof appears to be more than 10 years old. Information regarding roof warranties or bonds was not available. A copy of the warranty was requested but was not available. The roofs are maintained by an outside contractor.
- There is no evidence of roof deck or insulation deterioration. The roof substrate and insulation should be inspected during any future roof repair or replacement work.
- Roof drainage appears to be adequate. Clearing and minor repair of drain system components should be performed regularly as part of the routine maintenance and operations program.
- The attics are not accessible, and it could not be determined if there is moisture, water intrusion, or excessive daylight in the attics.
- Roof leaks have occurred within the past year, and some of these leaks remain active. The leaks occur (throughout the building). All active leaks must be repaired.

#16:	EPDM ROOF
------	-----------

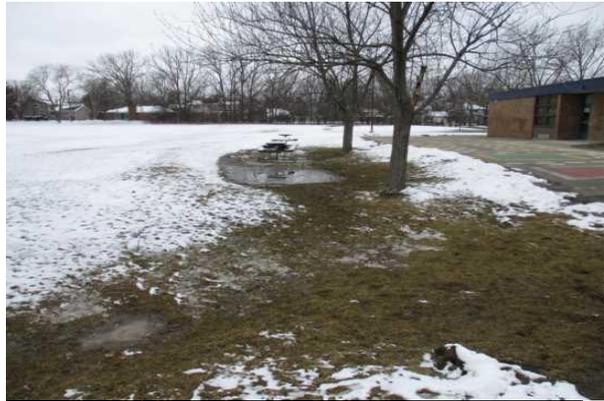
#20:	RE-SLOPE LANDSCAPING
------	----------------------

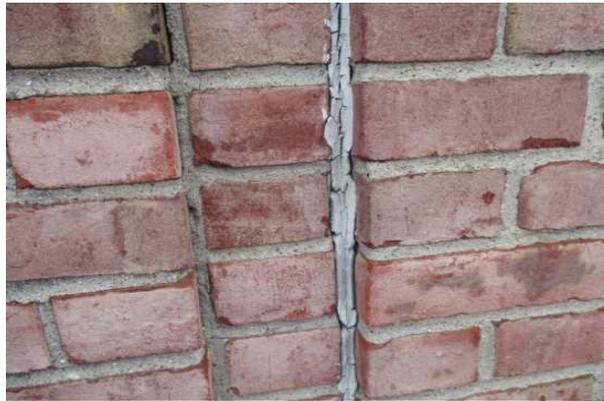
#22:	EXTERIOR WALL CAULKING
------	------------------------

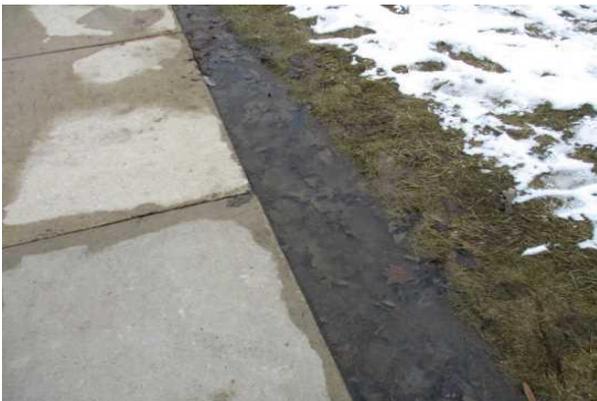
#23:	RE-SLOPE LANDSCAPING
------	----------------------

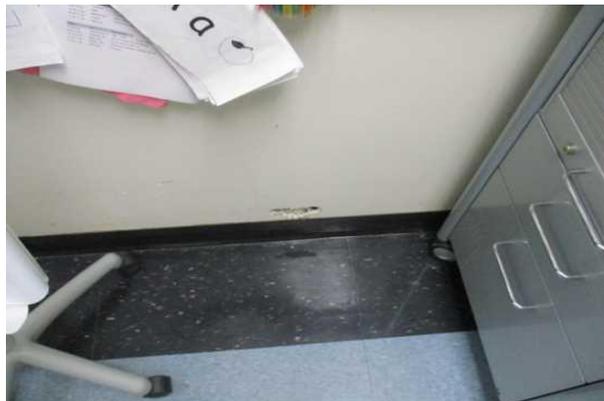
- There are isolated areas of damaged wall finishes. The damaged wall areas need to be repaired. The cost to repair the damaged finishes is relatively insignificant and the work can be performed as part of routine maintenance program.

#24:	INTERIOR WALL REPAIR
------	----------------------

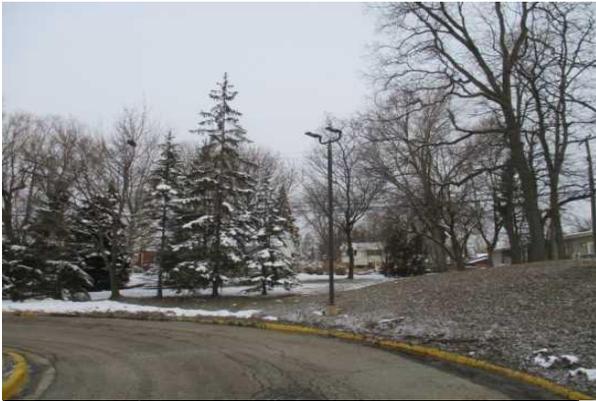
#25:	EXTERIOR POLE LIGHT AND CRACKED ASPHALT
------	--

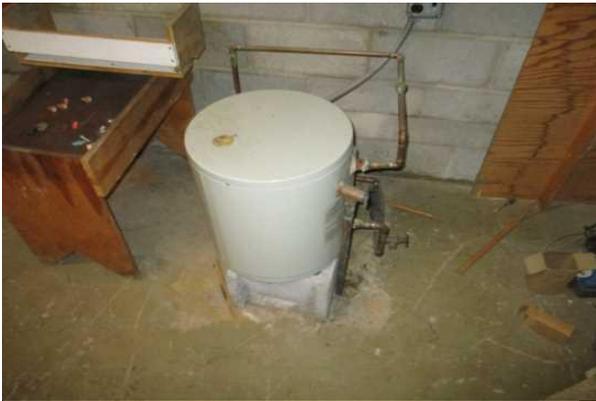
#27:	ELECTRIC WATER HEATER
------	-----------------------

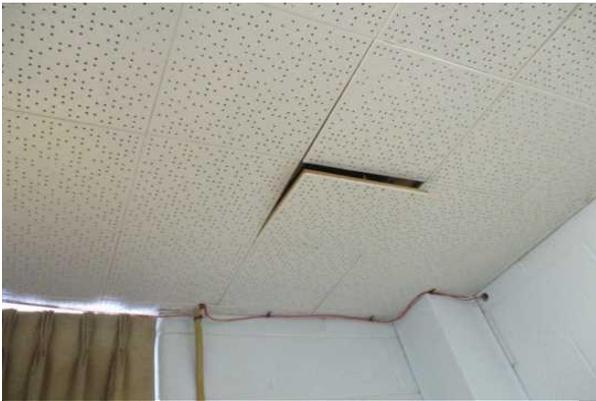
- The majority of the ceiling tiles in the classrooms have the same appearance as tiles that contain asbestos. The tiles and facility should be inspected for asbestos containing materials. This work should include the replacement of these ceiling tiles. There are funds in the reserve for this work. Tiles hidden above existing lay-in ceilings are not included in the reserve.

#33:	ASBESTOS STUDY & POSSIBLE REPLACEMENT
------	--

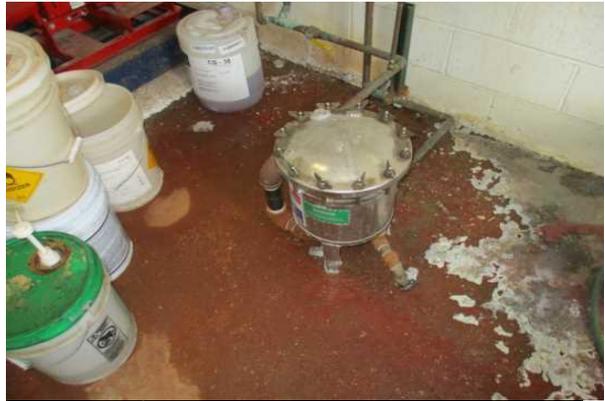
#38:	HYDRONIC BOILER SOLUTION FILTER, DAMAGED FLOOR FINISH
------	---

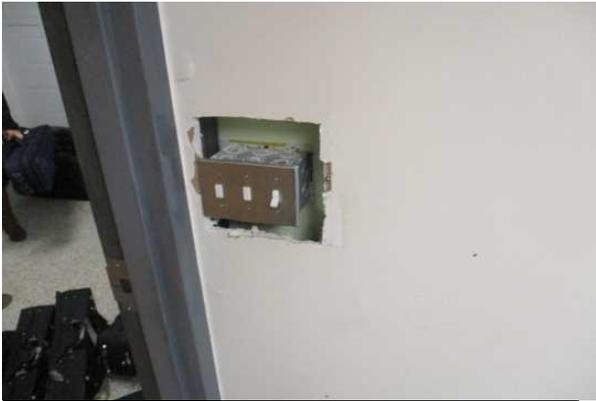
#43:	INTERIOR WALL FINISH REPAIR
------	-----------------------------

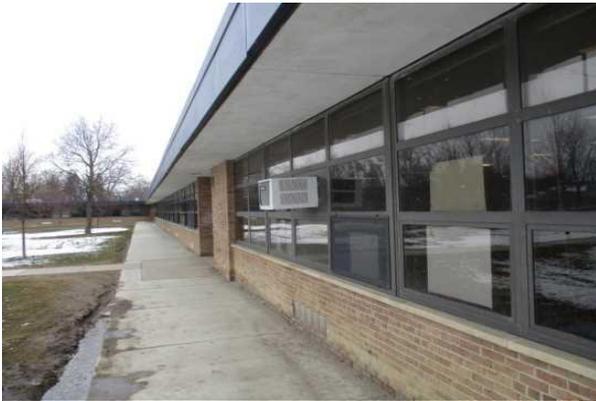
#57:	RE-POINTING BRICK
------	-------------------

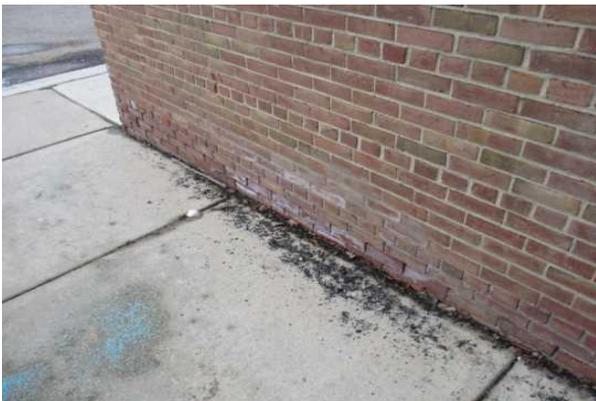
#59:	BRICK REPAIR
------	--------------

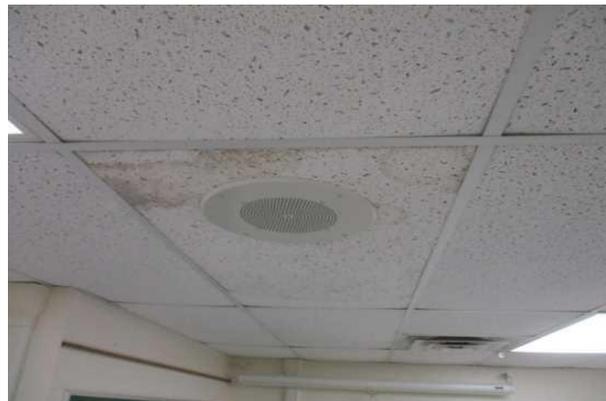
#60:	MOLD REMEDIATION,
------	-------------------
