# FACILITY CONDITION ASSESSMENT

June 29, 2018

FACILITY CONDITION ASSESSMENT

MACK ELEMENTARY / OPEN SCHOOL  
920 MILLER ROAD  
ANN ARBOR, MICHIGAN 48103

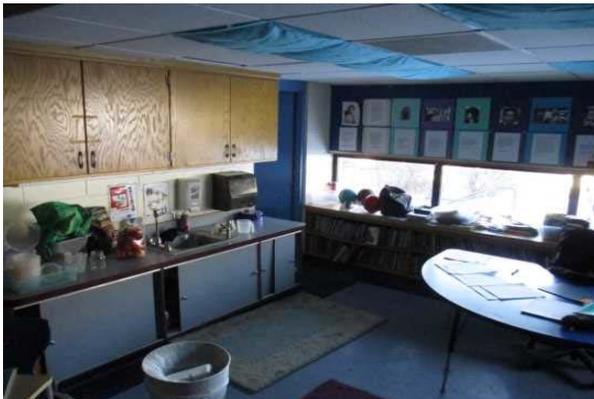
#9:	WINDOWS, CASEWORK AND VCT IN CLASSROOM
-----	--

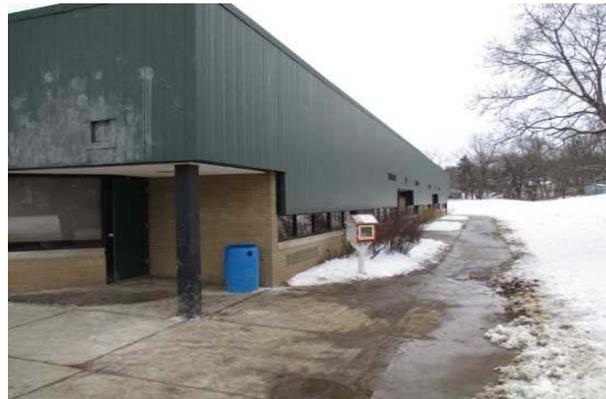
#10:	ALUMINUM FACED INSULATED PANEL SYSTEM
------	---------------------------------------

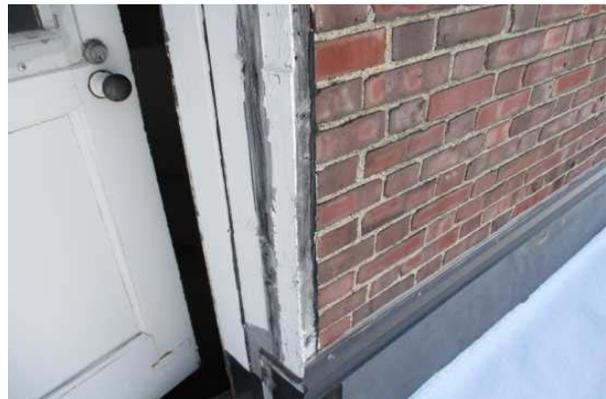
#12:	EXTERIOR DOOR ROOF ACCESS
------	---------------------------

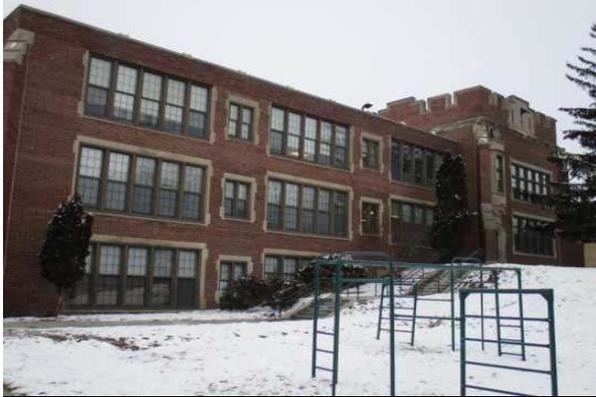
#13:	WINDOWS AND PLAYGROUND EQUIPMENT
------	----------------------------------

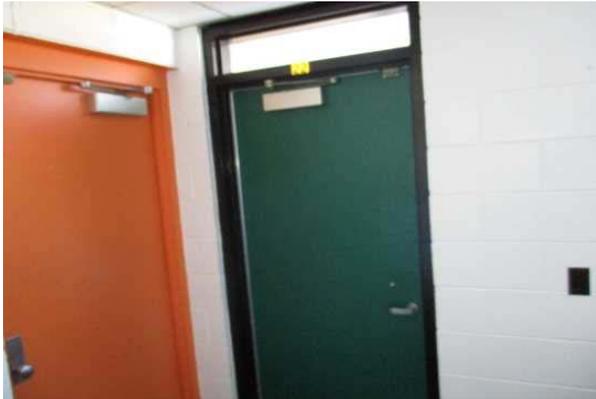
#15:	EXTERIOR DOOR AND INTERIOR DOOR
------	---------------------------------

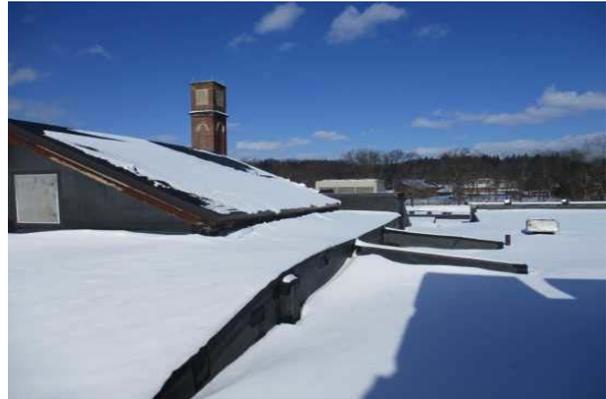
#16:	ROOF BALLASTED SECTION
------	------------------------

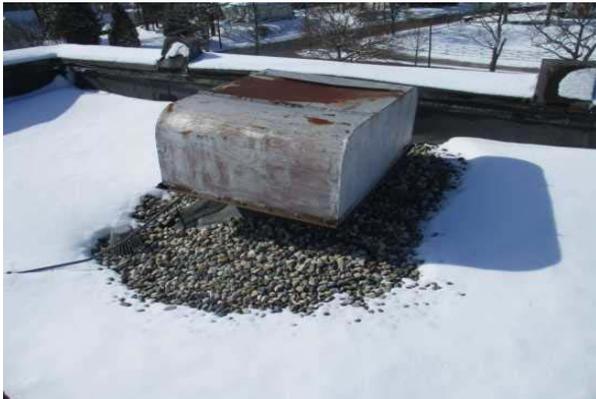
#17:	ROOF, BALLASTED WITH EXHAUST FAN
------	----------------------------------

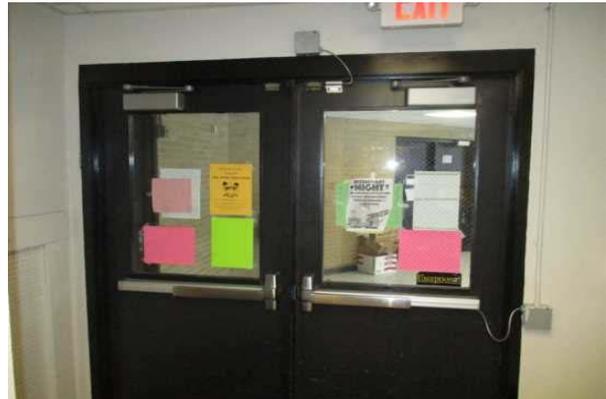
#18:	FIRE RATED INTERIOR DOORS
------	---------------------------

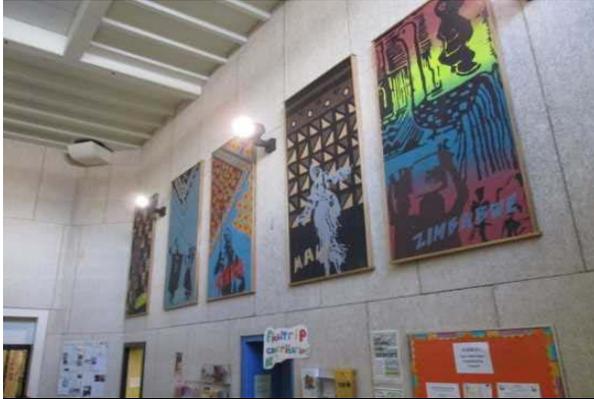
#19:	SOUND DAMPENING SURFACE TREATMENT
------	-----------------------------------

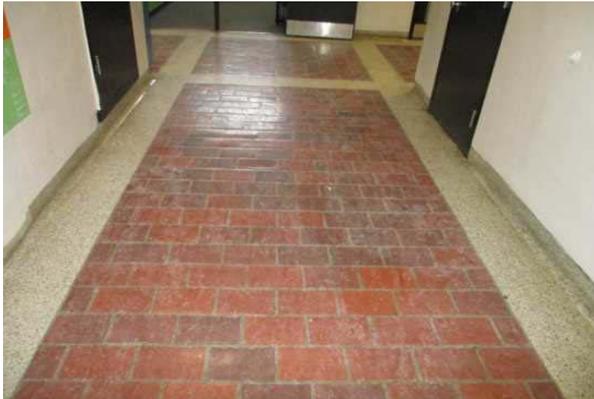
#21:	TERRAZZO FLOORING
------	-------------------

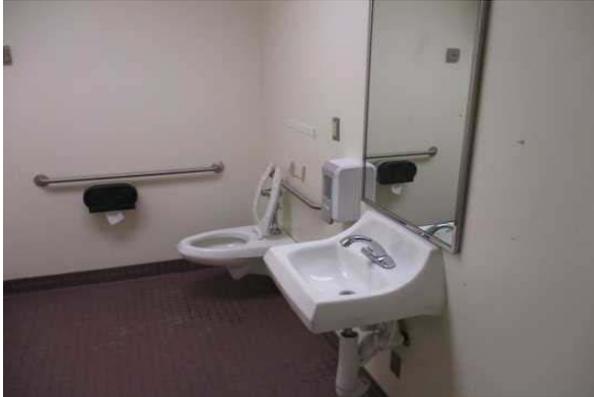
#25:	ADA RESTROOM WITH CERAMIC FLOOR TILE
------	--------------------------------------

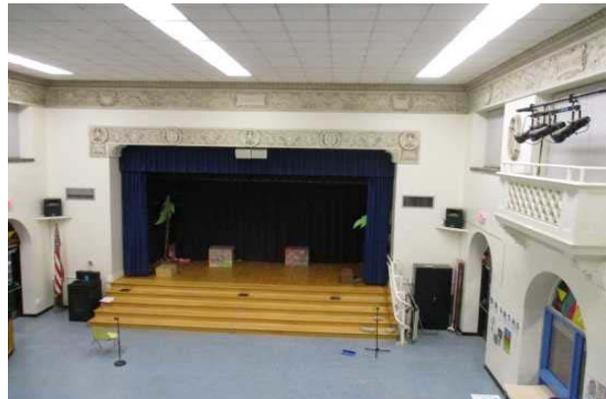
#28:	STAGE CURTAIN
------	---------------

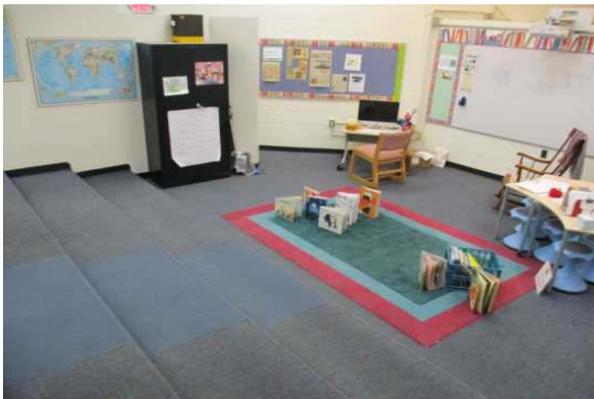
#29:	CARPETED AREA
------	---------------

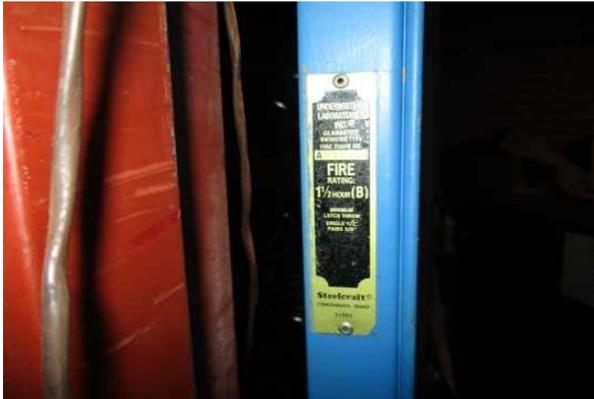
#31:	FIRE DOOR TAG
------	---------------

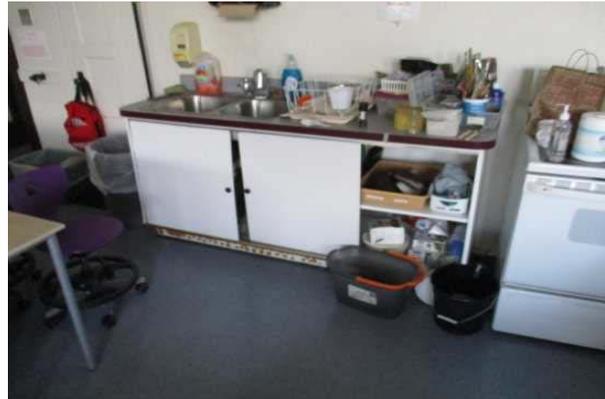
#32:	STAINLESS SINK WITH KITCHEN CABINETS
------	--------------------------------------

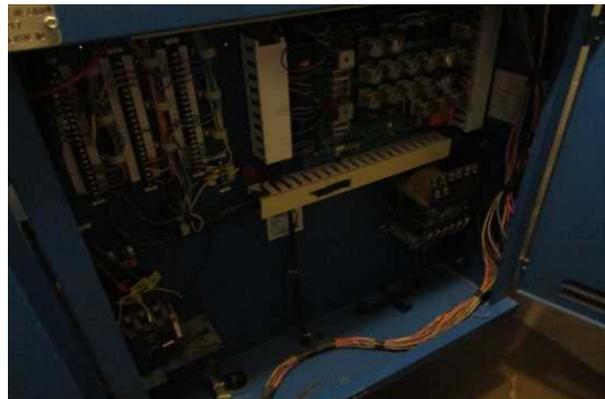
#36:	ELEVATOR RELAY CONTROLS
------	-------------------------

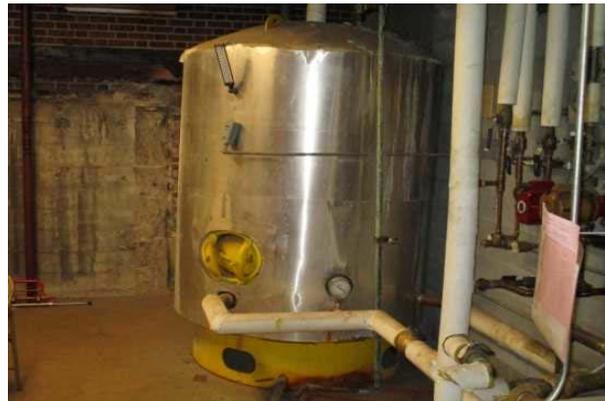
#38: HOT WATER STORAGE TANK

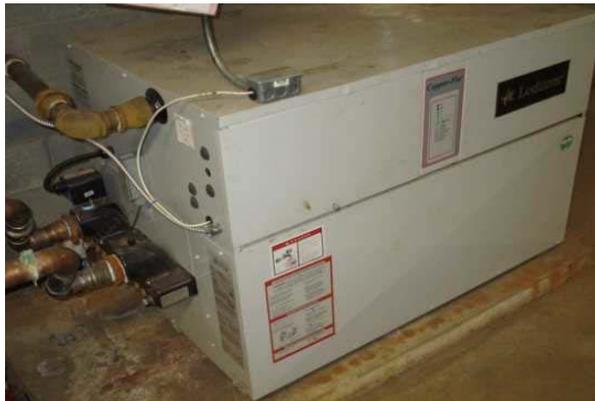
#39: TANKLESS WATER HEATER

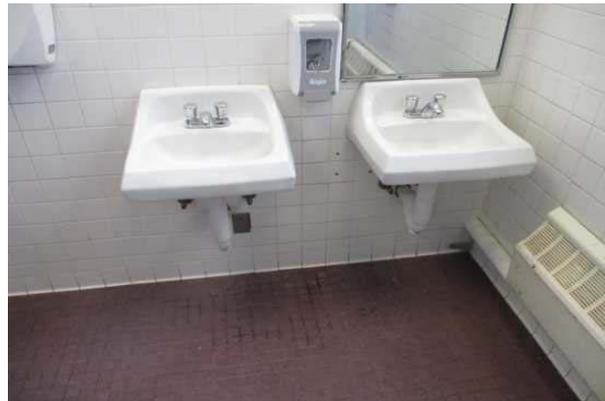
#40: CHINA SINKS WITH WRAPPED PIPES

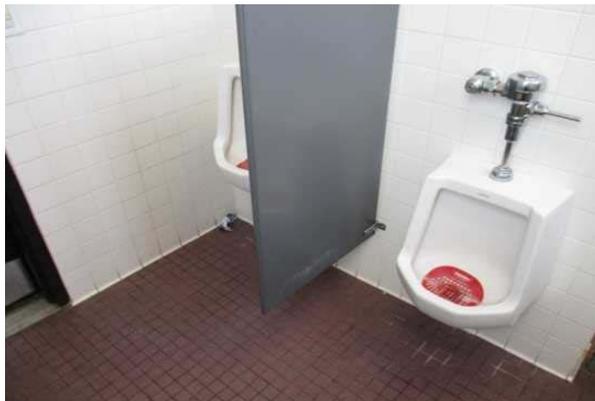
#41: URINAL

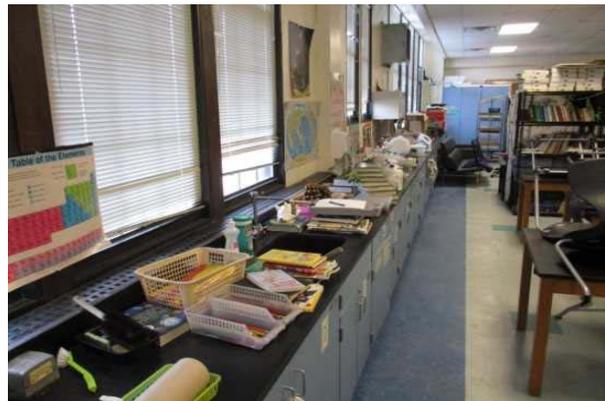
#42: EPOXY RESIN SINKS

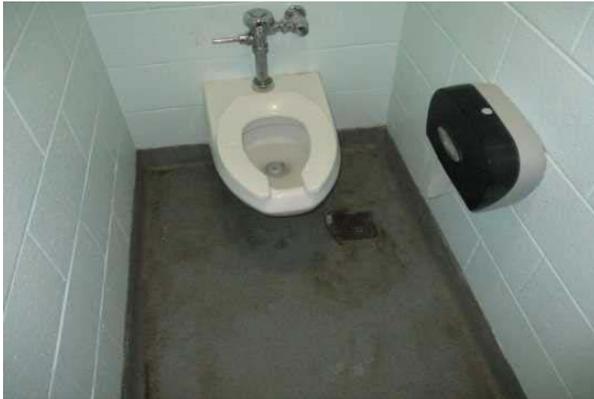
#43: TANKLESS TOILET

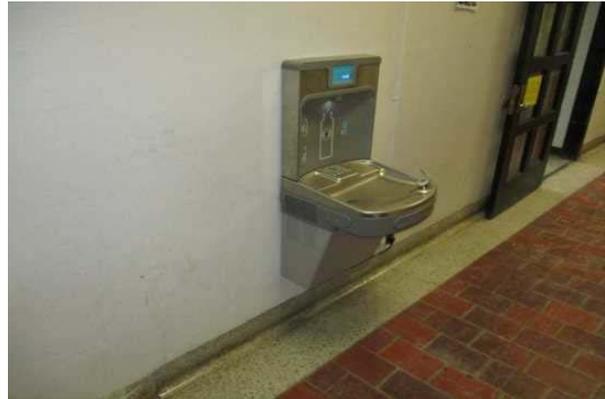
#44: DRINKING FOUNTAIN

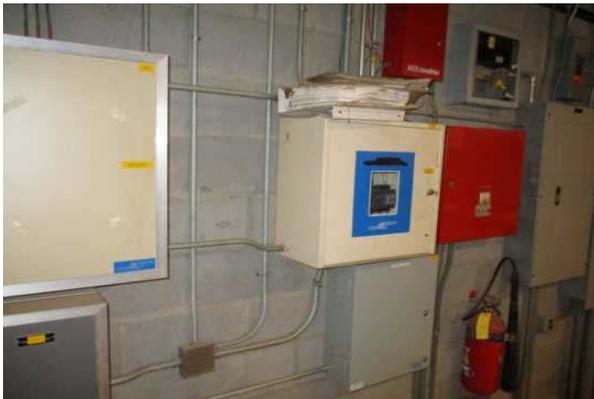
#45: BUILDING AUTOMATION SYSTEM

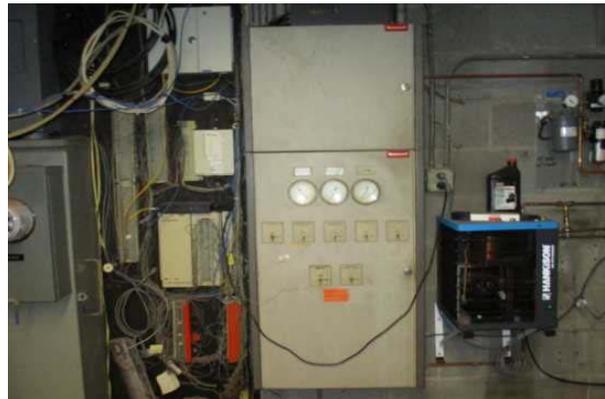
#46: BUILDING AUTOMATION SYSTEM

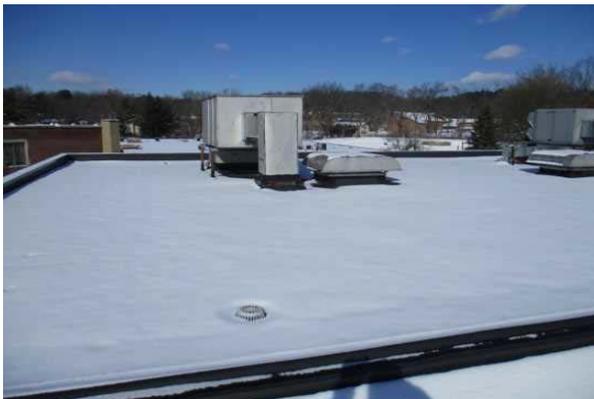
#47: MAKE-UP AIR UNIT

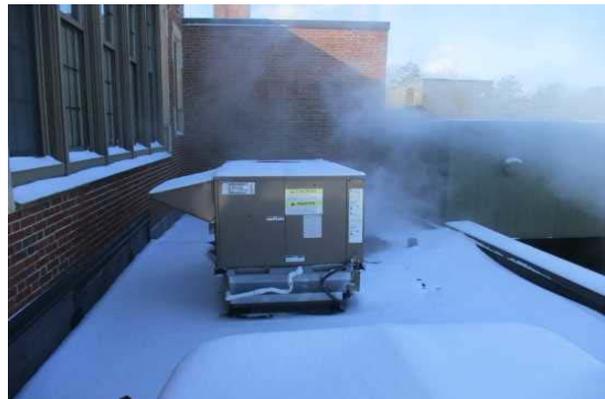
#48: RTU

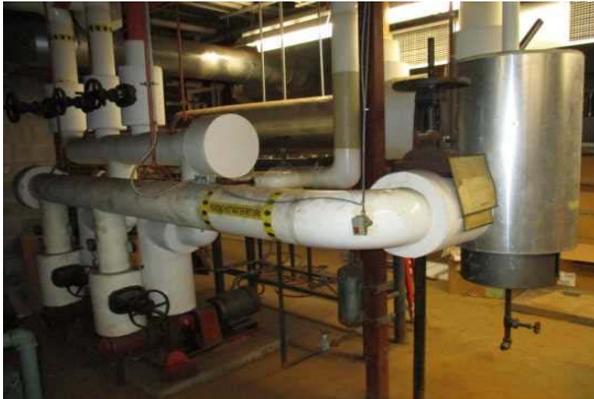
#49:	HEAT EXCHANGER AND BOOSTER PUMPS
------	----------------------------------

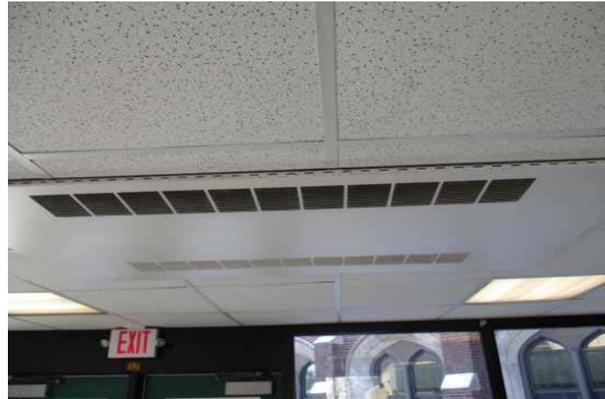
#50:	FAN COIL UNIT, HYDRONIC
------	-------------------------

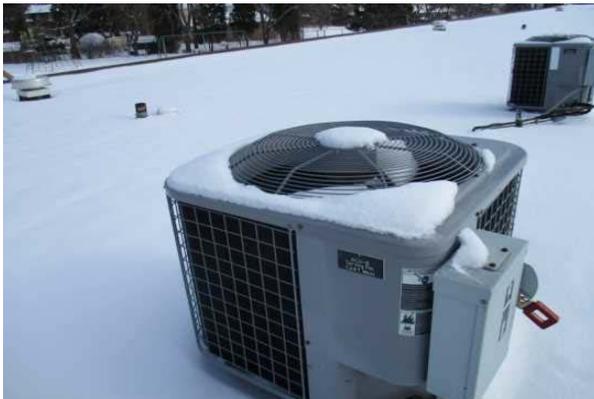
#51:	CONDENSER, AIR-COOLED
------	-----------------------

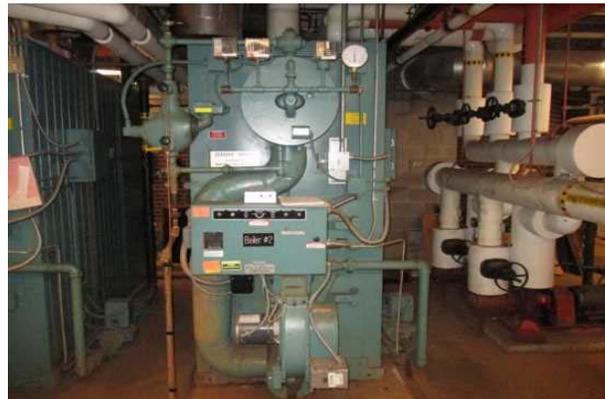
#52:	BOILER
------	--------

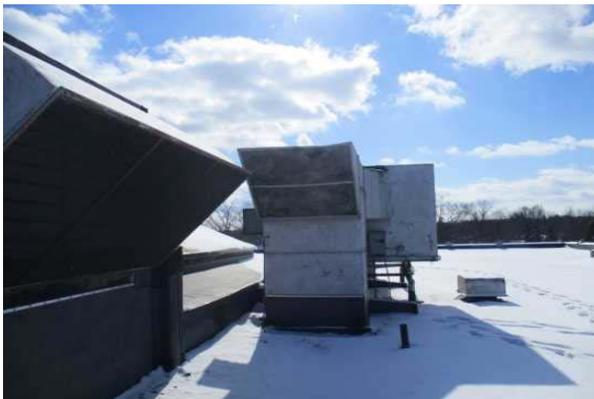
#53:	MAKE-UP AIR UNIT
------	------------------

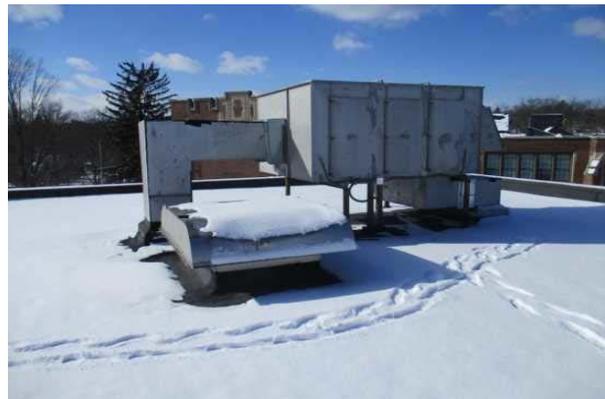
#54:	MAKE-UP AIR UNIT
------	------------------

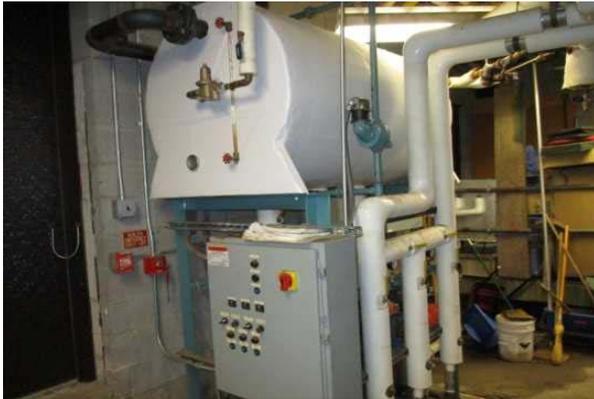
#55: DEAERATOR

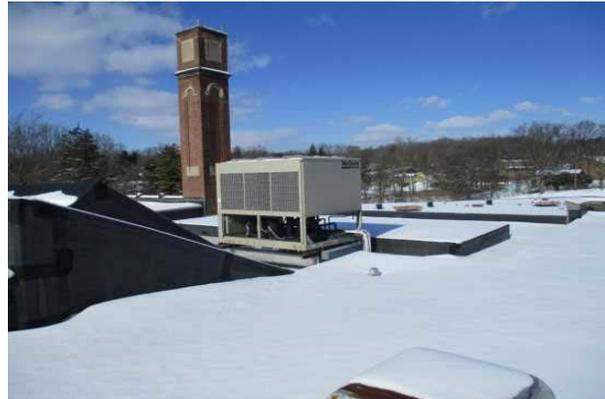
#56: COOLING TOWER

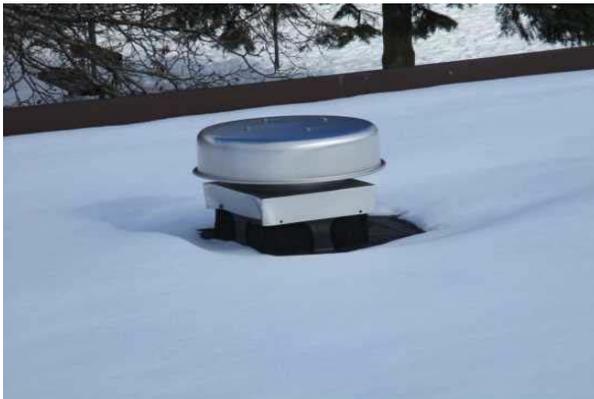
#57: SUPPLY FAN FOR CLASSROOM

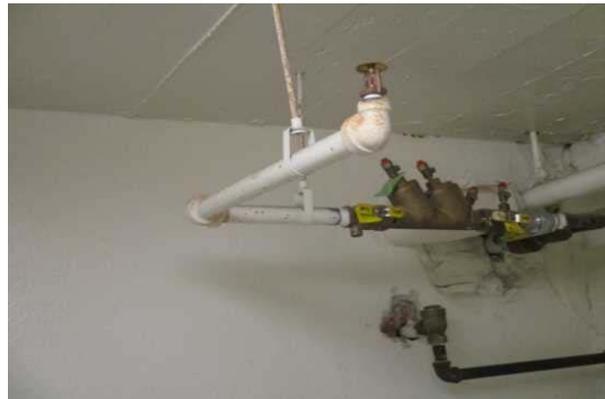
#58: SPRINKLER HEAD AND BACKFLOW PREVENTER

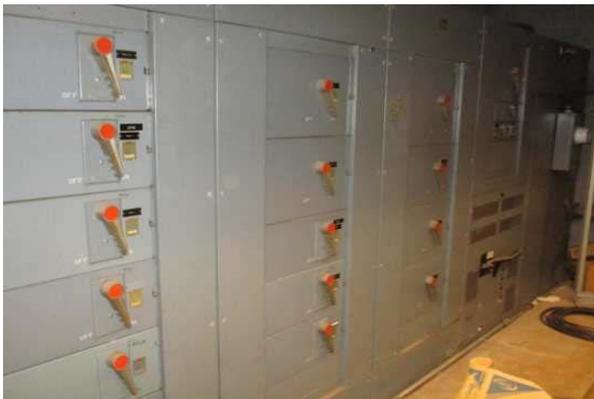
#59: BUILDING MAIN PANEL

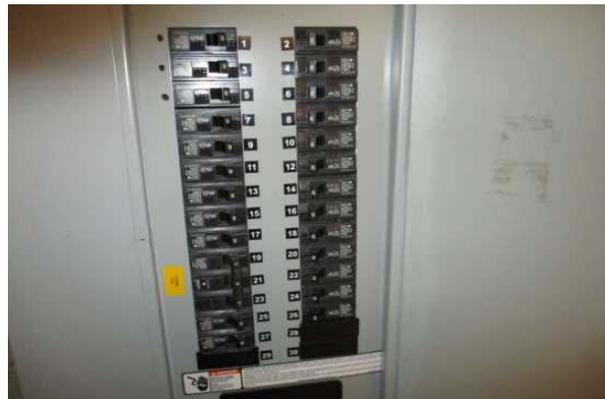
#60: DISTRIBUTION PANEL

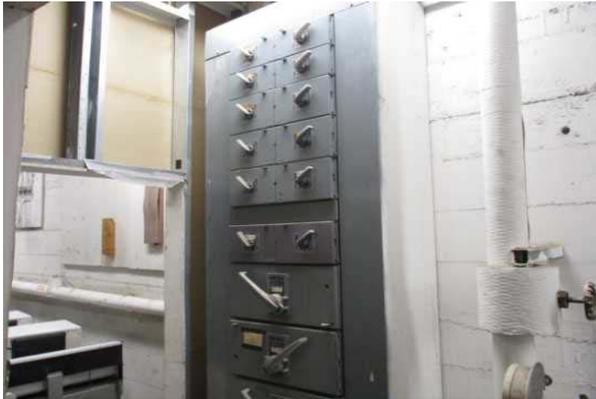
#61: SUB-PANEL SWITCHGEAR

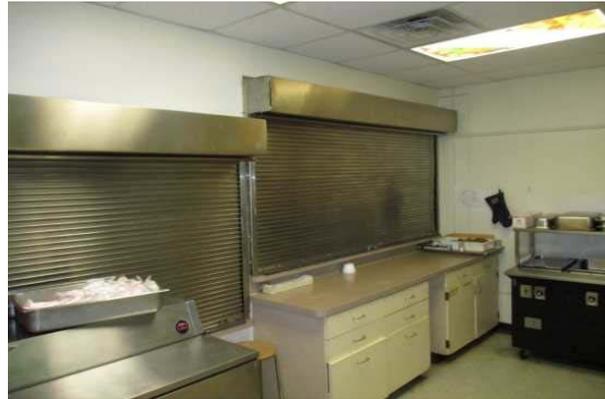
#62: FIRE SHUTTER

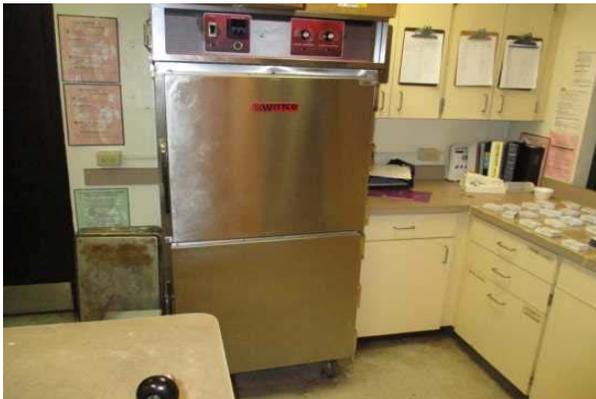
#63: CONVECTION OVEN DOUBLE DOOR

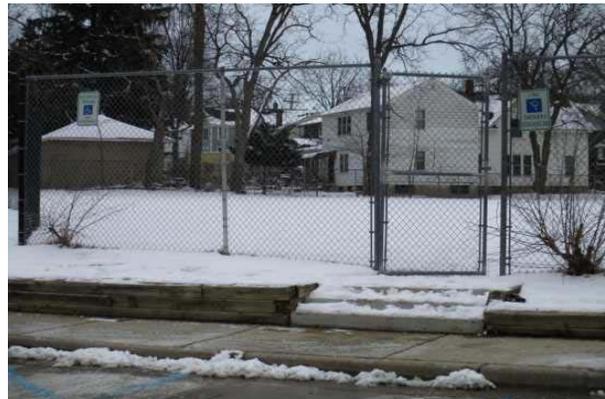
#64: RETAINING WALL AND FENCING

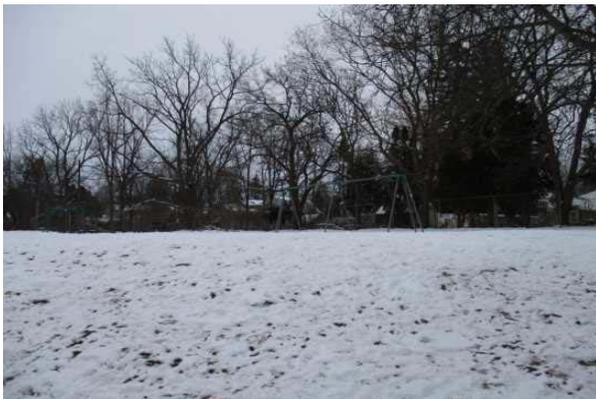
#65: PLAYGROUND EQUIPMENT

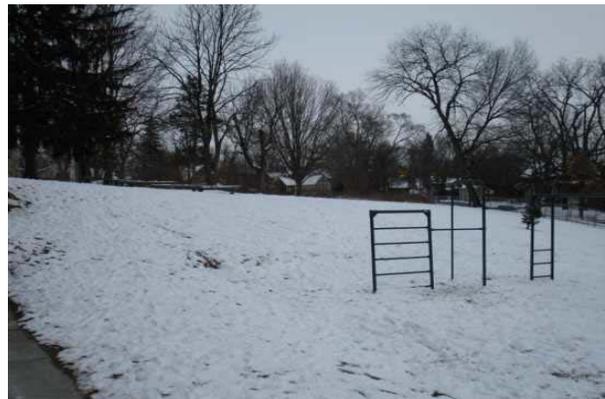
#66: PLAYGROUND EQUIPMENT
