FACILITY CONDITION ASSESSMENT

June 29, 2018

February 8, 2018

HAISLEY ELEMENTARY
825 DUNCAN SREET
ANN ARBOR, MICHIGAN 48103

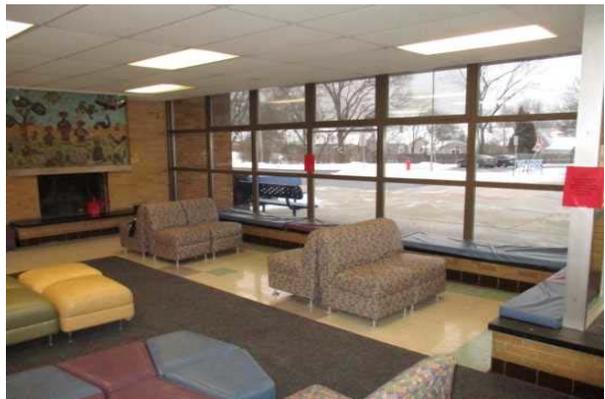
#6:	ALUMINUM WINDOWS IN LOBBY
-----	------------------------------

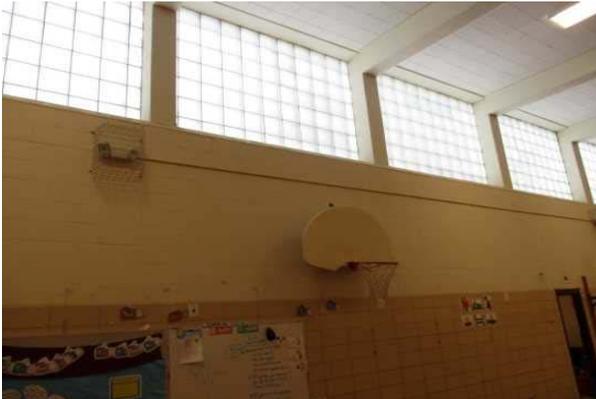
#7: EXTERIOR WALL WITH GLASS BLOCK

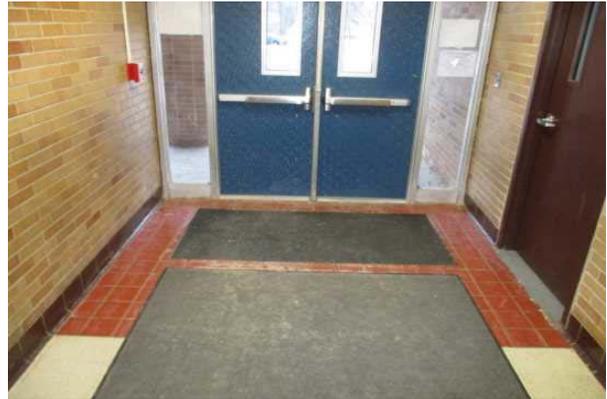
#8: EXTERIOR DOOR QUARRY TILE FLOOR

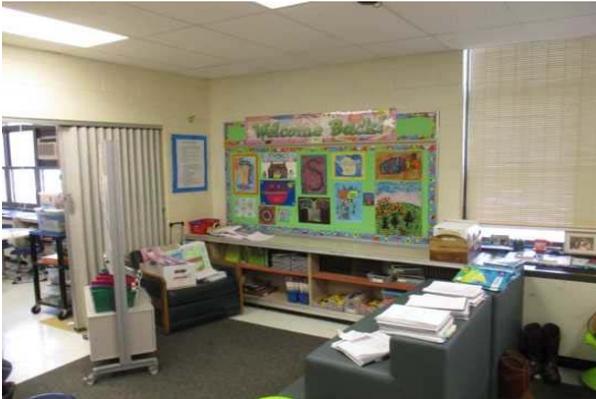
#15: FOLDING DOOR BETWEEN CLASSROOMS

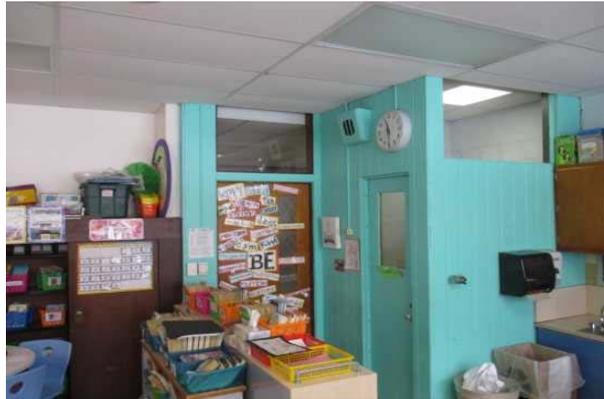
#16: INTERIOR DOOR INTO CLASSROOM AND TOILET ROOM

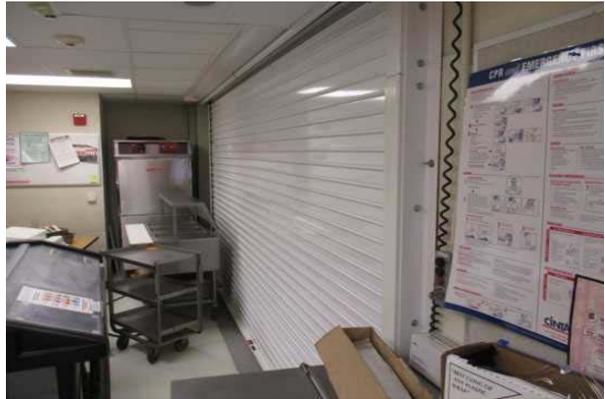
#20: MOTOR OPERATED FIRE SHUTTER

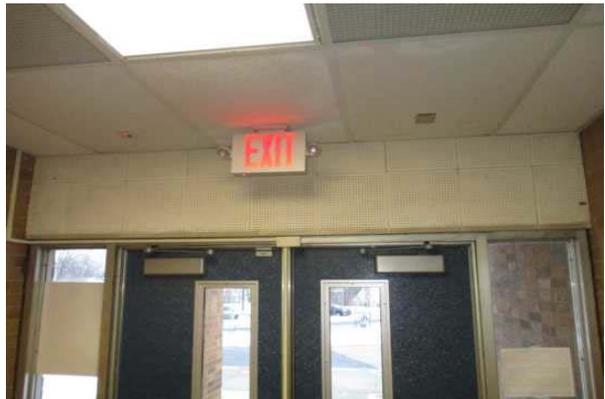
#22: EXIT SIGNAGE

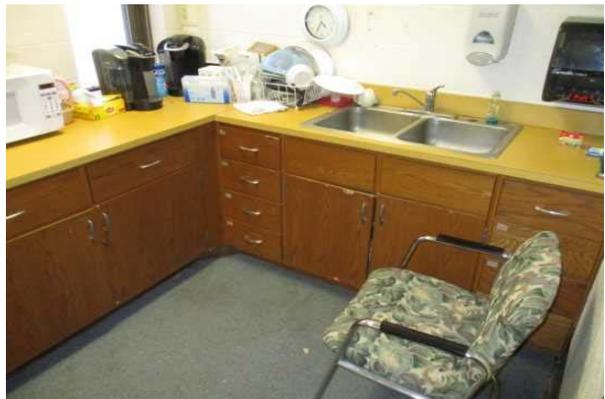
#24: KITCHEN CABINETS IN TEACHERS LOUNGE

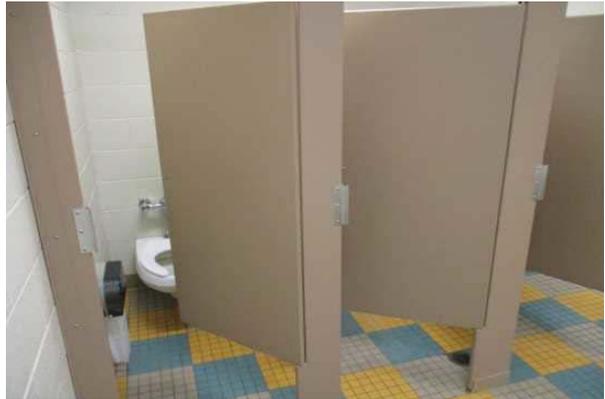
#26:	TOILET PARTITIONS
------	-------------------

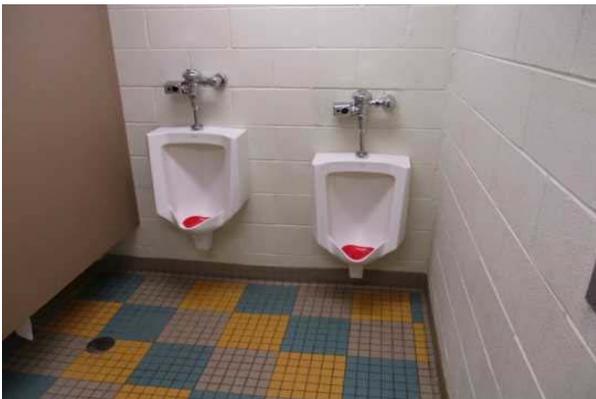
#29:	CERAMIC TILE AND URINALS
------	--------------------------

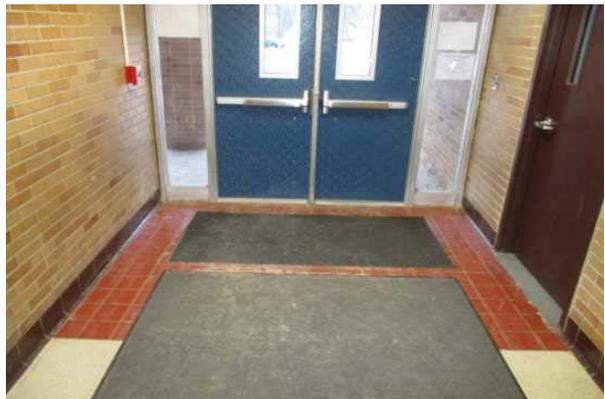
#30:	QUARRY TILE
------	-------------

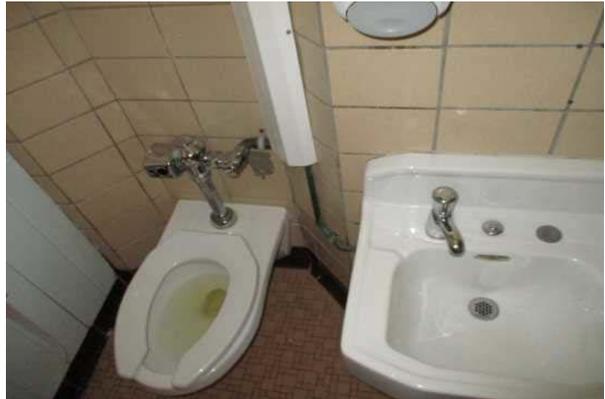
#32:	SINK AND TOILET
------	-----------------

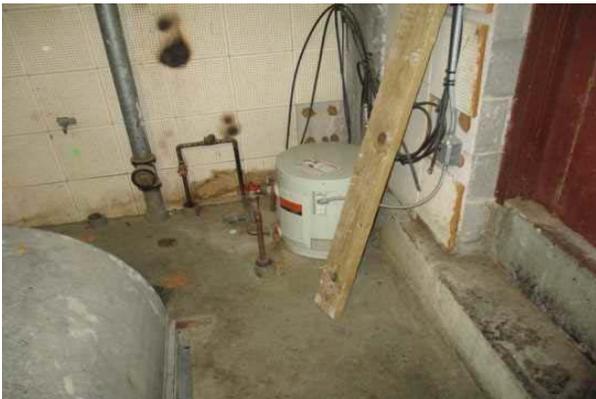
#33:	ELECTRIC WATER HEATER
------	-----------------------

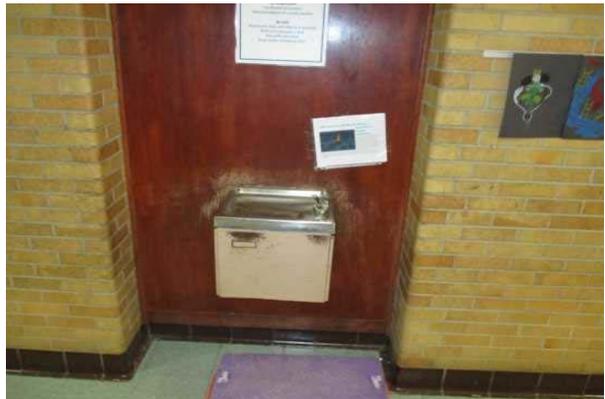
#34:	DRINKING FOUNTAIN
------	-------------------

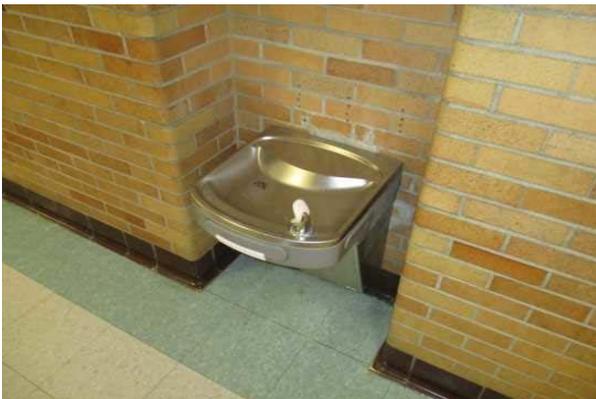
#35:	DRINKING FOUNTAIN
------	-------------------

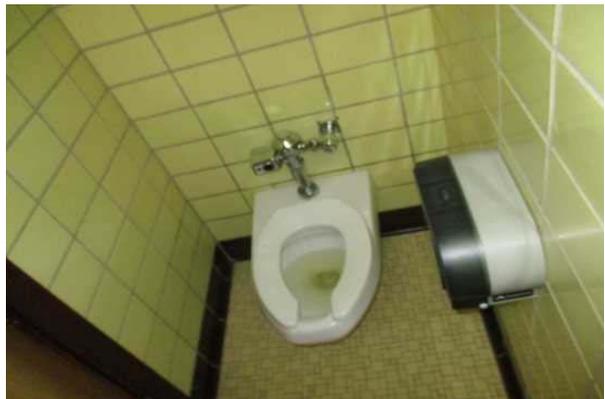
#36:	TOILET
------	--------

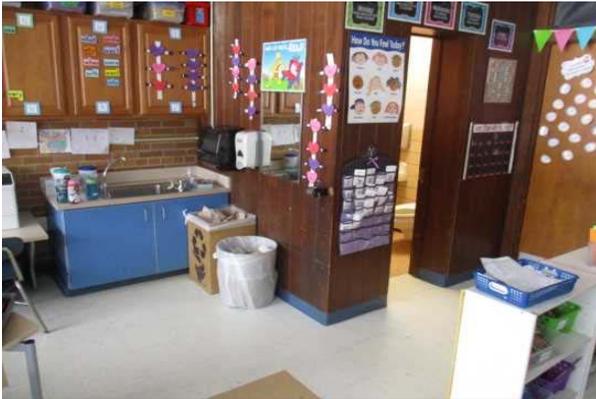
#37: STAINLESS STEEL SINK AND CASEWORK

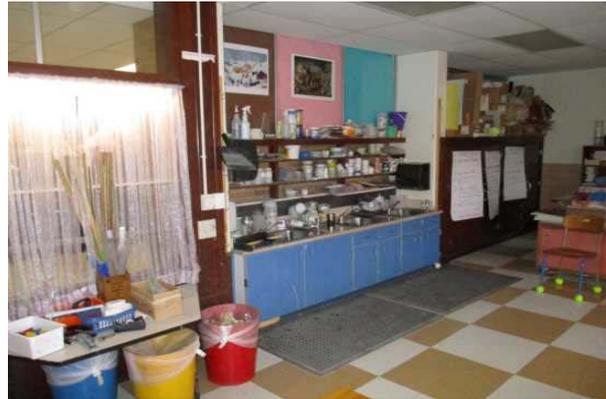
#38: STAINLESS STEEL SINK AND CASEWORK

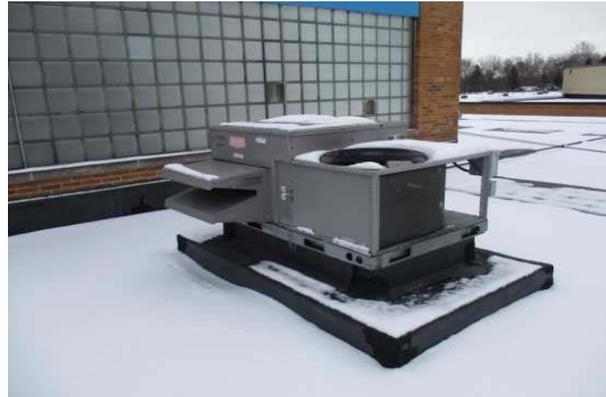
#40: PACKAGED UNIT (RTU)

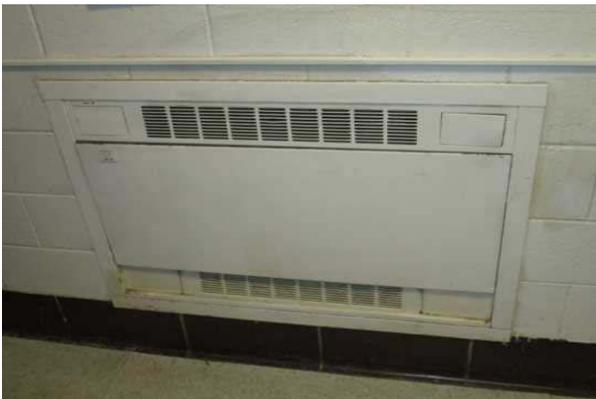
#41: HYDRONIC FAN COIL UNIT

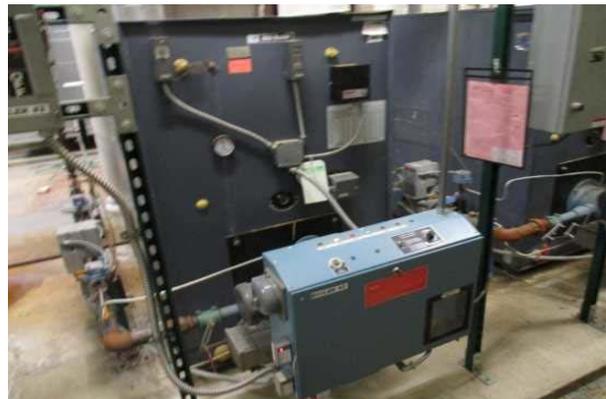
#42: BOILER

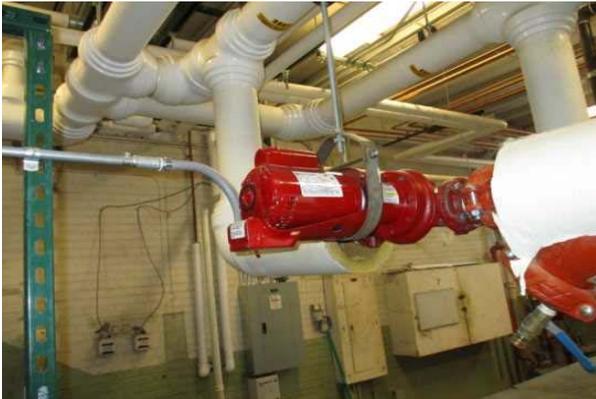
#43: HOT WATER PUMP

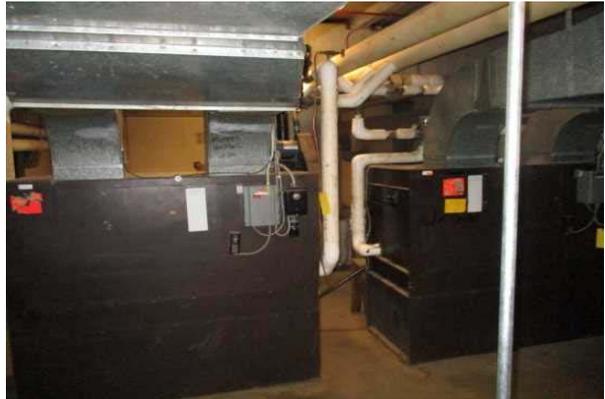
#44: AIR HANDLERS ON MEZZANINE

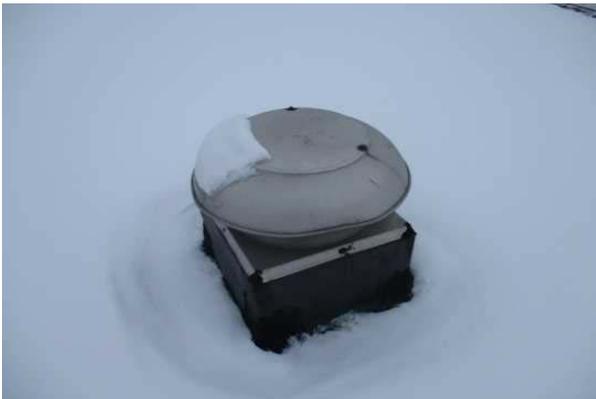
#45: EXHAUST FAN

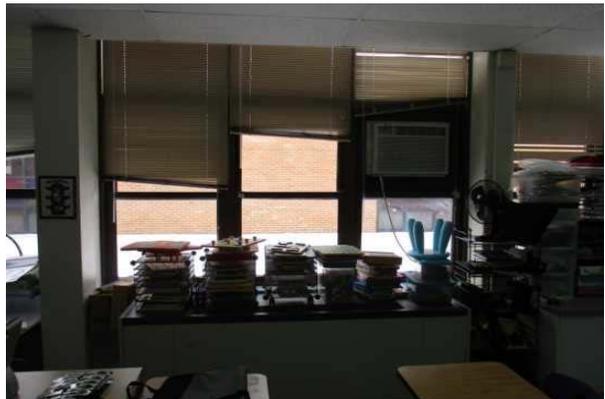
#46: HYDRONIC CABINET HEATER

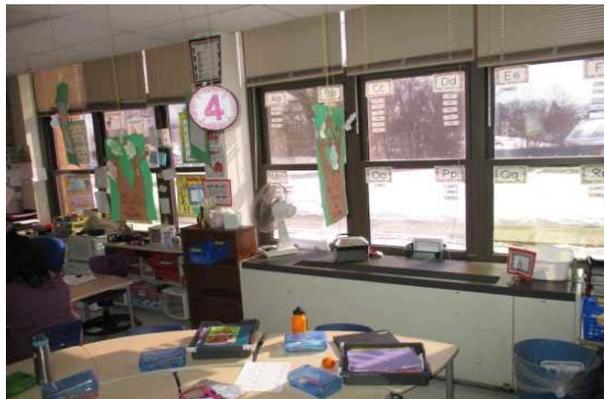
#48: HYDRONIC CABINET HEATER

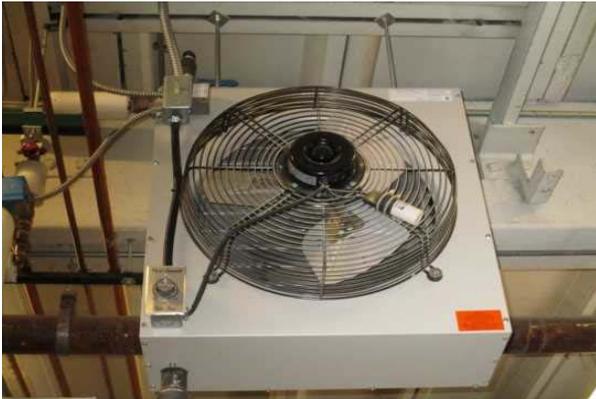
#49: HYDRONIC UNIT HEATER

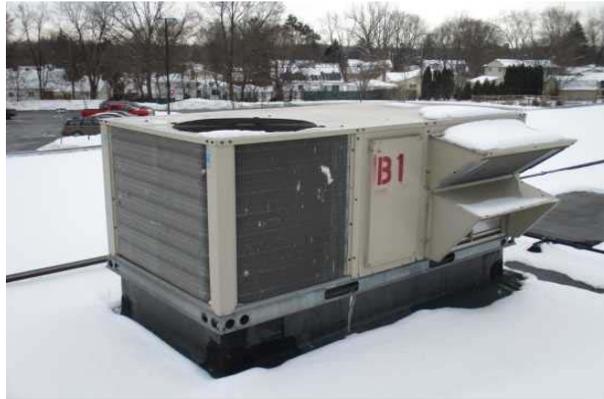
#50: PACKAGED UNIT (RTU)

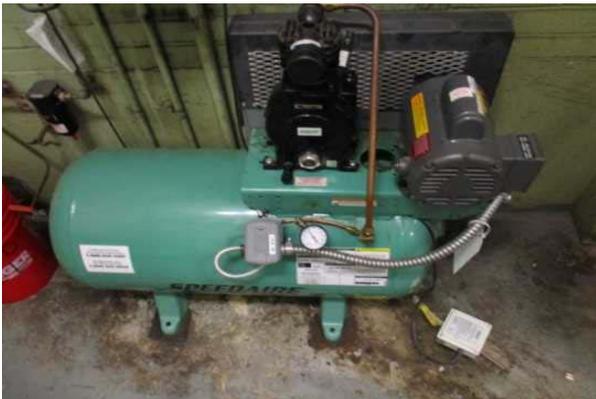
#51: AIR COMPRESSOR, BUILDING CONTROLS

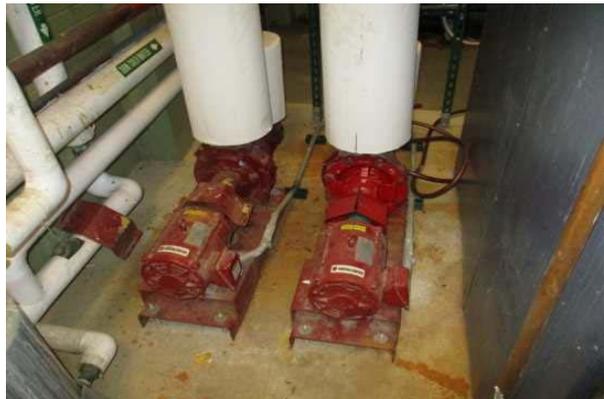
#52: BOOSTER PUMPS

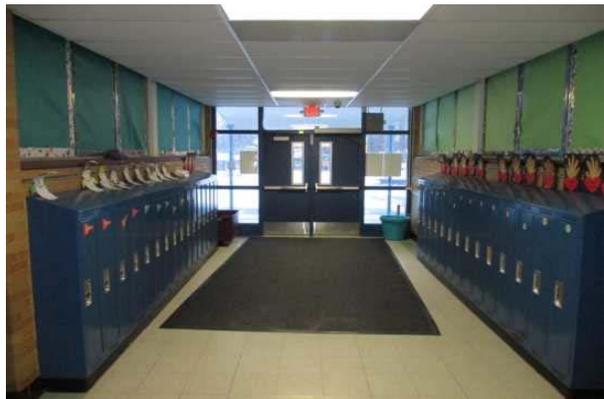
#54: FLUORESCENT LIGHTING FIXTURE, VCT AND ENTRY DOORS WITH ADA OPENER

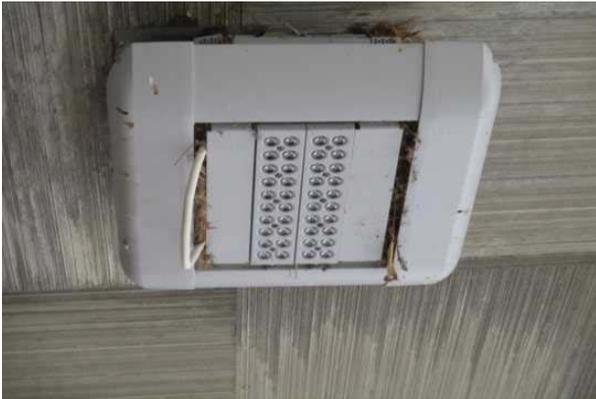
#55:	EXTERIOR LED LIGHTING FIXTURE
------	-------------------------------

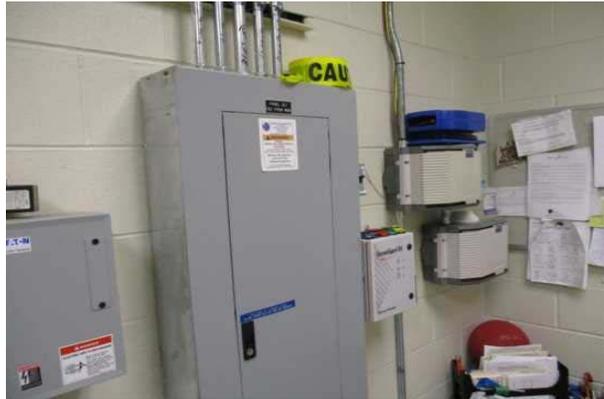
#56:	ELECTRICAL DISTRIBUTION PANEL
------	-------------------------------

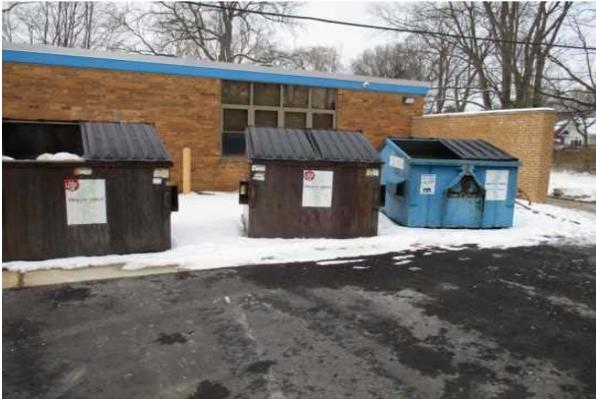
#57:	DUMPSTERS
------	-----------

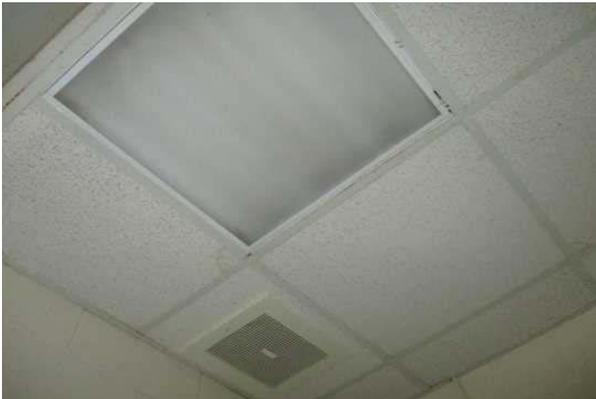
#58:	LIGHTING FIXTURE
------	------------------

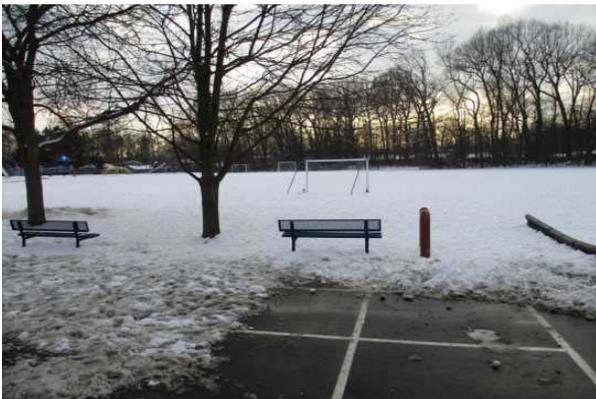
#64:	ASPHALT PAVEMENT
------	------------------
