# FACILITY CONDITION ASSESSMENT

LAWTON ELEMENTARY  
2250 SOUTH SEVENTH STREET  
ANN ARBOR, MICHIGAN 48103

*June 29, 2018*

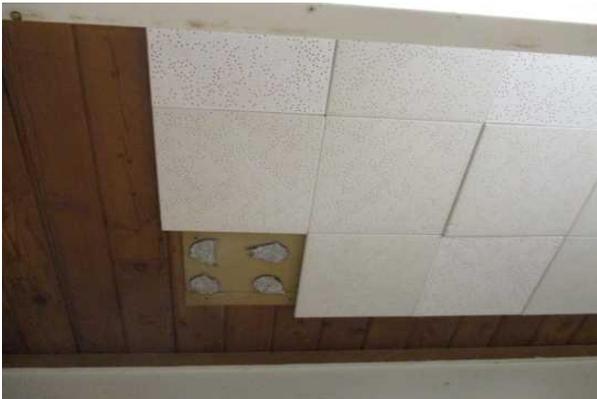
#5:	CEILING TILE POSSIBLY CONTAINING ASBESTOS
-----	---

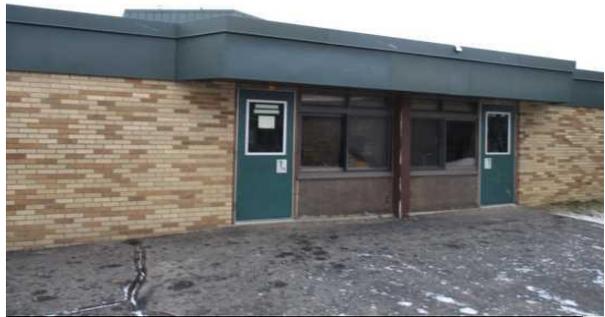
#8:	EXTERIOR DOORS, EXTERIOR FASCIA
-----	---------------------------------

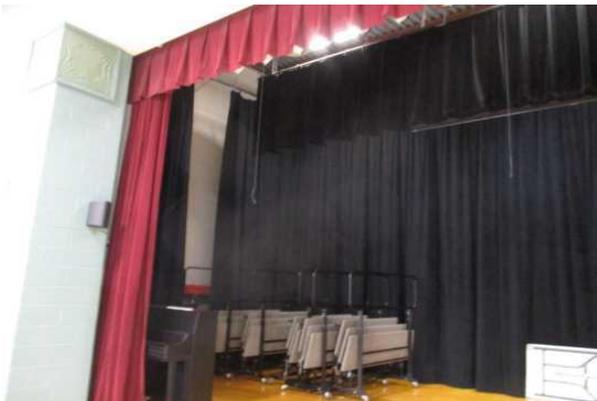
#29:	STAGE CURTAIN
------	---------------

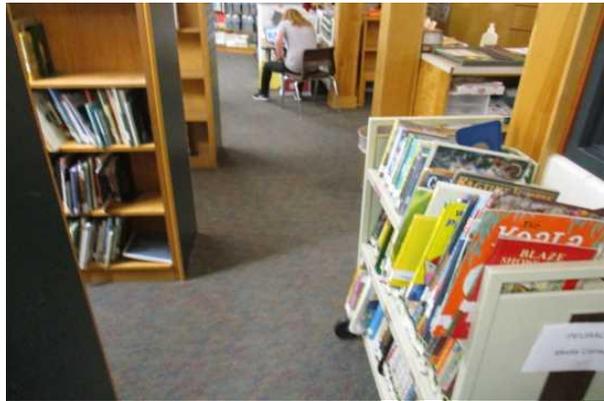
#34:	CARPET
------	--------

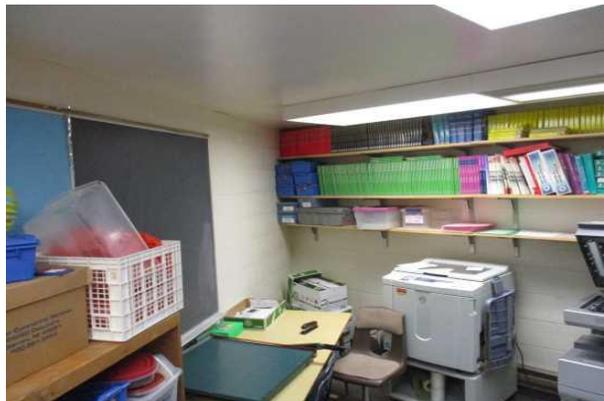
#36:	HARD CEILING FINISH
------	---------------------

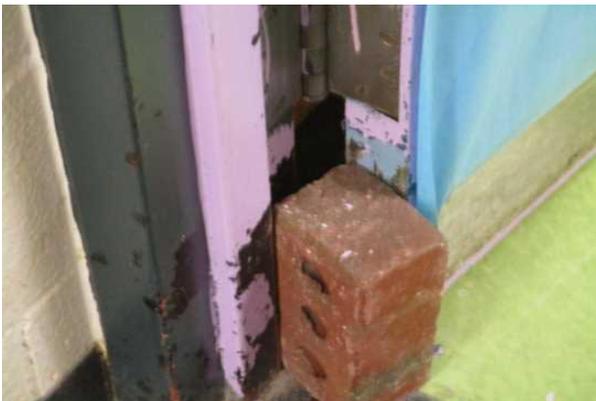
#47:	GLAZED, STEEL INTERIOR DOOR
------	-----------------------------
