FACILITY CONDITION ASSESSMENT

129010.18R000-024.354

July 2, 2018

COMMUNITY HIGH SCHOOL
401 NORTH DIVISON STREET
ANN ARBOR, MICHIGAN 48104

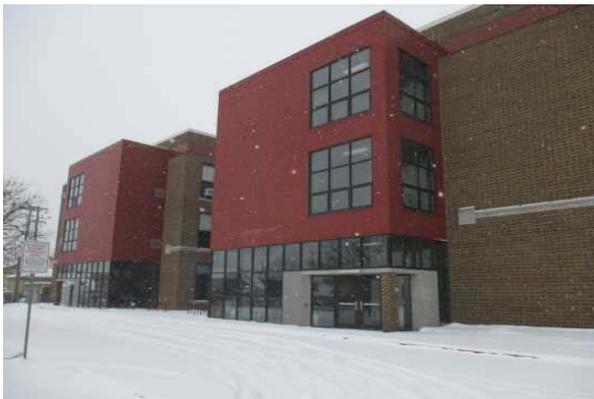
#11: CURTAIN WALL AND SWING GLASS DOORS, VERTICAL METAL SIDING

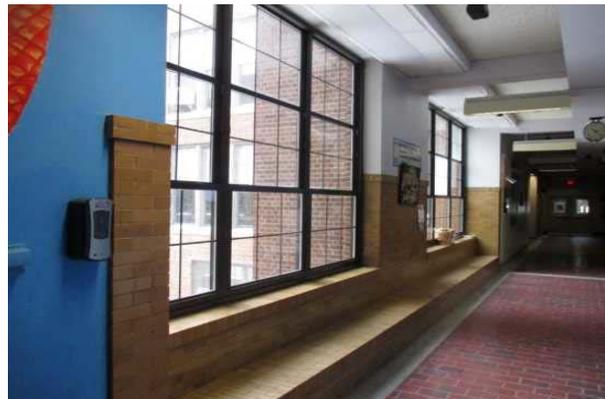
#12: QUARRY TILE FLOOR, PAINTED CEILING AND WALLS

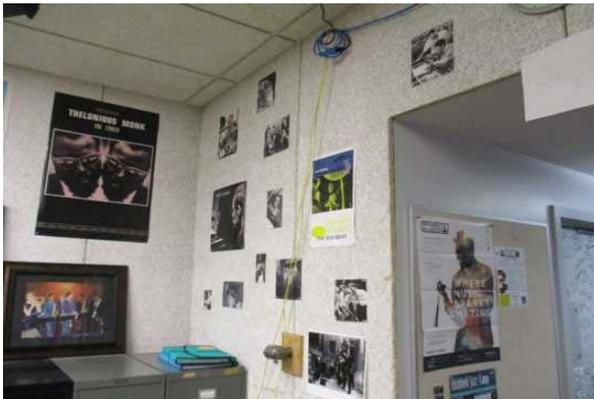
#15:

SOUND DAMPENING BOARD ON
WALL

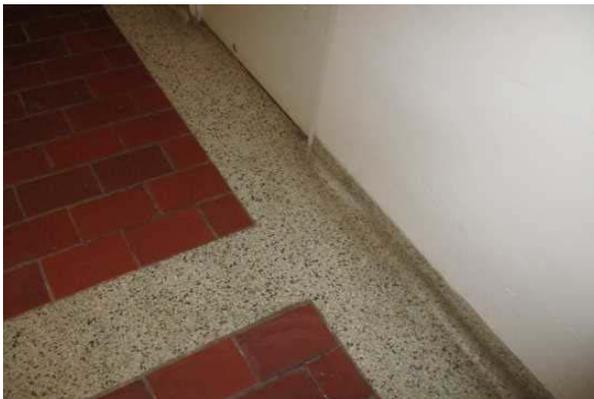
#17:

TERRAZZO AND QUARRY TILE
FLOOR AND BASE

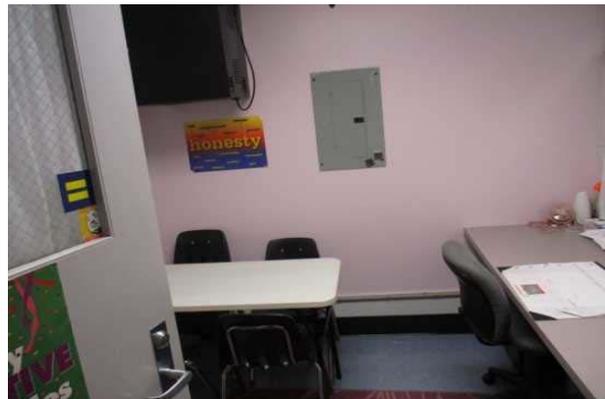
#18:

INTERIOR DOOR WITH GLAZING

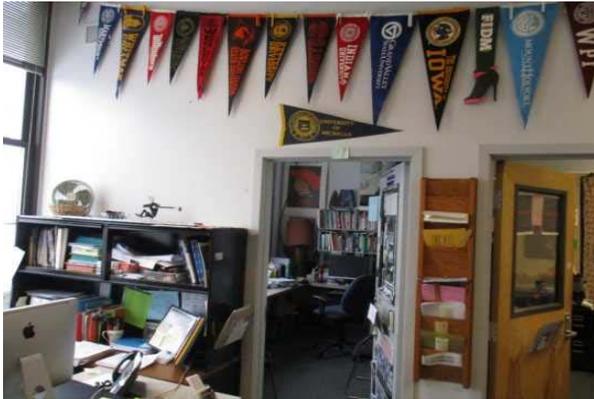
#19:	INTERIOR DOOR WITH GLAZING
------	----------------------------

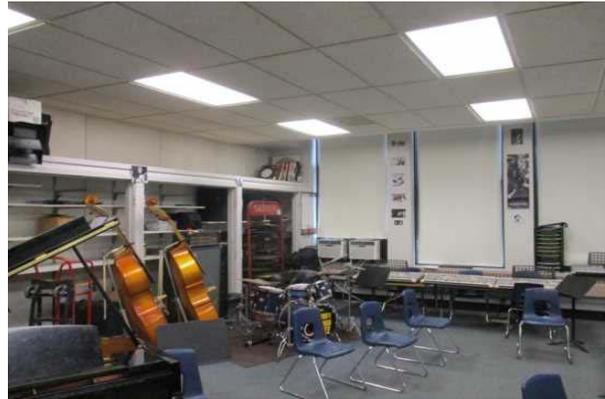
#20:	SOUND DAMPENING ACT
------	---------------------

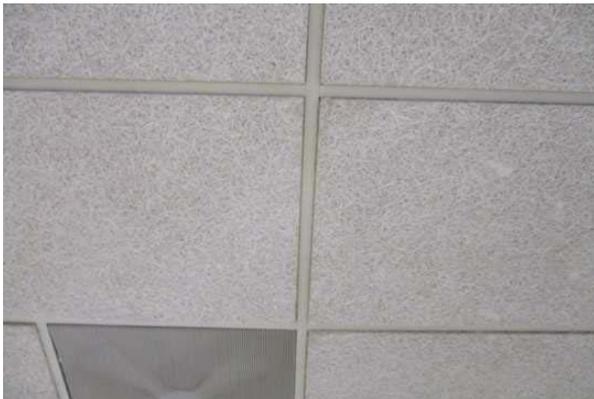
#21:	SOUND DAMPENING ACT
------	---------------------

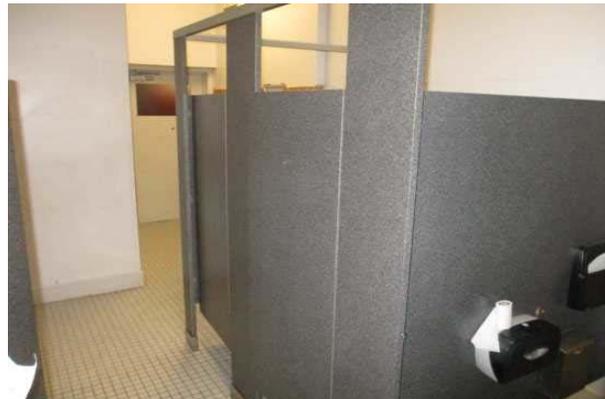
#22:	TOILET PARTITIONS AND CERAMIC TILE
------	------------------------------------

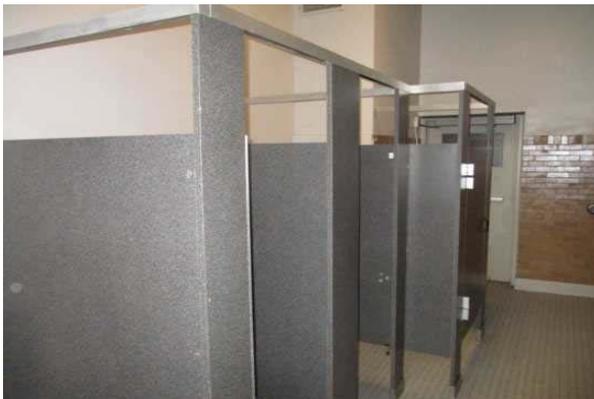
#23:	TOILET PARTITIONS
------	-------------------

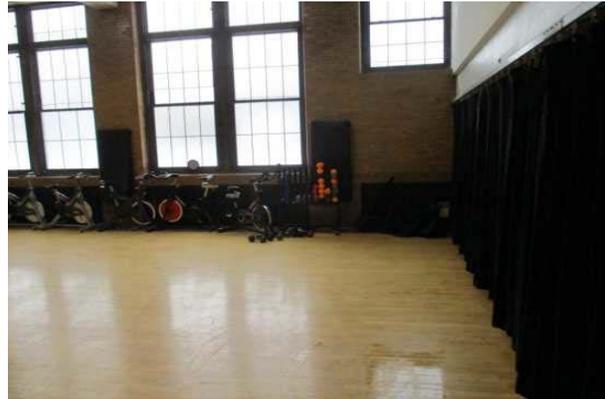
#26:	STAGE CURTAIN
------	---------------

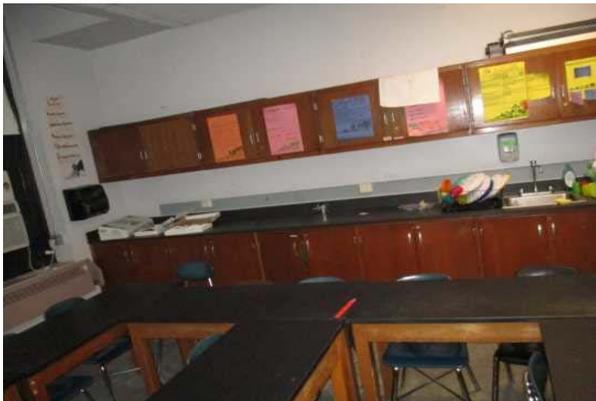
#27:	CASEWORK AND WALLS
------	--------------------

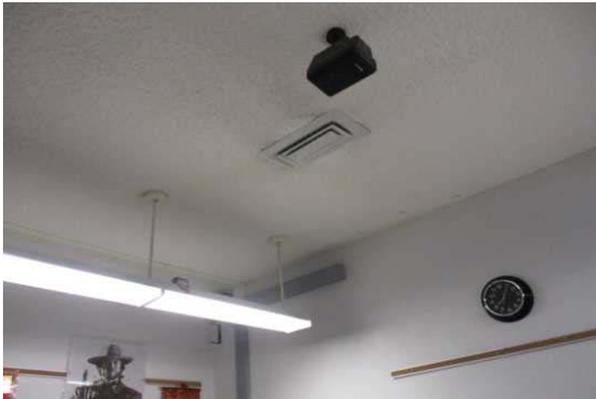
#29:	CEILING
------	---------

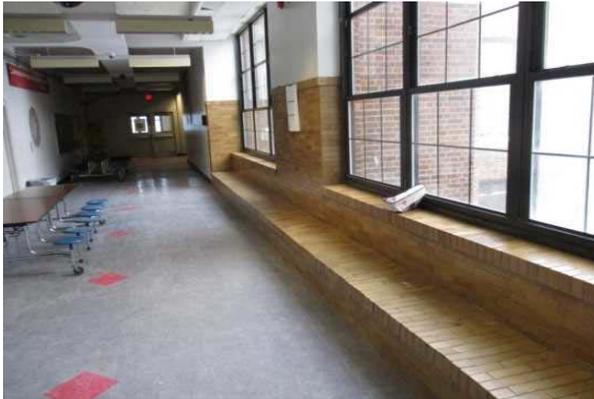
#31:	FIRE DOORS AT END OF HALL, VCT AND FLUORESCENT LIGHTS
------	--

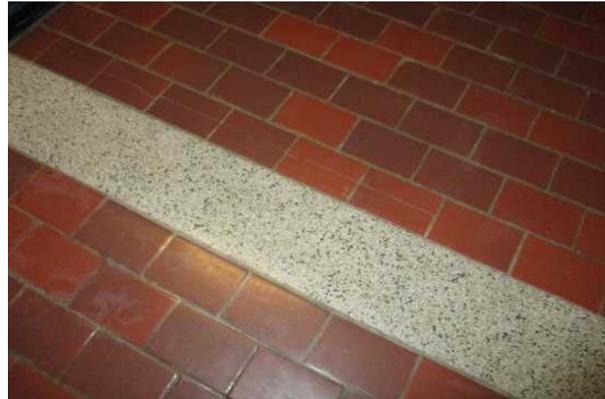
#32:	QUARRY TILE AND TERRAZZO
------	--------------------------

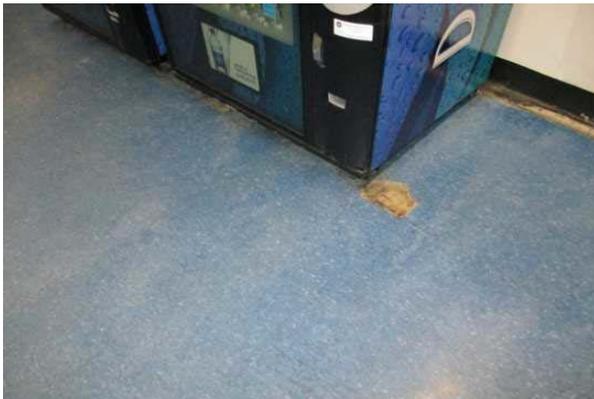
#33:	VCT ON LOWER LEVEL
------	--------------------

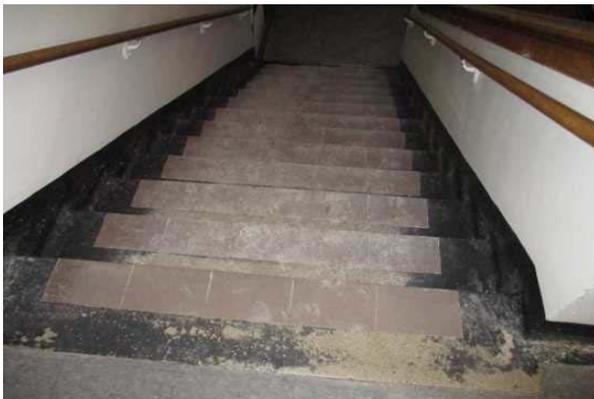
#35:	STAIRS AND WALLS
------	------------------

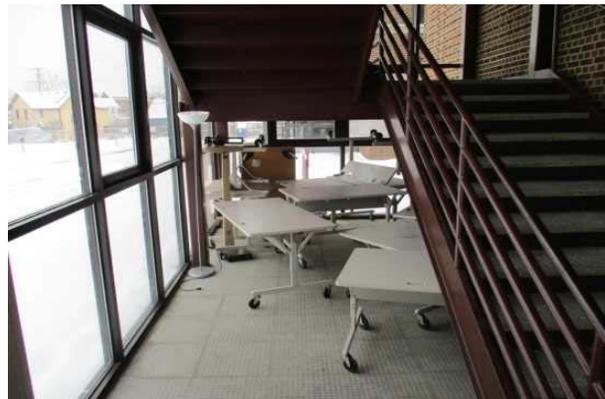
#36:	RUBBER STAIR TREADS AND FLOORING IN WEST STAIRWELLS
------	---

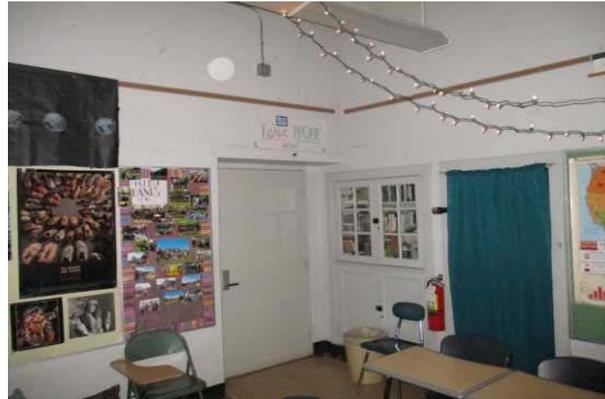
#38: SOLID INTERIOR DOOR

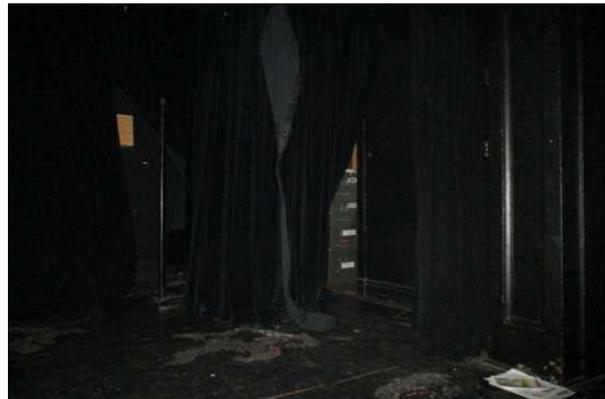
#40: STAGE CURTAIN IN THEATER

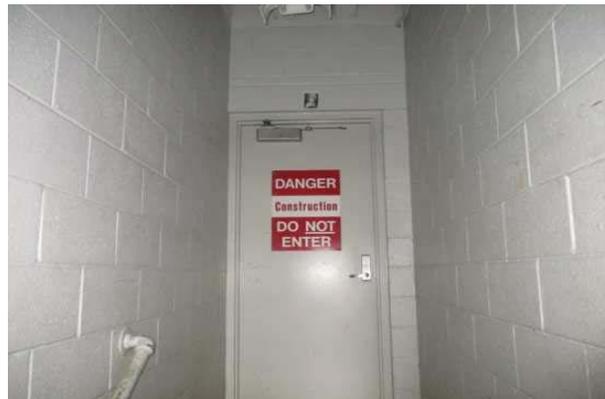
#42: FIRE DOOR

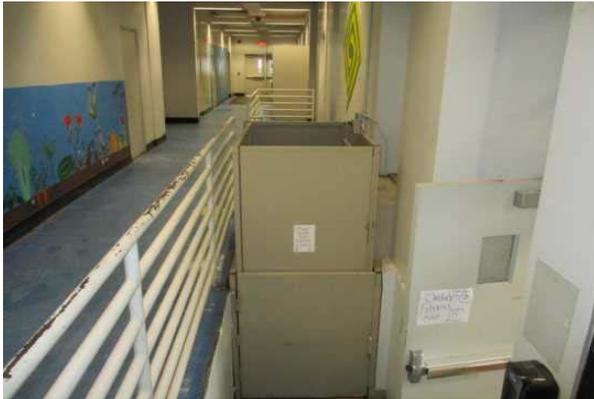
#43: WHEELCHAIR LIFT

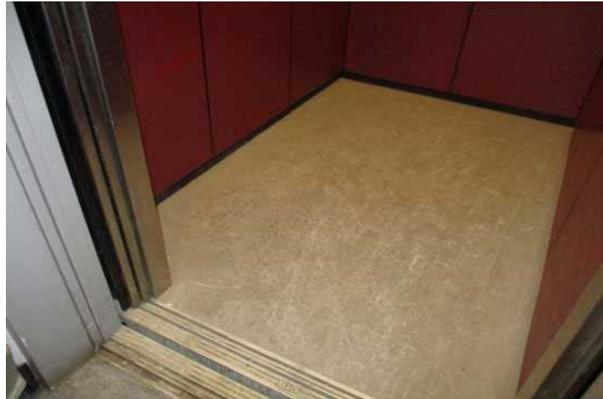
#44: ELEVATOR FINISHES

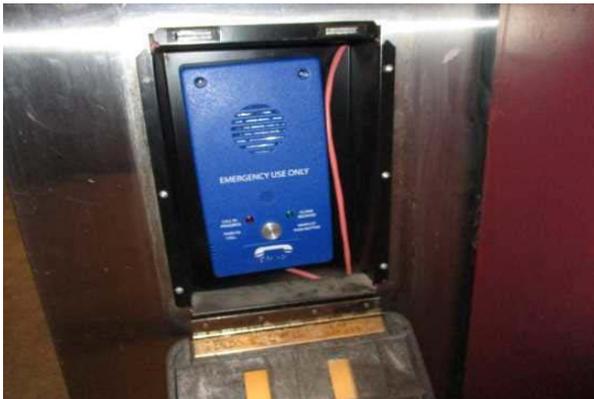
#45: ELEVATOR EMERGENCY CALL

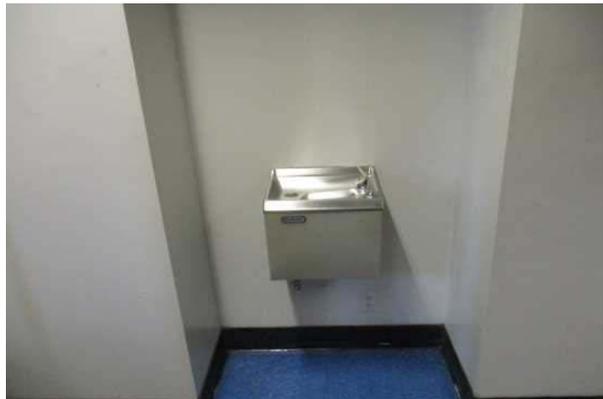
#46: DRINKING FOUNTAIN

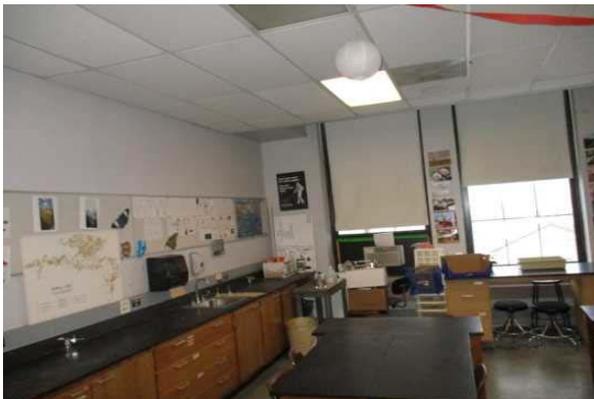
#47: EPOXY RESIN SINK AND CASEWORK

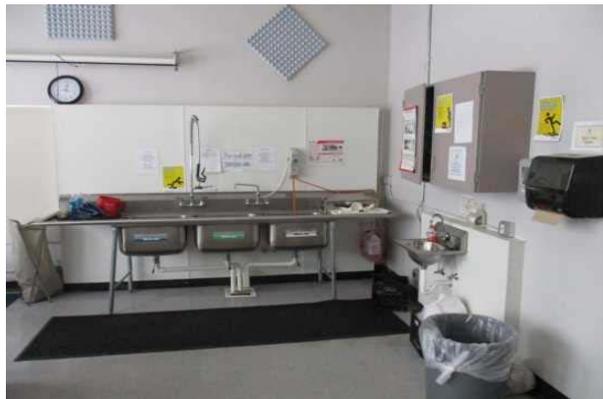
#48: STAINLESS STEEL SINK

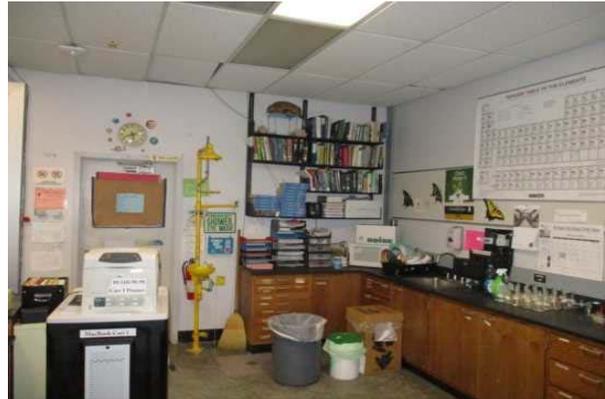
#50: EMERGENCY EYE WASH AND SHOWER STATION, AND CASEWORK

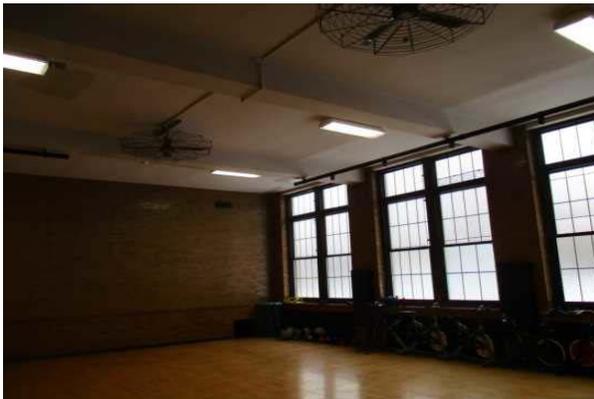
#51: CEILING FANS IN GYM

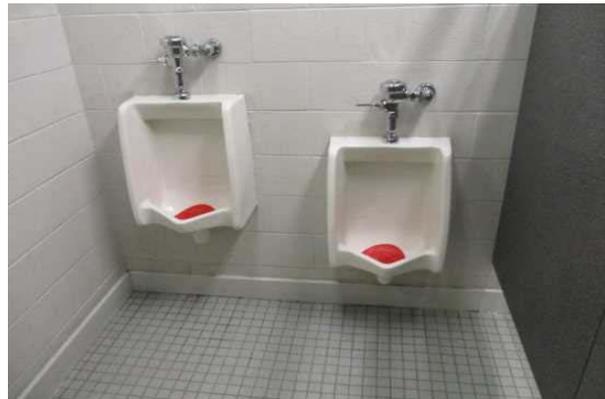
#52: URINAL AND CERAMIC TILE

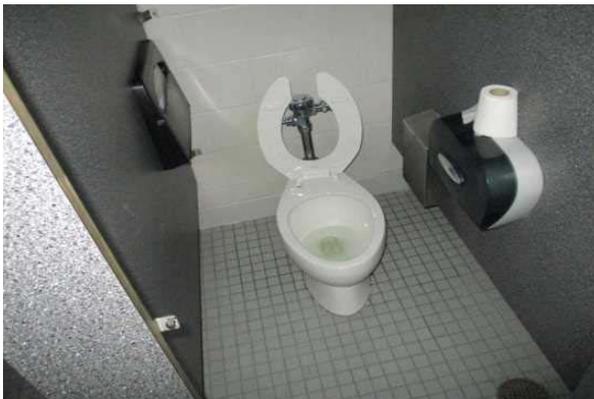
#53: TANKLESS TOILET

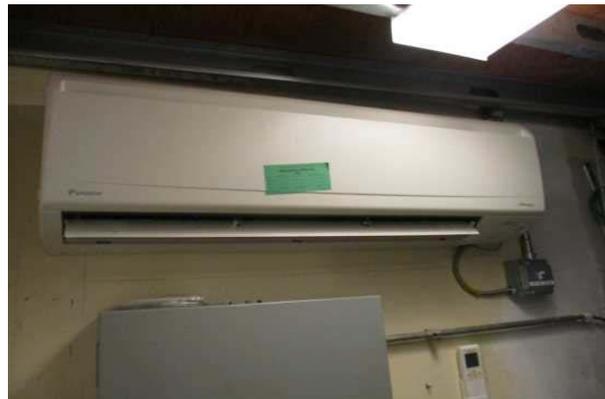
#54: DUCTLESS SPLIT SYSTEM

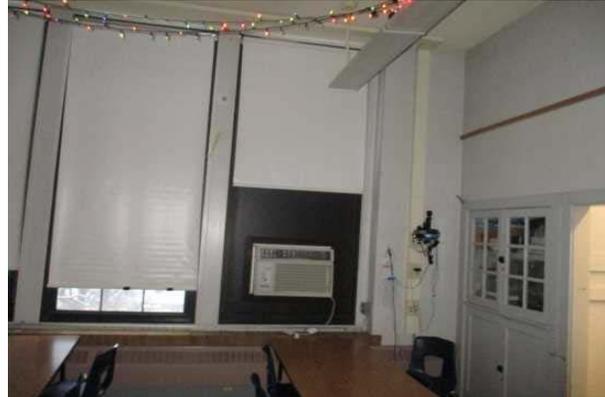
#55: DUCTLESS SPLIT SYSTEM

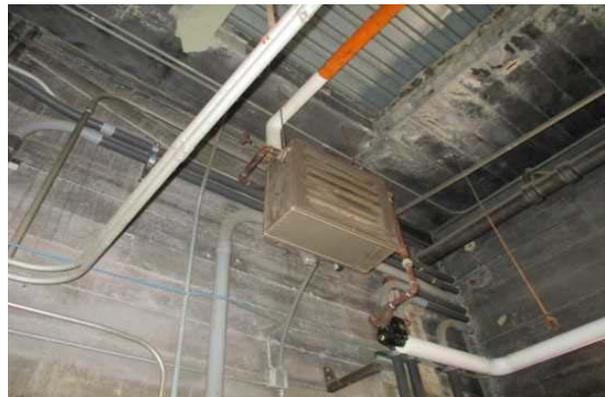
#59: HYDRONIC FAN COIL CABINET

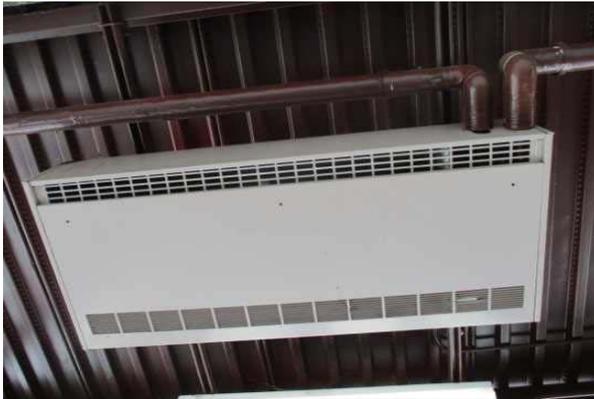
#60: HYDRONIC FAN COIL UNIT

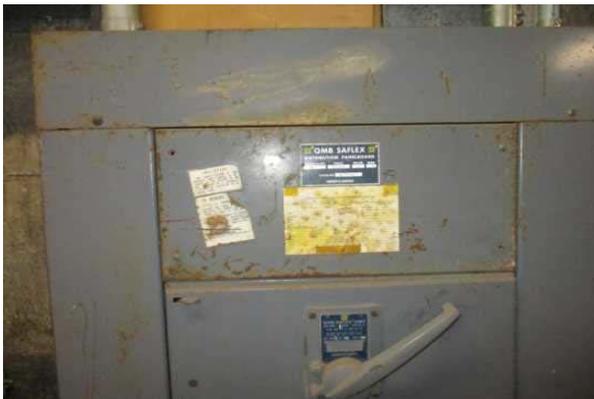
#70: DISTRIBUTION PANEL
