FACILITY CONDITION ASSESSMENT

June 28, 2018

ABBOT ELEMENTARY
2670 SEQUOIA PARKWAY
ANN ARBOR, MICHIGAN 48103

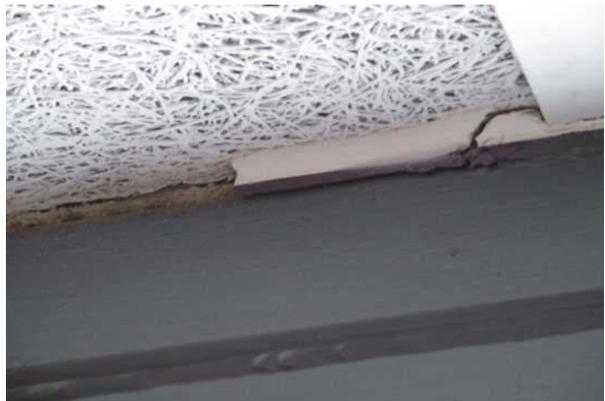
#6:	FAILED CAULKING AT CURTAIN WALL
-----	---------------------------------

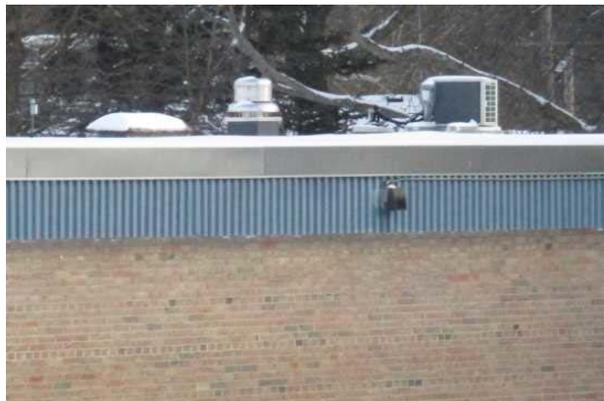
#10: BRICK VENEER WALLS, ACCENT SIDING

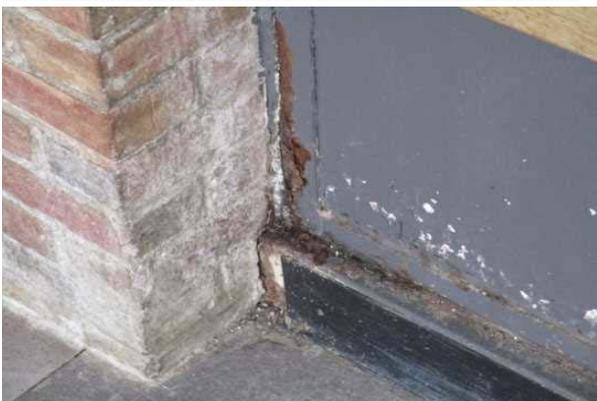
#11: RUSTING CURTAIN WALL PANEL AND EFFLORESCENCE

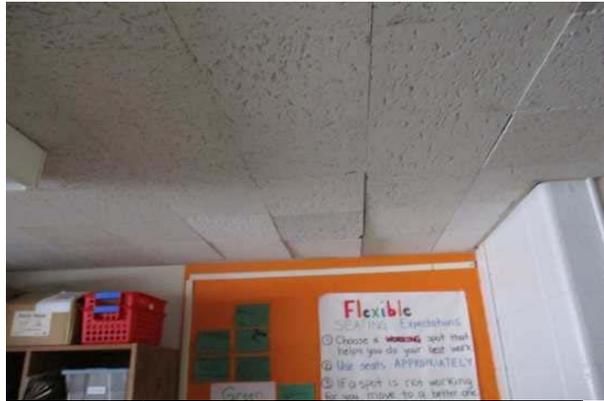
#14:	DAMAGED ACOUSTICAL CEILING
------	----------------------------

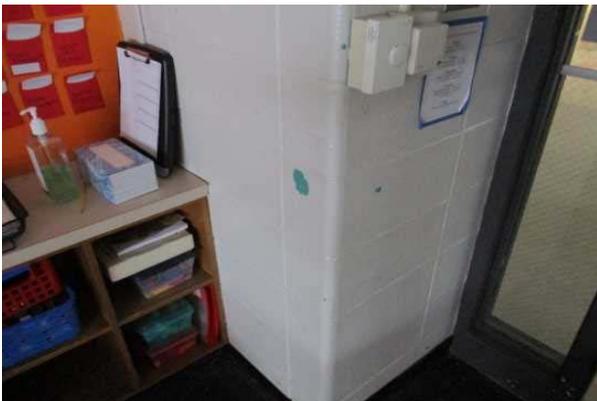
#17:	PEELING PAINT ON BLOCK WALL
------	-----------------------------

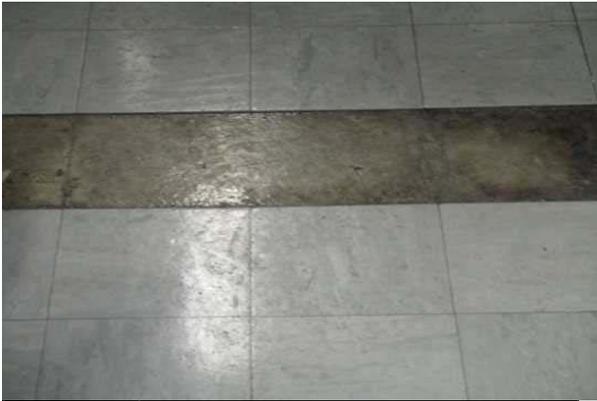
#19:	POSSIBLE ASBESTOS CONTAINING TILE
------	-----------------------------------

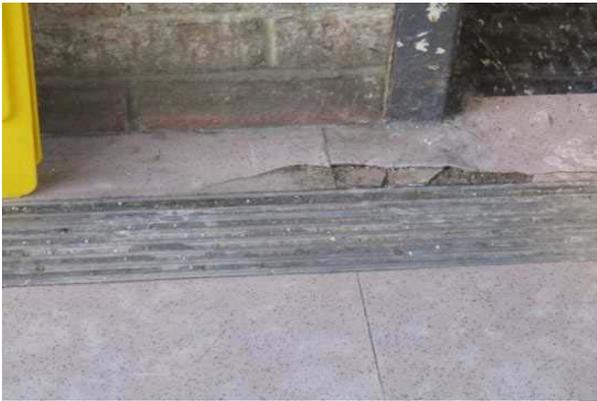
#21:	DAMAGED VCT NEAR DOOR
------	-----------------------

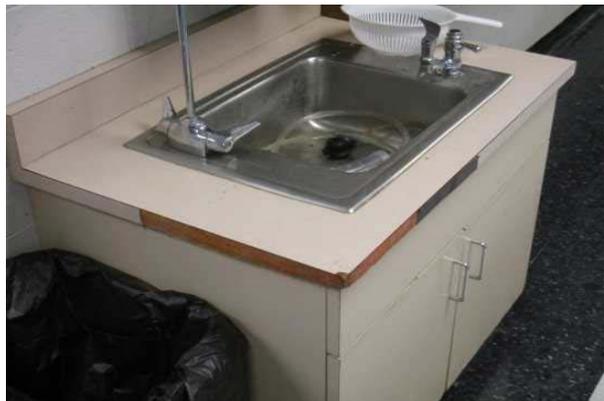
#24:	DAMAGED CASEWORK
------	------------------

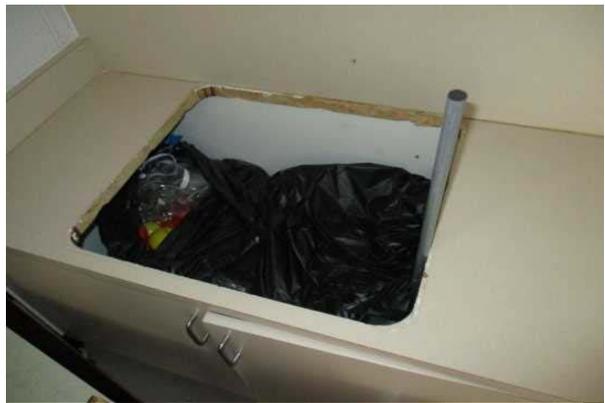
#28: CASEWORK WITH MISSING SINK

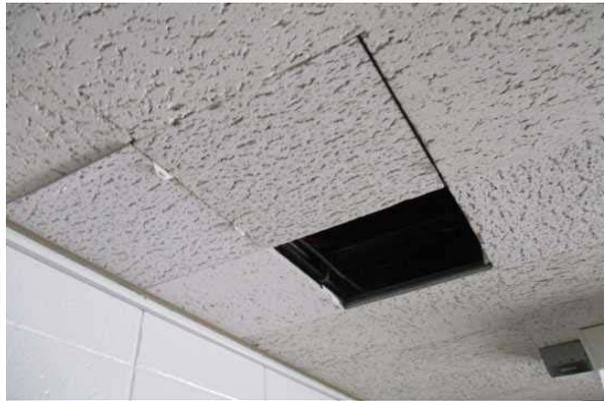
#34:	DAMAGED AND MISSING ACOUSTICAL CEILING TILES
------	--

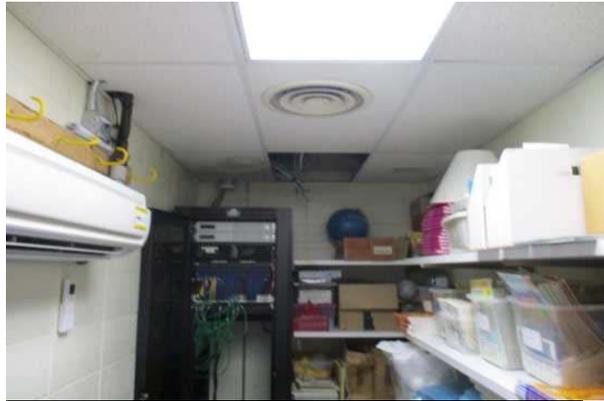
#56:	DUCTLESS FAN COIL, MISSING CEILING TILE
------	---

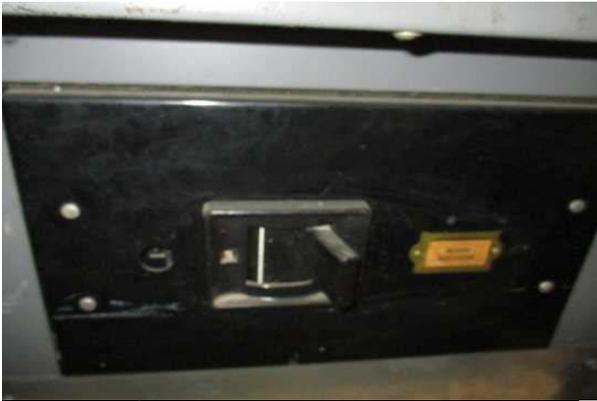
#66:	MAIN BREAKER
------	--------------

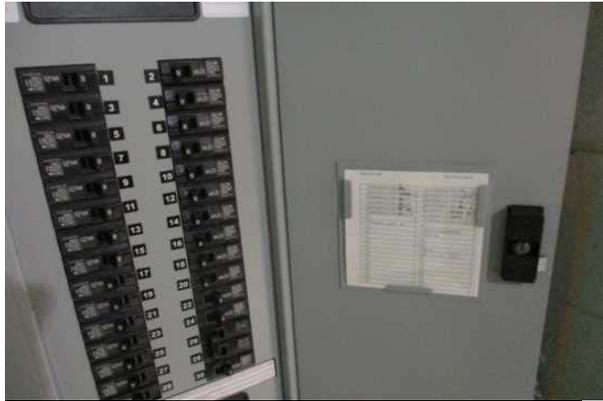
#67:	MAIN BUILDING ELECTRICAL BREAKER
------	----------------------------------
