FACILITY CONDITION ASSESSMENT

Ann Arbor Public Schools
2555 South State Street
Ann Arbor, Michigan 48104
Jim Vibbart

July 2, 2018

WINES ELEMENTARY
1701 NEWPORT ROAD
ANN ARBOR, MICHIGAN 48103

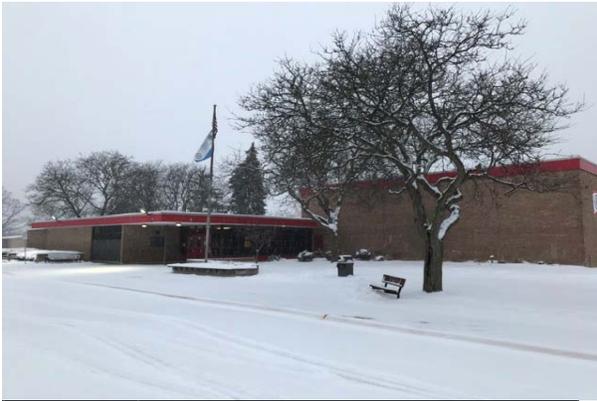
#1:	FRONT ELEVATION
-----	-----------------

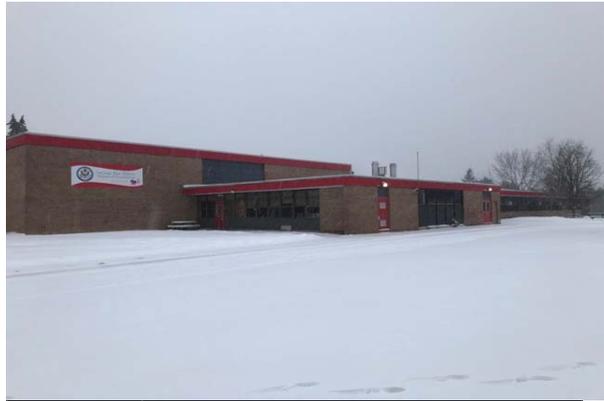
#2:	SIDE ELEVATION
-----	----------------

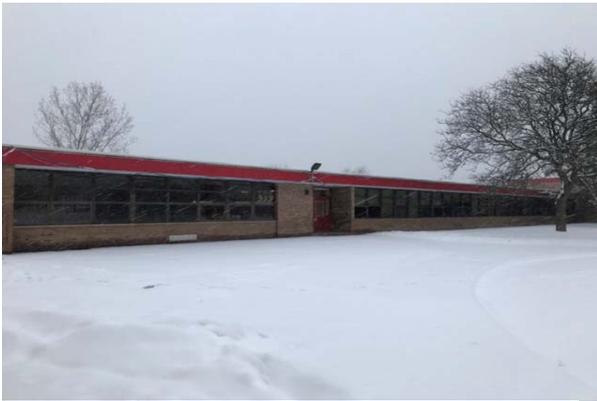
#3:	SIDE ELEVATION
-----	----------------

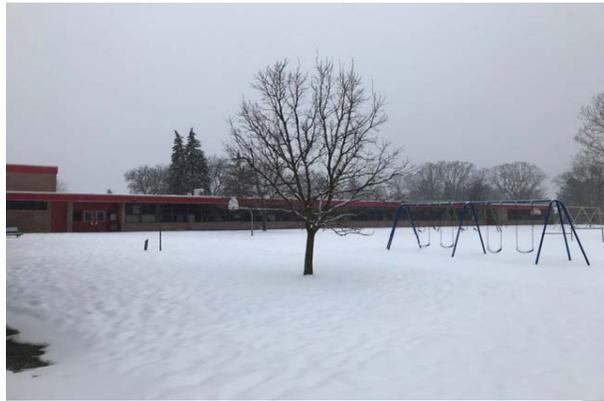
#4:	REAR ELEVATION
-----	----------------

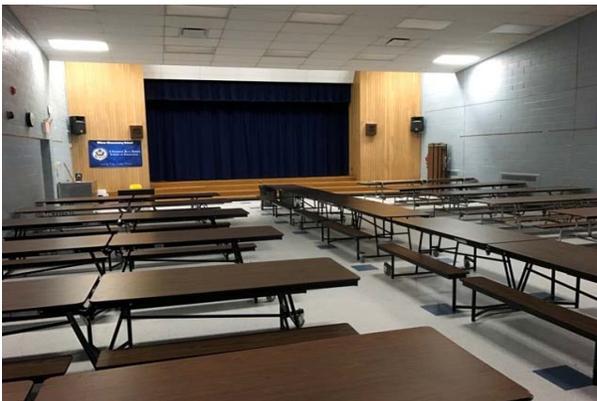
#5:	MULTI-PURPOSE ROOM
-----	--------------------

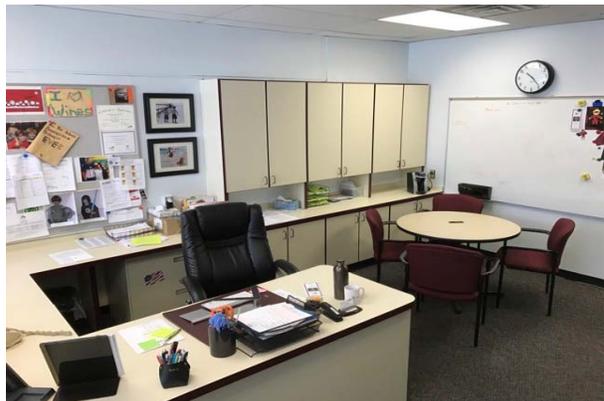
#6:	PRINCIPALS OFFICE
-----	-------------------

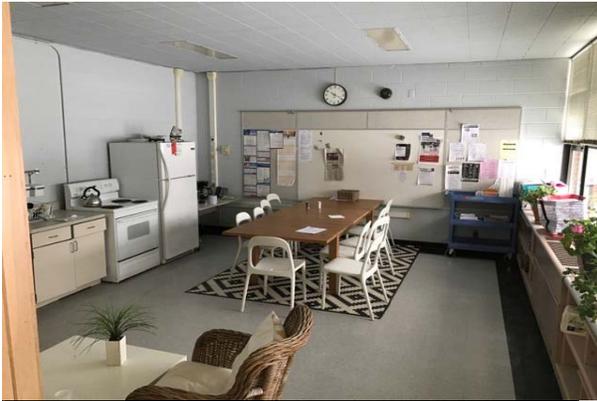
#7:	STAFF LOUNGE
-----	--------------

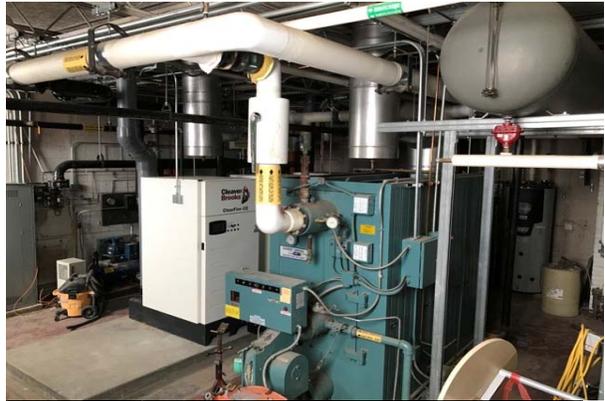
#8:	MECHANICAL ROOM
-----	-----------------

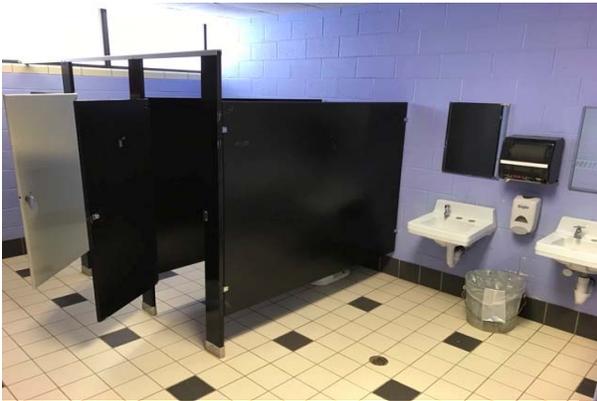
#9:	RESTROOM
-----	----------

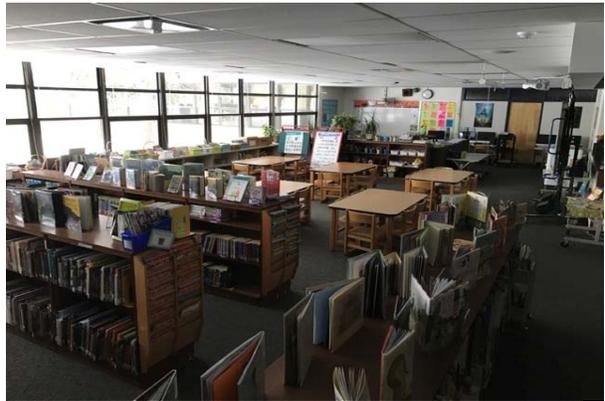
#10:	LIBRARY
------	---------

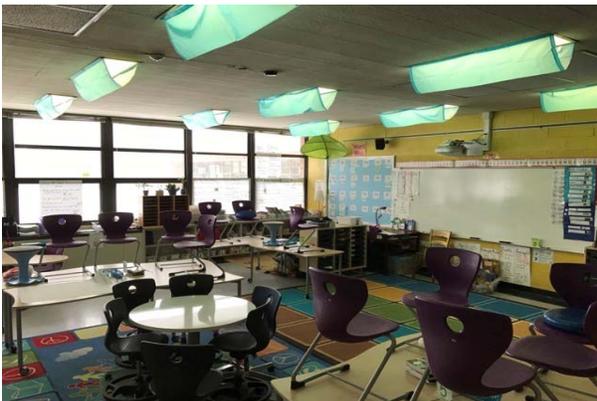
#11:	CLASSROOM
------	-----------

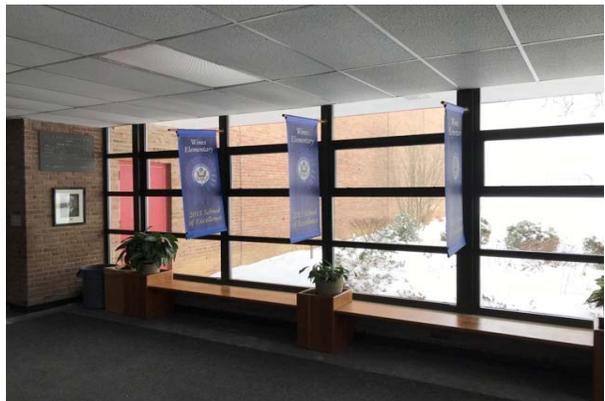
#12:	WAITING AREA
------	--------------

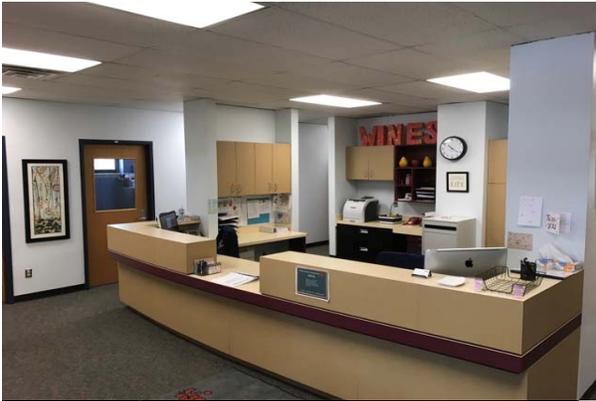
#13:	OFFICE
------	--------

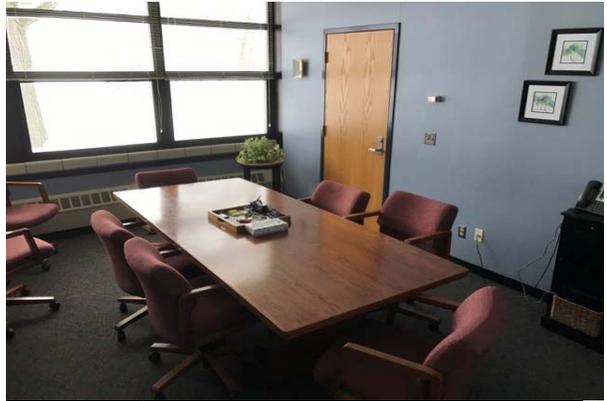
#14:	MEETING ROOM
------	--------------

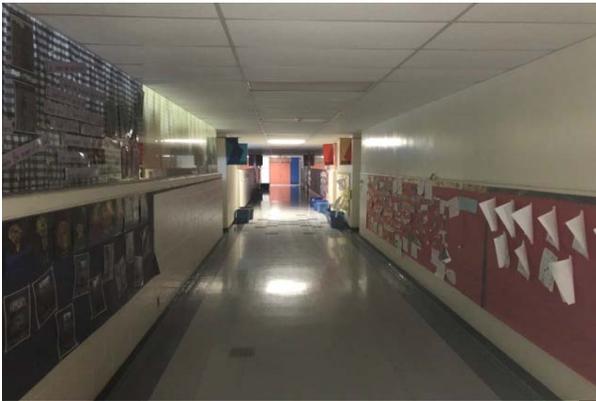
#15:	HALLWAY
------	---------

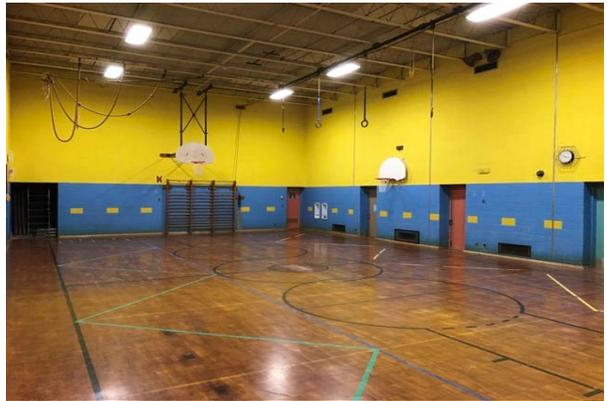
#16:	GYMNASIUM
------	-----------

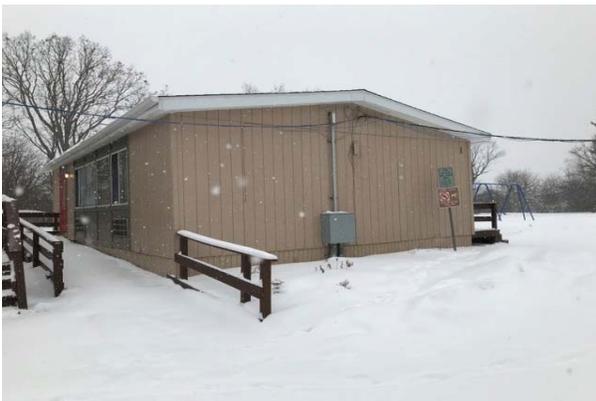
#17:	EAST BUILDING 1
------	-----------------

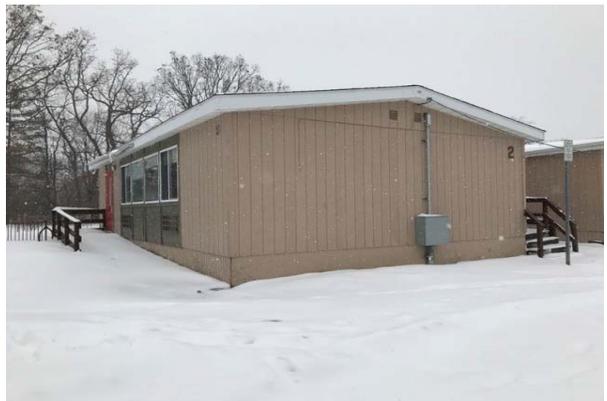
#18:	EAST BUILDING 2
------	-----------------

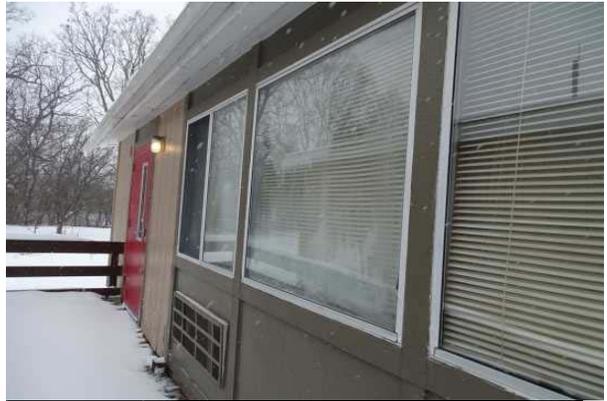
#20:	EAST BUILDINGS, WINDOWS
------	-------------------------

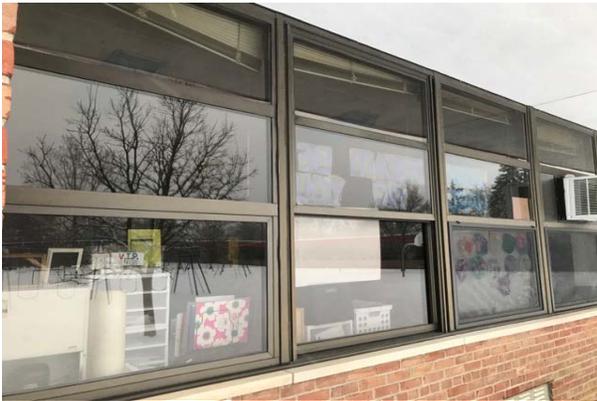
#21:	WINDOWS
------	---------

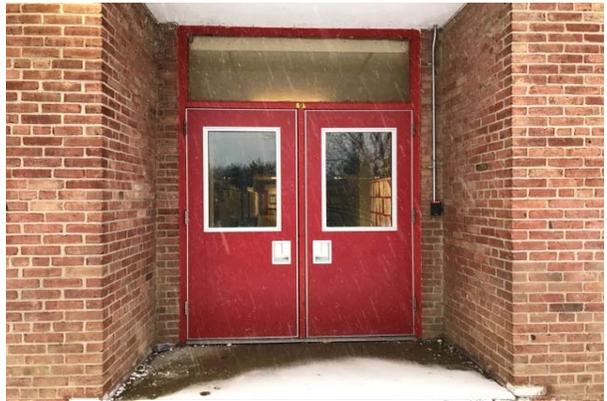
#22:	DOORS
------	-------

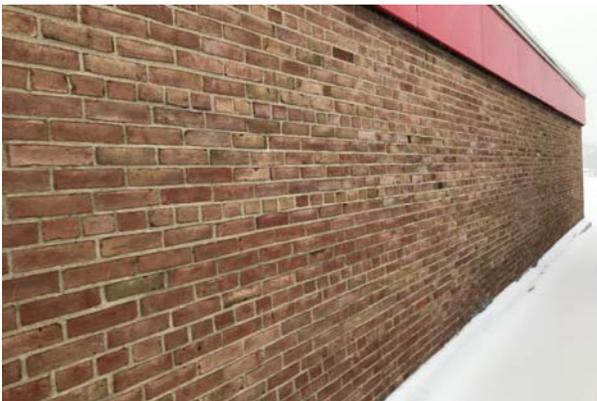
#23:	BRICK WALLS
------	-------------

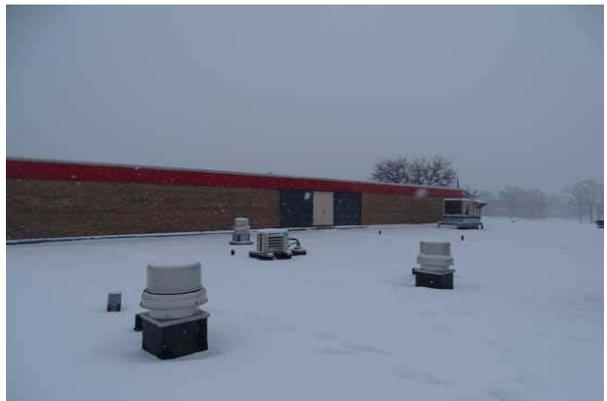
#24:	METAL SIDING
------	--------------

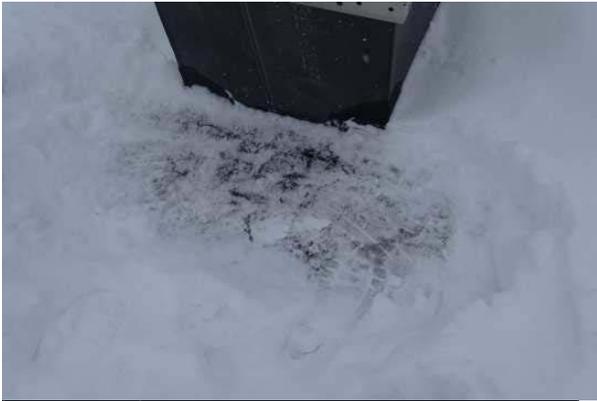
#25:	ROOF EPDM
------	-----------

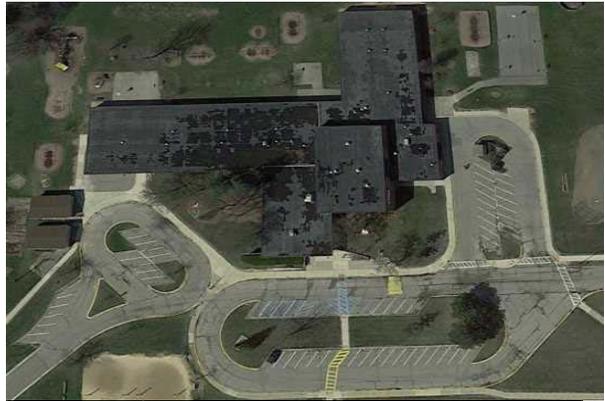
#26:	ROOFS
------	-------

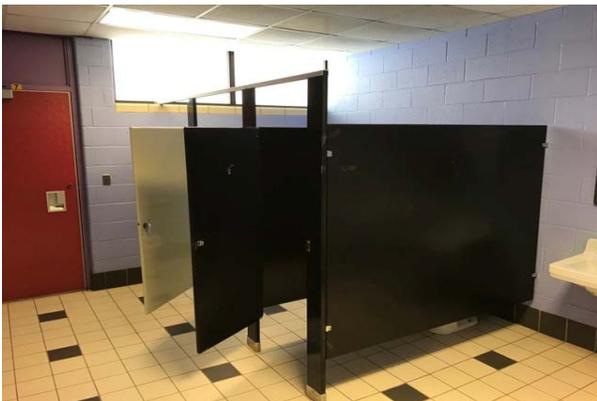
#29:	TOILET PARTITION
------	------------------

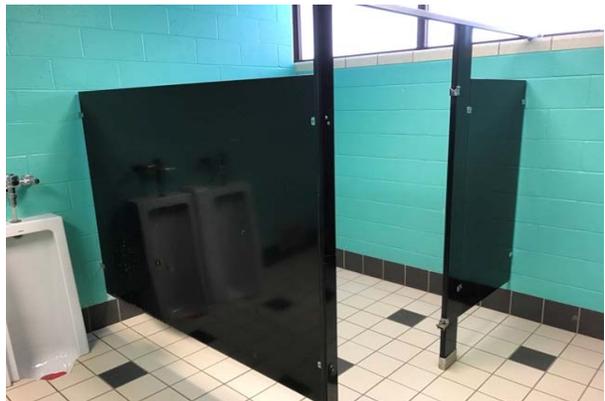
#30:	TOILET PARTITION
------	------------------

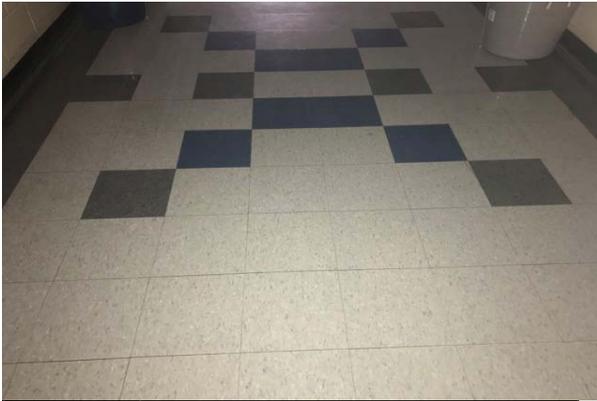
#31:	VINYL TILE FLOOR
------	------------------

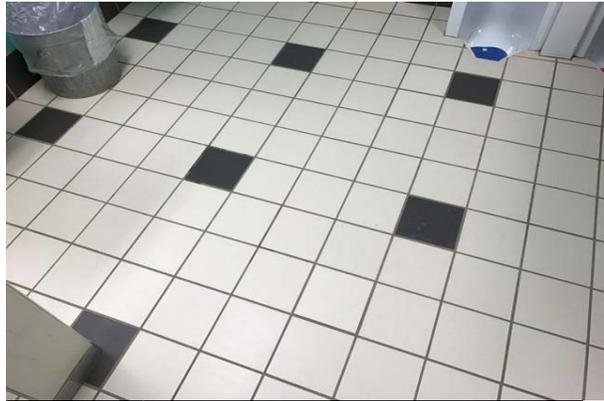
#32:	CERAMIC TILE FLOOR
------	--------------------

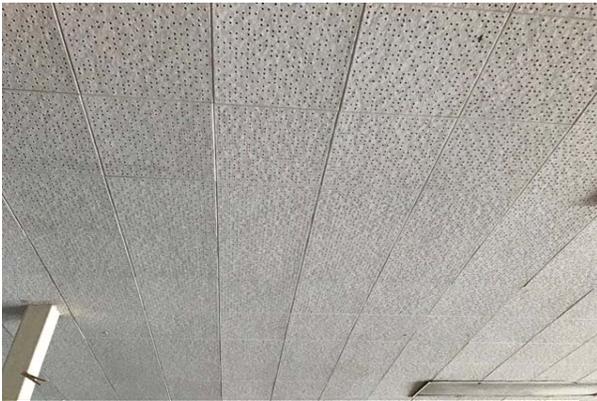
#33:	ACOUSTICAL HARD TILE
------	----------------------

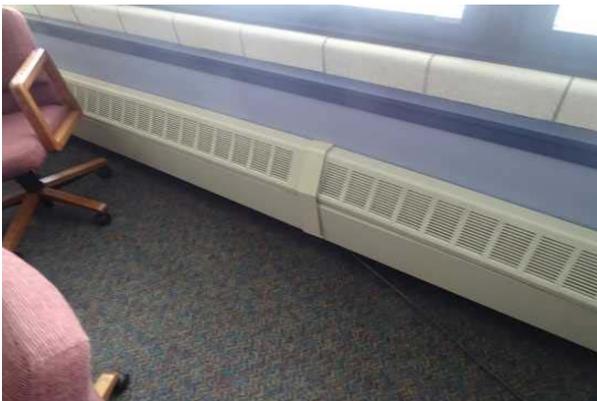
#35:	CARPET
------	--------

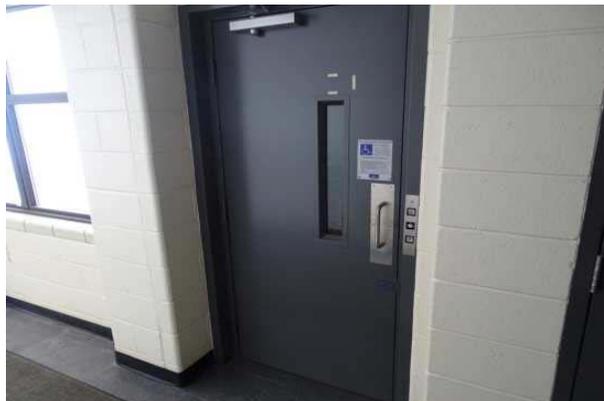
#36:	HYDRAULIC STAGE LIFT
------	----------------------

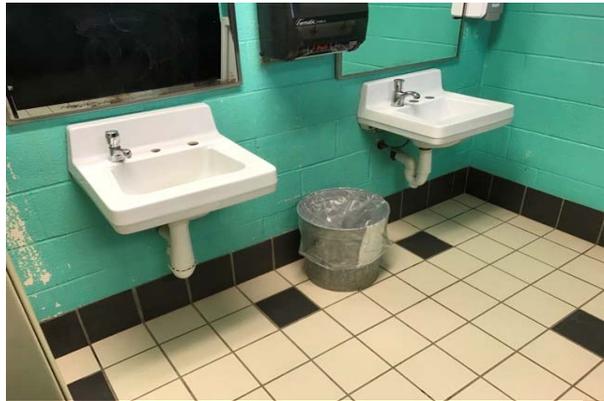
#40:	SINKS
------	-------

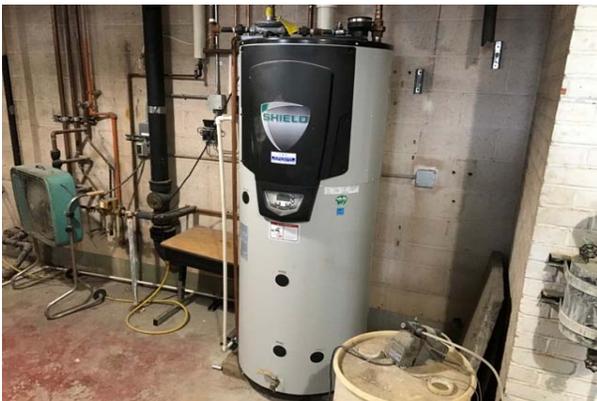
#41:	WATER HEATER
------	--------------

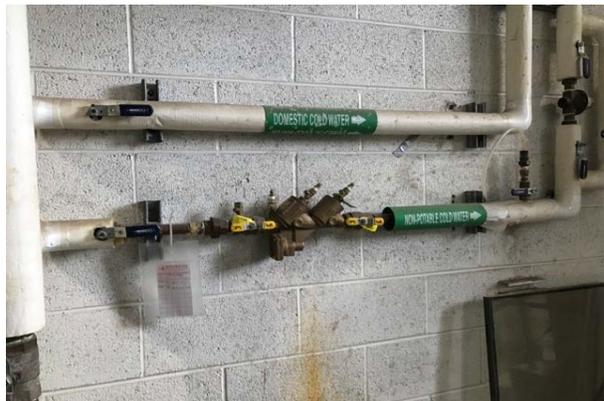
#42:	BACKFLOW PREVENTER
------	--------------------

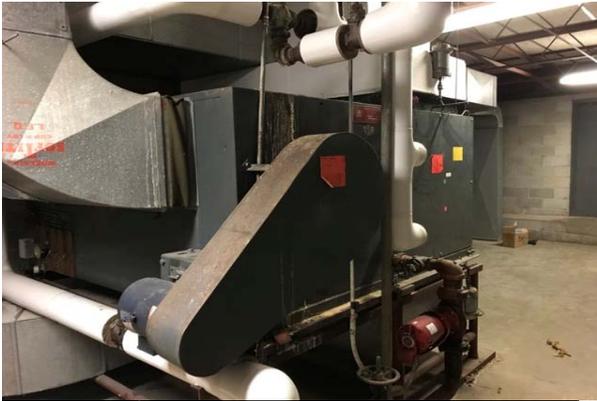
#43:	AIR HANDLER
------	-------------

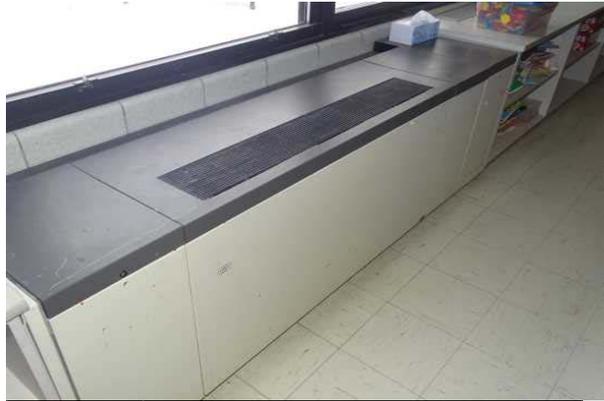
#44:	UNIT VENTILATOR
------	-----------------

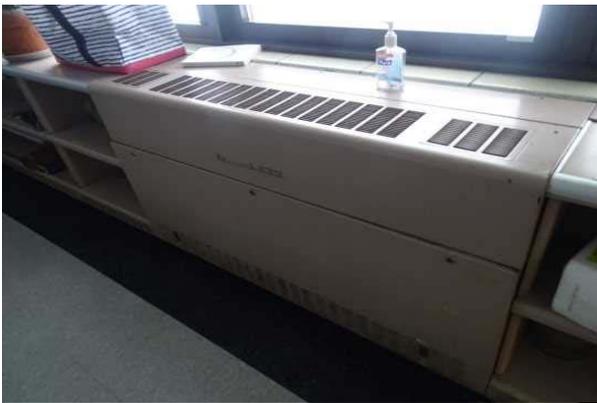
#45:	UNIT VENTILATOR
------	-----------------
